**INCIDENT**

<b>Aircraft Type and Registration:</b>	ATR42-300, EI-SLD	
<b>No &amp; Type of Engines:</b>	2 Pratt and Whitney PW120 turboprop engines	
<b>Year of Manufacture:</b>	1985	
<b>Date &amp; Time (UTC):</b>	18 January 2007 at 2225 hrs	
<b>Location:</b>	London Stansted Airport	
<b>Type of Flight:</b>	Commercial Air Transport (Cargo)	
<b>Persons on Board:</b>	Crew - 2	Passengers - None
<b>Injuries:</b>	Crew - None	Passengers N/A
<b>Nature of Damage:</b>	None	
<b>Commander's Licence:</b>	Airline Transport Pilot's Licence	
<b>Commander's Age:</b>	41 years	
<b>Commander's Flying Experience:</b>	2,732 hours (of which 2,144 were on type) Last 90 days - 147 hours Last 28 days - 35 hours	
<b>Information Source:</b>	AAIB Field Investigation

**Synopsis**

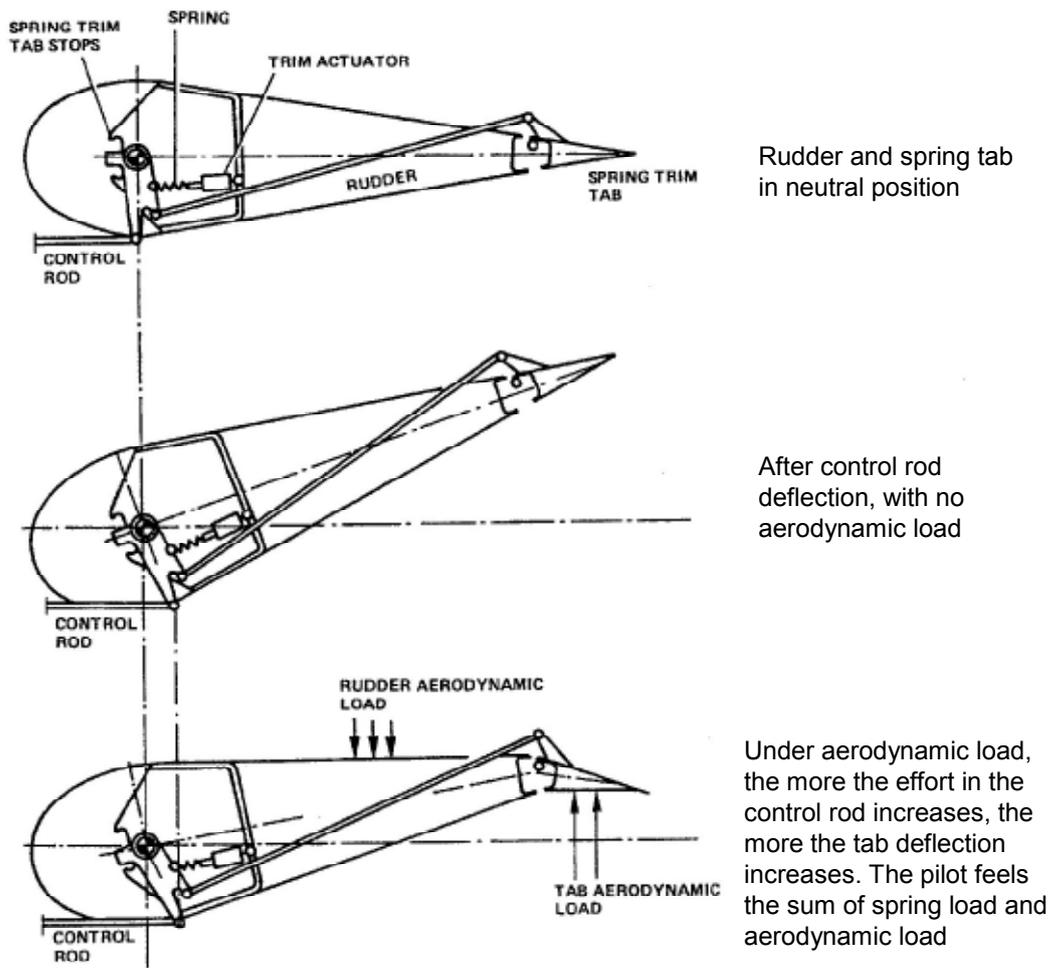
**Figure 2**

Schematic representation of rudder and spring tab operation

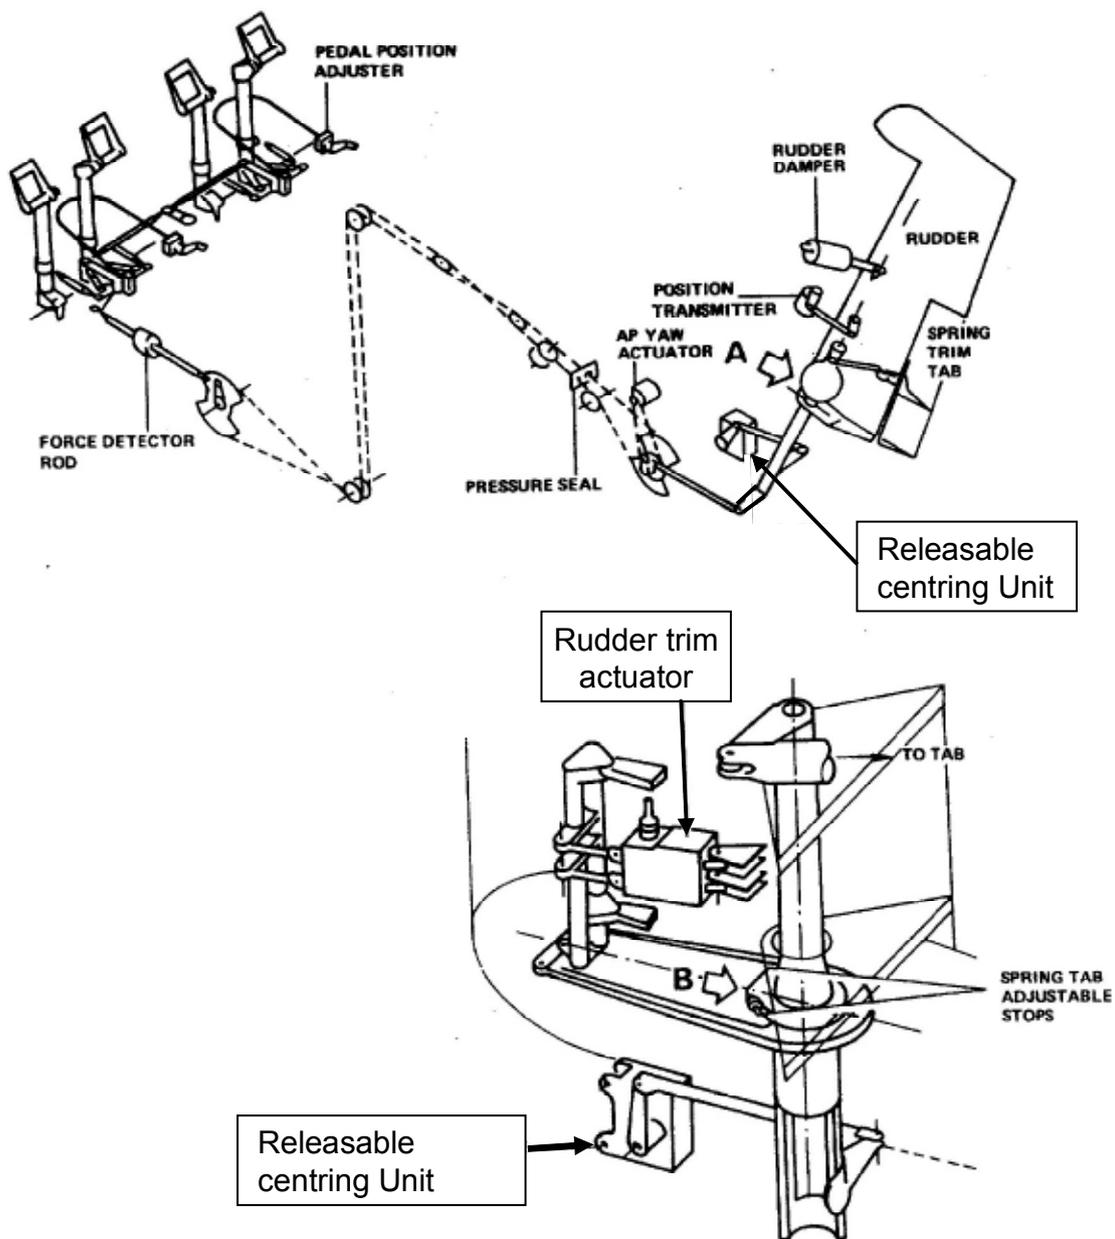
An electrically operated trim actuator acts on the same linkage and is controlled from the flight deck pedestal (Figure 3). The design of the rudder trim switch in the flight deck is such that a left or right trim demand also makes an electrical connection to an electromagnetic clutch within the RCU, causing it to release the rudder linkage, thus allowing it to centre on the new trimmed

**Figure 3**  
Rudder system layout
