ACCIDENT

Aircraft Type and Registration:	P&M Aviation Ltd Flight Design CTSW, G-VINH	
No & Type of Engines:	1 Rotax 912ULS piston engine	
Year of Manufacture:	2006	
Date & Time (UTC):	12 August 2009 at 1550 hrs	
Location:	Caird Park Golf Course, Dundee	
Type of Flight:	Private	
Persons on Board:	Crew - 1	Passengers - None
Injuries:	Crew - 1 (Minor)	Passengers - N/A
Nature of Damage:	Aircraft destroyed	
Commander's Licence:	National Private Pilot's Licence	
Commander's Age:	63 years	
Commander's Flying Experience:	136 hours (of which most were on type) ¹ Last 90 days - 20 hours Last 28 days - 13 hours	
Information Source:	AAIB Field Investigation

The pilot made a forced landing in a tree after the engine stopped near Dundee. The investigation identified flight planning as a contributory factor. One Safety Recommendation is made.

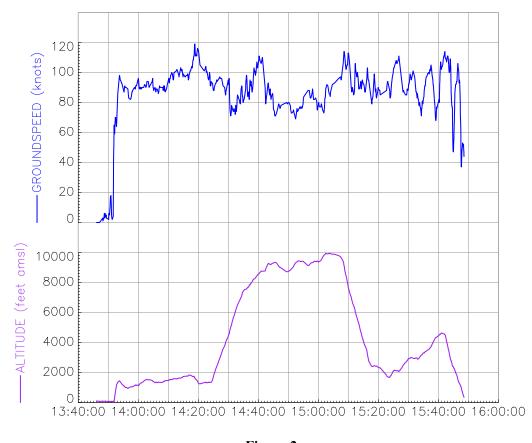
Figure 2 The aircraft's altitude and groundspeed

The GPS unit had a complete log of the accident flight starting at 1346:03 hrs at Walney Airfield, Barrow-on-Furness, and ending at 1548:31 hrs at the Caird Park golf course, Dundee. The recorded track included altitude information and is presented at Figure 1. The highest altitude the aircraft reached was 9,935 ft amsl, at 1504:24 hrs, when it was approximately 15 nm south of Edinburgh. Altitude and groundspeed, averaged between consecutive points, are plotted in Figure 2. This shows a descent from 9,935 ft to 1,663 ft amsl, as the aircraft crossed the A91 north of Glenrothes, before it climbed again.

The final descent was at a rate of approximately 900 ft/min, reducing to 600 ft/min as the aircraft flew a descending turn, clockwise, through 270° (see Figure 3) The aircraft continued descending at about this rate until the final recorded GPS position, which placed the aircraft at 340 ft amsl (110 ft agl), close to the accident site.
