ACCIDENT

Aircraft Type and Registration:	Europa, G-HOFC	
No & Type of Engines:	1 Rotax 912-UL piston engine	
Year of Manufacture:	1996	
Date & Time (UTC):	1 June 2007 at 1445 hrs	
Location:	Near Magor, Gwent	
Type of Flight:	Private	
Persons on Board:	Crew - 1	Passengers - 1
Injuries:	Crew - 1 (Fatal)	Passengers - 1 (Fatal)
Nature of Damage:	Aircraft destroyed	
Commander's Licence:	Private Pilot's Licence	
Commander's Age:	66 years	
Commander's Flying Experience:	1,631 hours (of which 1,054 hours were on type) Last 90 days - 17 hours Last 28 days - 8 hours	
Information Source:	AAIB Field Investigation

Synopsis

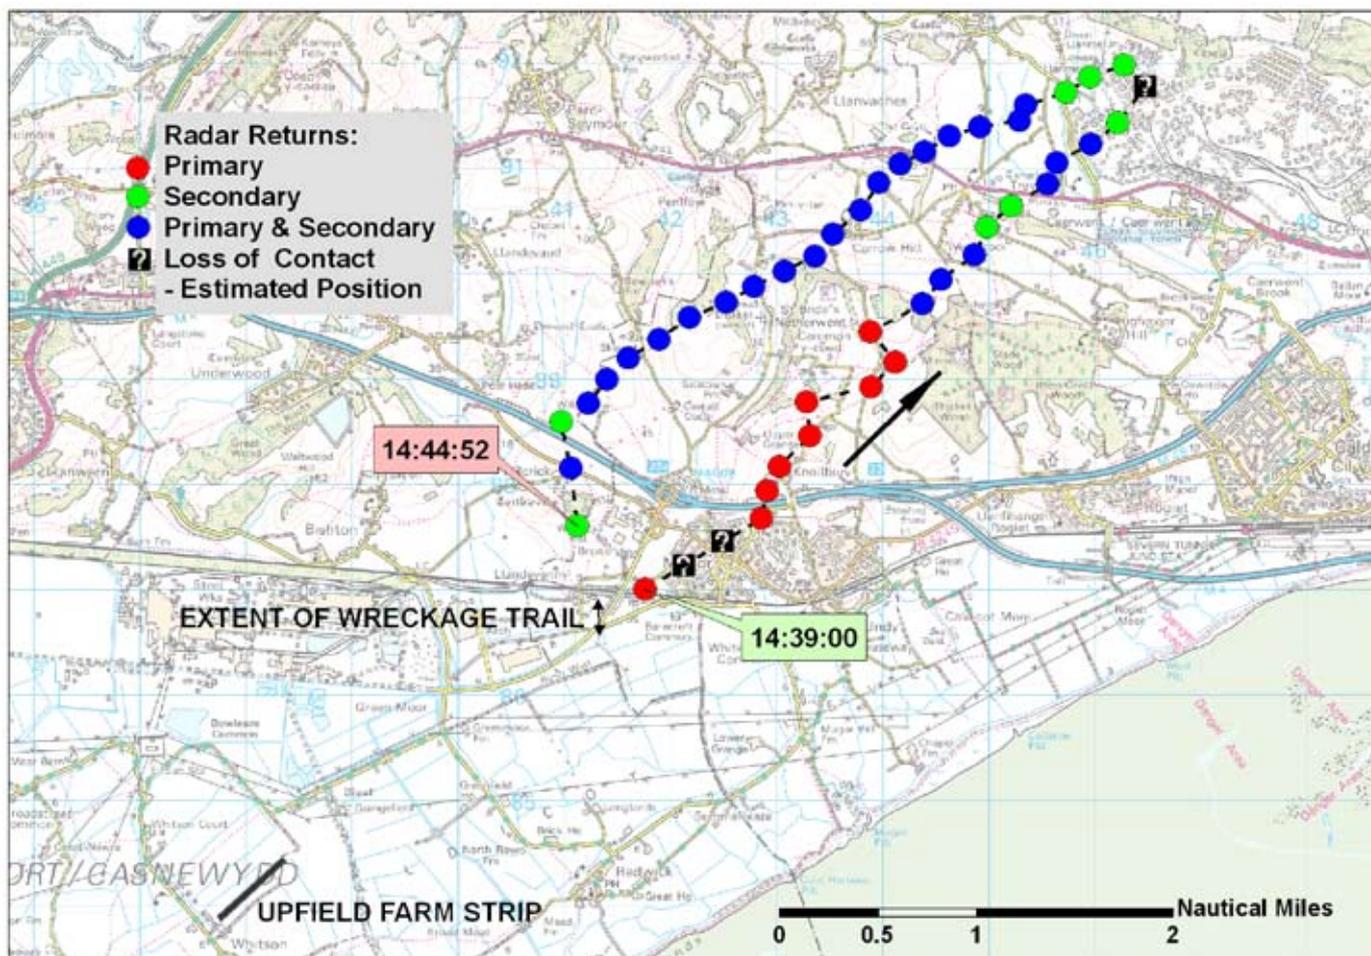
Figure 1

Radar data obtained from the Cardiff radar site recorded the aircraft track and ground speed. No Mode C (altitude) information was received and therefore no height information was available. The aircraft track is shown at Figure 1. From this information the aircraft flew north-east, away from Uckfield Farm and then made a sharp left turn onto a south-westerly heading. No reason for this turn was identified.

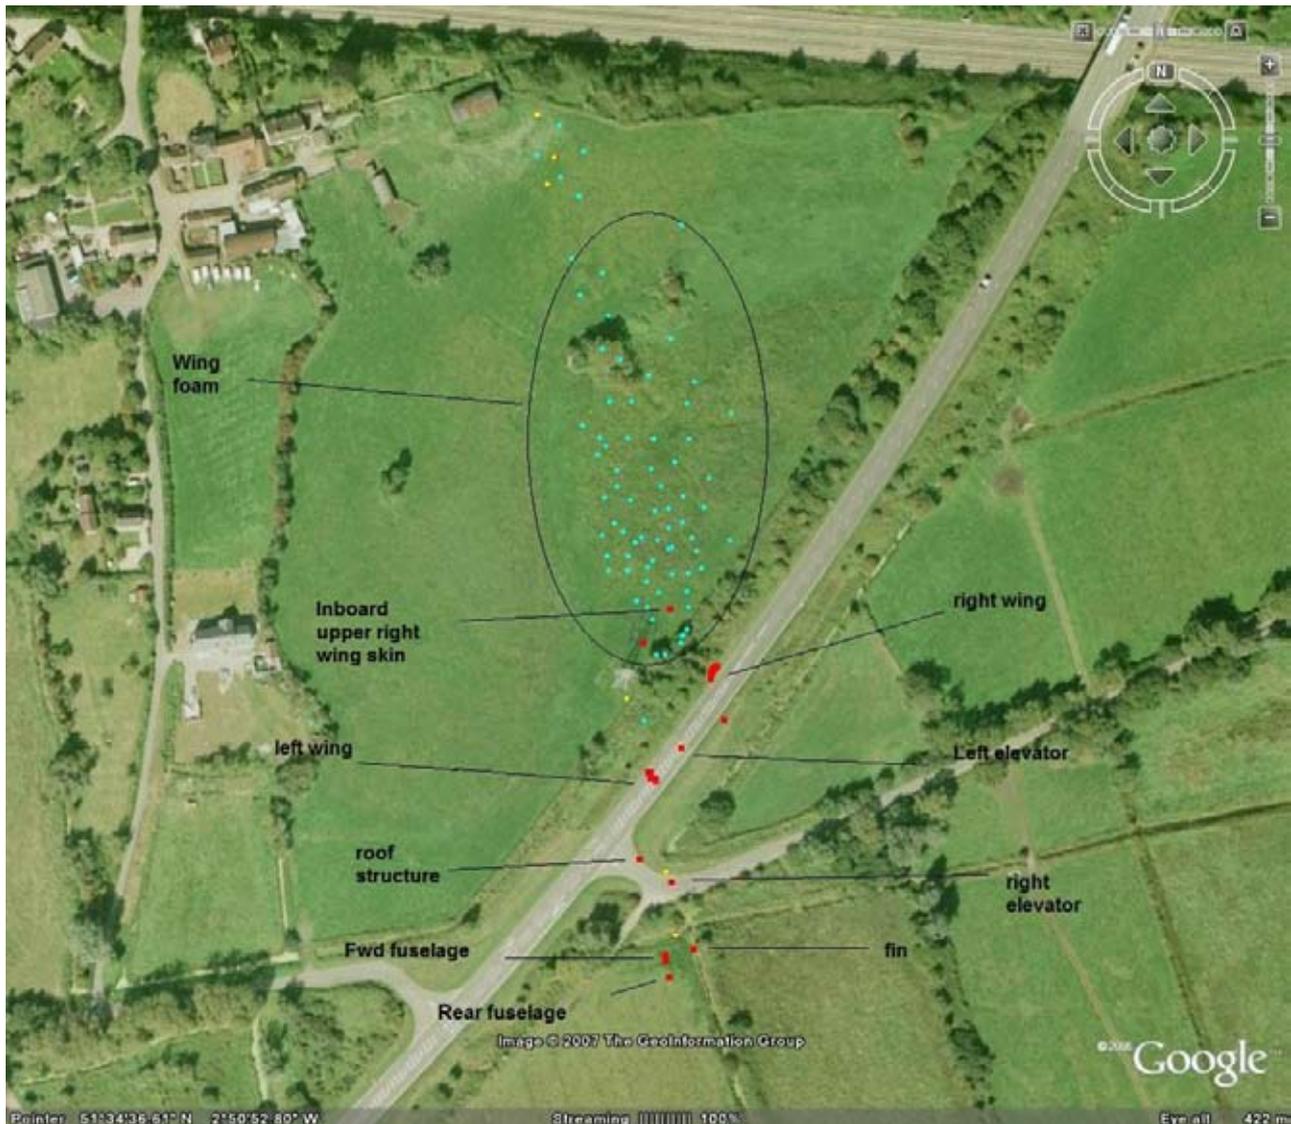
Figure 2

The wreckage trail continued for 430 metres on an approximate heading of 170° immediately to the south of a railway line, see Figure 2. The first items recovered were flight documentation and some personal effects. Approximately 35 metres south of the railway

embankment small fragments of blue foam were found, which were later identified as being part of the internal structure of the right wing. As the trail of foam fragments continued southwards, the size and frequency of these fragments increased. A significant amount of the cockpit glazing was also found in the field. A fragment of the right inboard upper wing skin about 1.5 metres square was found close to an electricity pylon within the field. The remains of the right wing were found on the verge as the wreckage trail passed over a road. The left tailplane and sections of the cockpit doors and rear right wing root lay on the road, together with the left wing. The remains of the cockpit roof and the right tailplane lay 25 metres beyond the left wing at the road junction.

The fuselage had struck the ground in a steep nose-down attitude in a field immediately to the south of the junction. The engine and cockpit sections had both come to rest close to the point of impact. The rear fuselage and fin structure had broken away from the cockpit section and come to rest 15 metres from the initial impact point. The fin and rudder were found in a water-filled ditch 15 metres beyond the rear fuselage. The aircraft's fuel tank had been thrown from the aircraft and was also found in the ditch. Examination of the overhead power lines by the local electricity company confirmed that the aircraft had not struck the overhead cables.

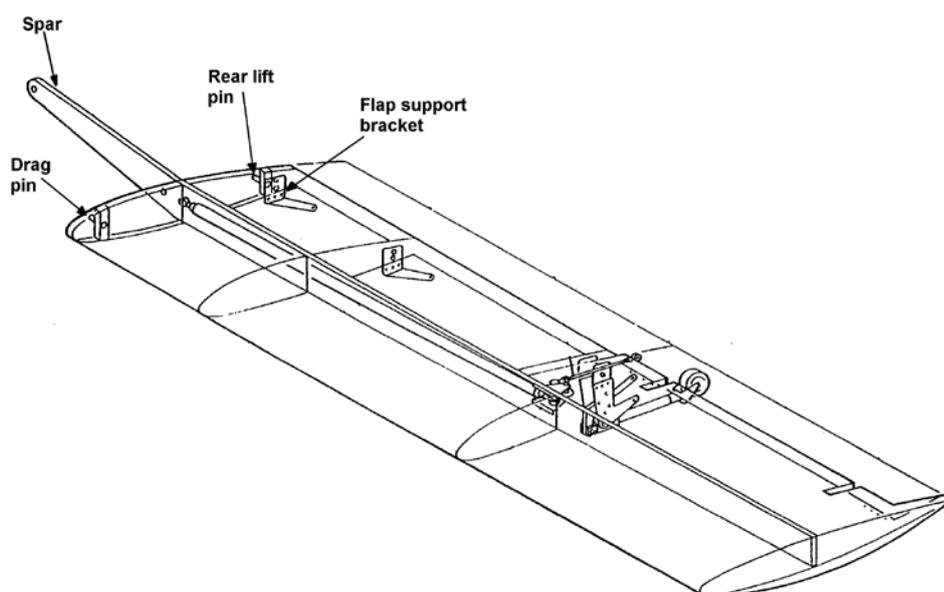
Figure 3

The fuselage of the Europa is made up of a series of Glass Reinforced Plastic (GRP) mouldings fitted out and bonded together by the builder. Each wing of the 'Classic' consists of a single GRP spar, to which is attached a series of ribs. The profile of the wing is produced through the use of shaped medium density foam 'infill' and bonded GRP skins. The wings are secured to the fuselage at three points; the spar, a 'lift' pin and also by a rear 'lift/drag' pin, see Figure 3. The wing spars, which carry the majority of the flight loads, pass through a slot in the fuselage

where they are connected to each other and to the fuselage by stainless steel 'rigging' pins. The lift pin is located towards the leading edge of the wing and the drag pin just forward of the trailing edge flap. The lift and drag pins are secured to the wing by a mount bonded to the face of the inboard wing rib. The mount consists of a laminated structure made up of three aluminium alloy plates, 25 mm wide and 3 mm thick, and layers of GRP cloth. (Later versions of the Europa, with factory assembled wings, made use of plates which were 50 mm wide.) The drag pins are designed to stabilise the wings in a fore and aft direction. The lift pin transmits some of the wing's lift load to the fuselage and maintains its torsional stiffness. At high angles of attack the lift distribution on the wing is such that the drag pin and its mounting are in tension. The aircraft is fitted with flaps which are connected to an actuation beam within the fuselage. The 'Classic' makes use of a mono-wheel main landing gear, with two 'outrigger' wheels mounted on the outboard end of the flaps. The flaps and landing gear cannot be lowered independently and are operated by a single lever in the cockpit.
