### **Detailed examination of the left engine accessory gears**

## **Analysis of the rupture of the idler pin support**

## **Investigations into torsional viscous damper's and accessory gears**

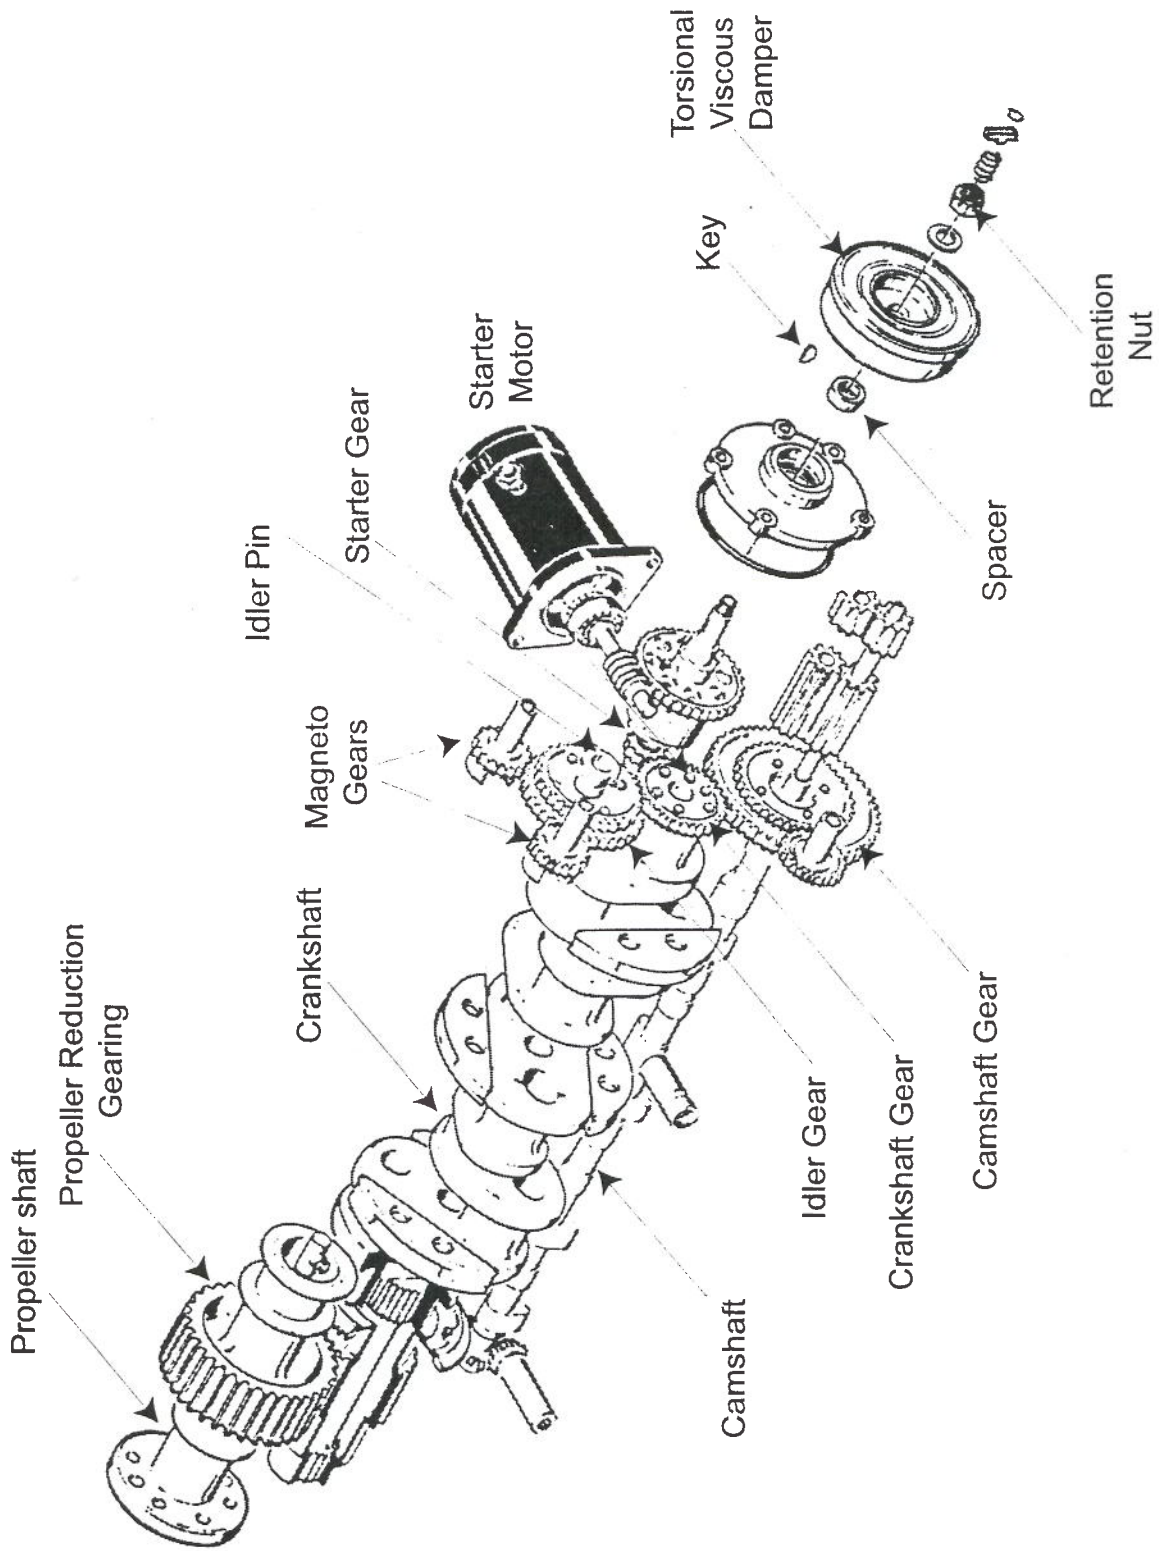
**PHOTOGRAPH OF DAMAGED ACCESSORY GEARS - LEFT ENGINE**

As the left engine and propeller was windmilling at impact and had continued to rotate after the initial failures, damage was caused to these components which tended to obscure the nature of the initial damage.

The starter gear (Part number 653712C) had been stripped of all its teeth and only four survived in recognisable state in the debris recovered from the sump. The one tooth of the starter gear, which was considered to be the first to fail, contained multiple fatigue sites. No material or manufacturing defects were identified and it appeared, therefore, that fatigue had developed due to high cyclic loading conditions. The gear tooth flanks showed evidence of heavy wear, being indented, polished and pitted and this, also, was an indication that the gear had been subjected to damaging loads. This wear was distinct from the coarse damage seen on the flanks of the other teeth and was taken to represent the condition of the gear before its break-up had begun and was therefore the result of a longer term wear process.

The crankshaft gear (Part Number 653580C) had lost 17 of its 30 teeth. All the tooth fractures were in overload. The 13 still in place showed bruising and impact damage from running out of mesh with the starter gear, the camshaft gear and the idler gear. Damage from the starter gear could be distinguished because its teeth were broader than those of the other two gears. The gear teeth flanks (both sides) also showed evidence of longer term wear. The teeth which had detached from the crankshaft gear and were found in the sump showed less damage from their contacts with the other gears but all showed heavy wear.

All the teeth on the camshaft gear had been removed and only the smeared roots of the teeth remained. No camshaft gear teeth were identified in the sump debris.

The idler gear was less damaged than the other gears described above. The crowns of the teeth were damaged but the teeth were not wiped out down to the roots as on the camshaft gear. One tooth had broken off at the root in overload and was recovered from the sump. One flank was highly polished, slightly dished at mid height (just perceptible) and there were two pits near one end. These features were indicative of wear rather than traumatic damage. On its crown and other flank the tooth showed evidence of having been sheared out by crown to crown impact with another gear tooth. The tooth's crown was almost undamaged but near its trailing edge (relative to direction of travel) material has been sheared downwards along a straight spanwise line. One half of the tooth was sheared downwards against the other, splitting the tooth from crown to root. This had forced the other half of the tooth backwards against direction of rotation shearing it off at the root. The two halves of the tooth appeared to be welded together along the
