SERIOUS INCIDENT

Aircraft Type and Registration:	AgustaWestland AW139, G-CHCV
No & Type of Engines:	2 Pratt & Whitney Canada PT6C-67C turboshaft engines
Year of Manufacture:	2007
Date & Time (UTC):	23 December 2008 at 1405 hrs
Location:	The North Sea, 65 nm north-east of North Denes Heliport
Type of Flight:	Commercial Air Transport (Passenger)
Persons on Board:	Crew - 2 Passengers - 8
Injuries:	Crew - None Passengers - None
Nature of Damage:	None
Commander's Licence:	Airline Transport Pilots Licence (Helicopters)
Commander's Age:	45 years
Commander's Flying Experience:	7,311 hours (of which 833 hours were on type) Last 90 days - 113 hours Last 28 days - 43 hours
Information Source:	AAIB Field Investigation

Synopsis

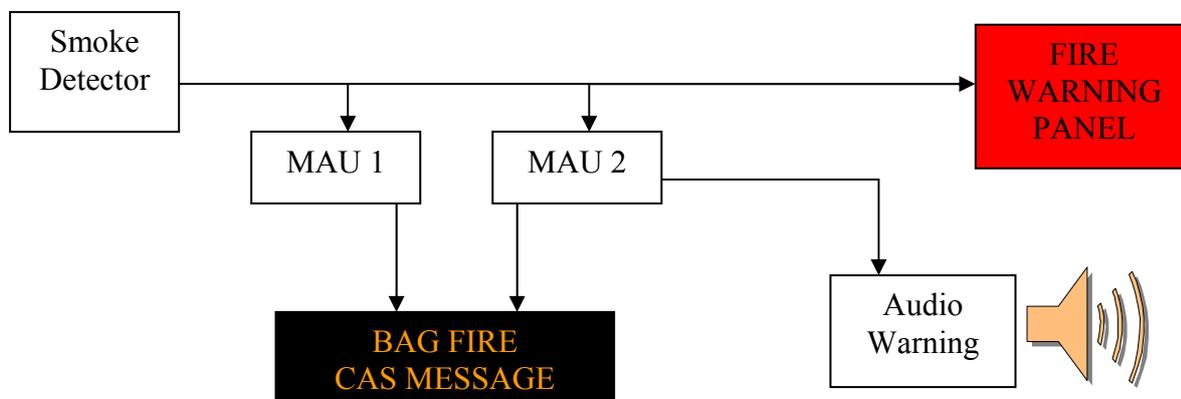
The baggage area is monitored by a smoke detector which is connected to both MAUs and the fire warning panel. If a baggage fire warning is detected, the crew should be alerted by a red light on the fire warning panel, a BAG FIRE CAS message and audio warning. The CAS warning will be displayed if either MAU detects a trigger from the smoke detector, but all audio warnings are generated by MAU 2. Figure 3 shows the system schematic diagram.

The baggage compartment fire detection system schematic

2. The data indicated that the CSIO2 module triggered the CAS BAG FIRE caption after water was sprayed between the two circuit boards of the module. Additional messages were generated simply as a result of water shorting out the 'Bag Fire 28V/Open Discrete' signal. However, it should be noted that the warning light on the Fire Control Panel is not connected to CSIO2 (or any other MAU module) and is only illuminated following activation of the bag fire sensor (see Figure 3).
