**ACCIDENT**

<b>Aircraft Type and Registration:</b>	Piper PA-34-200T, G-BEJV	
<b>No &amp; Type of Engines:</b>	2 Teledyne Continental TSIO-360-EB piston engines	
<b>Category:</b>	1.3	
<b>Year of Manufacture:</b>	1976	
<b>Date &amp; Time (UTC):</b>	30 March 2004 at 1810 hrs	
<b>Location:</b>	Oxford Airport, Oxfordshire	
<b>Type of Flight:</b>	Training	
<b>Persons on Board:</b>	Crew - 2	Passengers - 1
<b>Injuries:</b>	Crew - None	Passengers - None
<b>Nature of Damage:</b>	Damage to bulkhead aft of nose wheel	
<b>Commander's Licence:</b>	Commercial Pilot's Licence, with Instrument and Instructor ratings	
<b>Commander's Age:</b>	68 years	
<b>Commander's Flying Experience:</b>	12,300 hours (of which 5,100 were on type) Last 90 days - 102 hours Last 28 days - 45 hours	
<b>Information Source:</b>	Aircraft Accident Report Form submitted by the pilot and additional AAIB enquiries

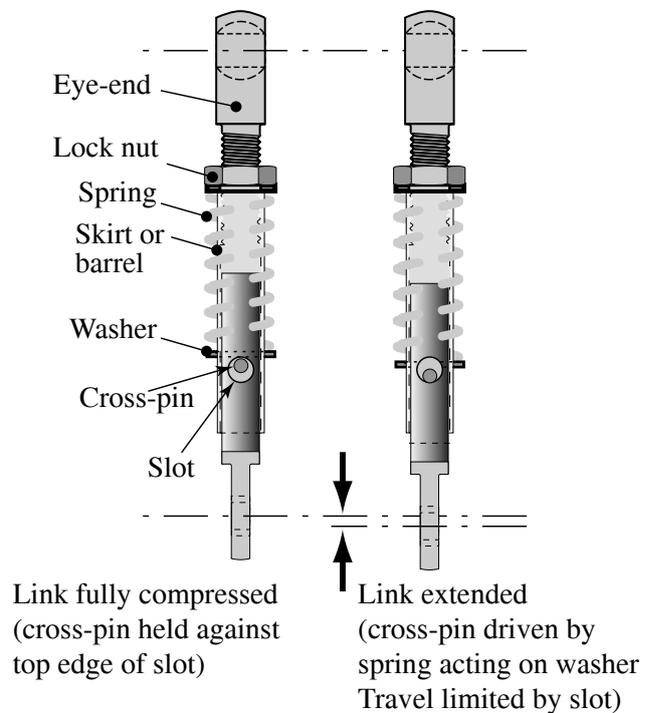
**Figure 2**  
Downlock link  
Sectioned assembly)

The lower part of the downlock link assembly is a spring strut (see Figure 2, below) which has a spring force of about 2-3 lbs and is compressible by about 0.06 inch. The sprung travel is limited by a cross-pin, fitted through the shank of the lower eye fitting, running in a control aperture in the barrel of the lower downlock link body. This aperture is described in the Service Manual as a 'slot'. The length of the lower downlock link is adjustable and is correct if, when the drag link assembly is driven to the fully over-centre position, the lower downlock link is almost fully compressed. The clearance of the cross-pin from the upper end of the slot, established by the rigging procedure, is a half turn of the adjustment thread, which is about 0.018 inch.

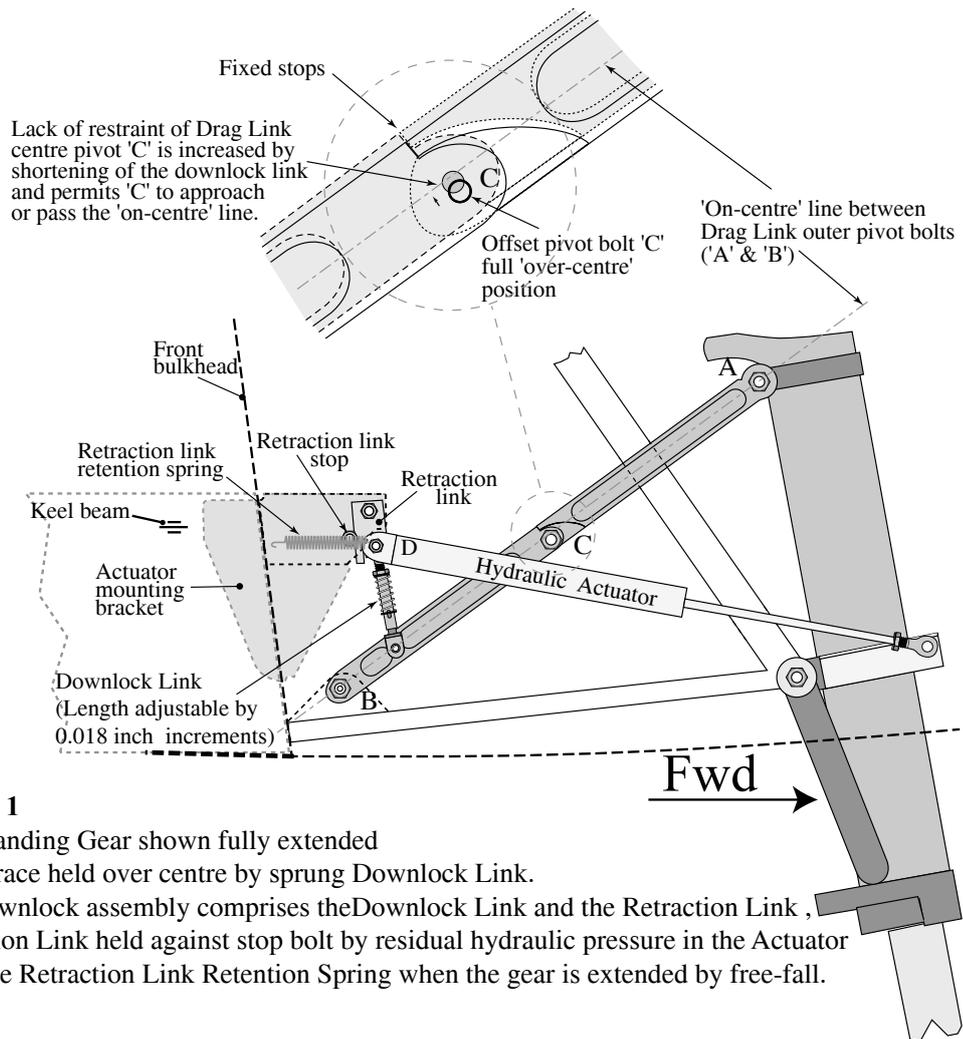
**Figure 1**

The nose landing gear of the Seneca is of the forward retracting type which, when extended, has the wheel axle forward of the oleo pivot. When retracted, the gear is held up by hydraulic pressure in the actuator and, when extended, it is held in the down position by a geometric downlock mechanism. When the nose landing gear is extended and under load the primary brace against collapse is the drag link assembly. When the landing gear is fully extended, the drag link centre pivot should be offset below the line between its two end pivots and, in this position, the fixed stops of the drag link centre joint, which limit the over-centre travel of these links, should be in abutment. (See Figure 1 Details, next page.)

Nose Landing Gear shown fully extended  
 Drag Brace held over centre by sprung Downlock Link.  
 The Downlock assembly comprises the Downlock Link and the Retraction Link ,  
 Retraction Link held against stop bolt by residual hydraulic pressure in the Actuator  
 or by the Retraction Link Retention Spring when the gear is extended by free-fall.

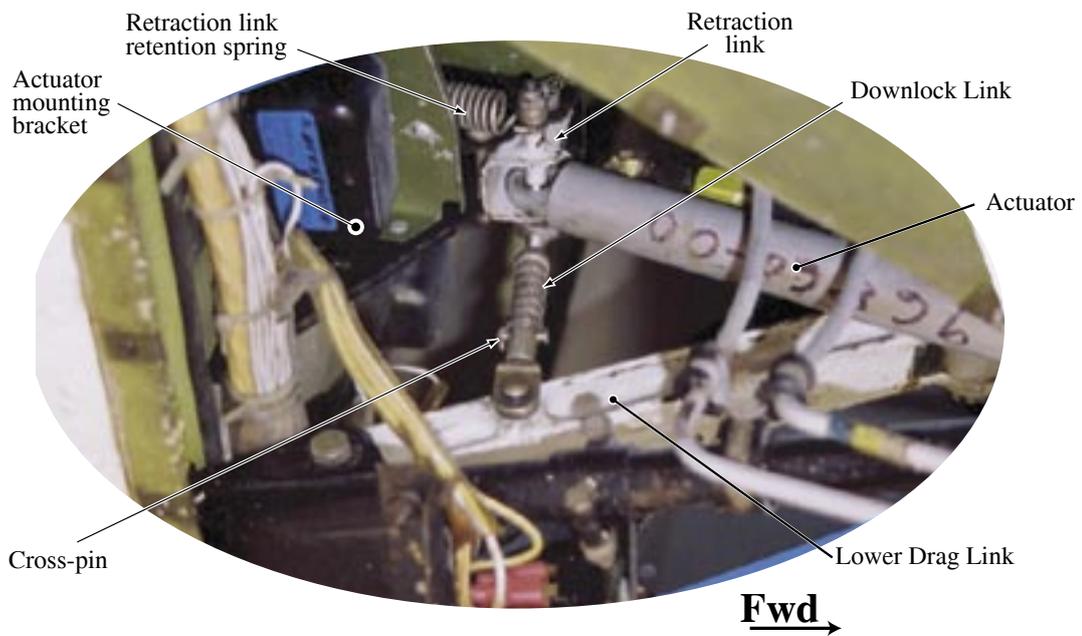
**Figure 1a**

PA-34 nose landing gear - view from below and right side showing lateral stagger of downlock linkage components.
