**ACCIDENT**

<b>Aircraft Type and Registration:</b>	Piper PA-24-260 Comanche, G-ATIA	
<b>No &amp; Type of Engines:</b>	1 Lycoming IO-540-D4A5 piston engine	
<b>Year of Manufacture:</b>	1964	
<b>Date &amp; Time (UTC):</b>	8 August 2007 at 1057 hrs	
<b>Location:</b>	Approximately half a mile east of Leicester Airport	
<b>Type of Flight:</b>	Private	
<b>Persons on Board:</b>	Crew - 1	Passengers - None
<b>Injuries:</b>	Crew - 1 (Serious)	Passengers - N/A
<b>Nature of Damage:</b>	Aircraft damaged beyond economic repair	
<b>Commander's Licence:</b>	Private Pilot's Licence	
<b>Commander's Age:</b>	74 years	
<b>Commander's Flying Experience:</b>	1,222 hours (of which 200 were on type) Last 90 days - 37 hours Last 28 days - 4 hours	
<b>Information Source:</b>	AAIB Field Investigation

**Synopsis**

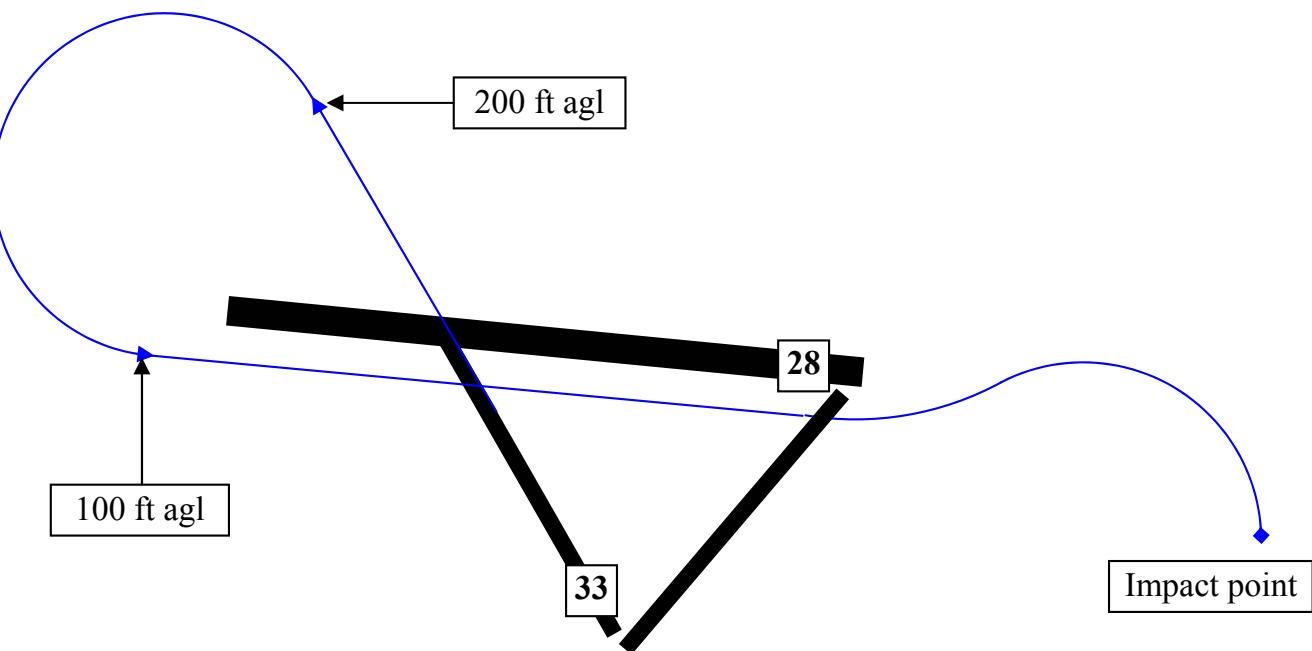
**Figure 1**  
Leicester Aerodrome layout showing aircraft’s track after go-around

with its landing gear up, so the instructor called on the radio to advise the pilot, who immediately lowered the landing gear. The engine continued to run intermittently and make noises, which another witness on the ground described as “like shotgun fire”. This witness saw the aircraft flying in an easterly direction at a speed and height that he considered too great for a landing on Runway 10. At a point south of the Runway 28 threshold, with the aircraft descending to within 50 ft of the ground, the pilot attempted to position the aircraft onto a right hand base leg for Runway 33. The aircraft was seen to climb very slowly then adopt a nose-down attitude and roll to the right. The pilot reported that at this point the engine had ceased to produce power. He responded by applying nose-up elevator control, which resulted in a nose-up attitude but no decrease in the rate of descent. This was followed almost immediately by the aircraft impacting the ground. Figure 1 depicts the aircraft’s track following the go-around.

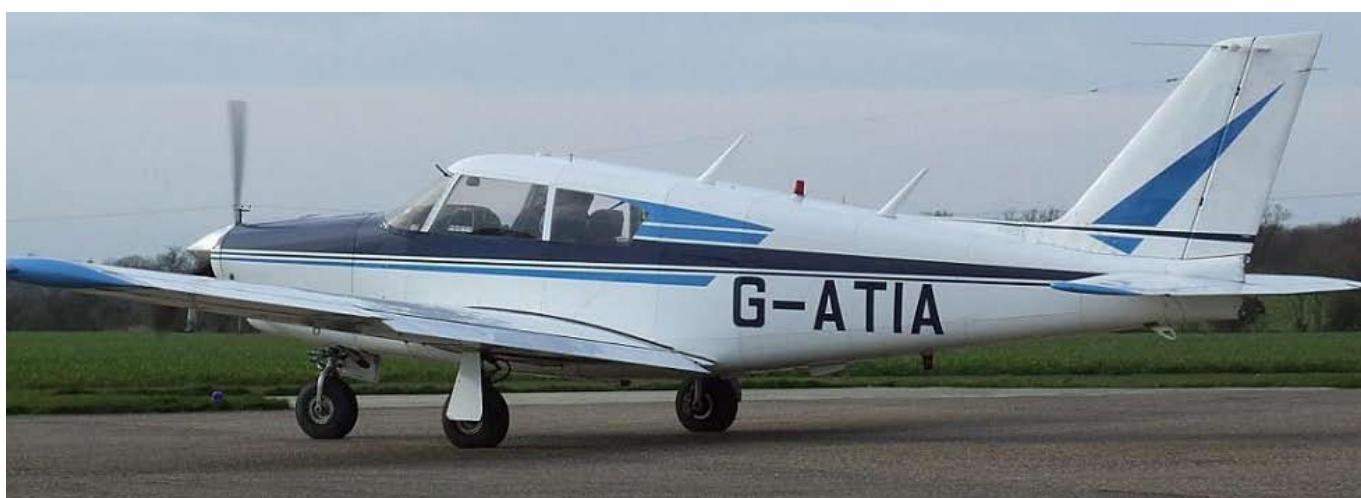
**Figure 2**  
The aircraft, G-ATIA, before the accident

and retractable tricycle landing gear (Figure 2). At the time of its last annual inspection on 4 May 2007, the airframe had accumulated 5,492 hours, the engine 81 hours, and the propeller 240 hours. The engine had been overhauled and rebuilt in the UK on 15 April 2006.
