ACCIDENT

Aircraft Type and Registration:	Cessna 401, N401JN	
No & Type of Engines:	2 Continental TSIO-520-E5B piston engines	
Year of Manufacture:	1966	
Date & Time (UTC):	21 January 2007 at 1206 hrs	
Location:	Blackpool Airport, Lancashire	
Type of Flight:	Private	
Persons on Board:	Crew - 2	Passengers - None
Injuries:	Crew - None	Passengers - N/A
Nature of Damage:	Right wing, right landing gear and right propeller damaged	
Commander's Licence:	Private Pilot's Licence	
Commander's Age:	58 years	
Commander's Flying Experience:	1,091 hours (of which 531 were on type) Last 90 days - 6 hours Last 28 days - 3 hours	
Information Source:	AAIB field investigation

Synopsis

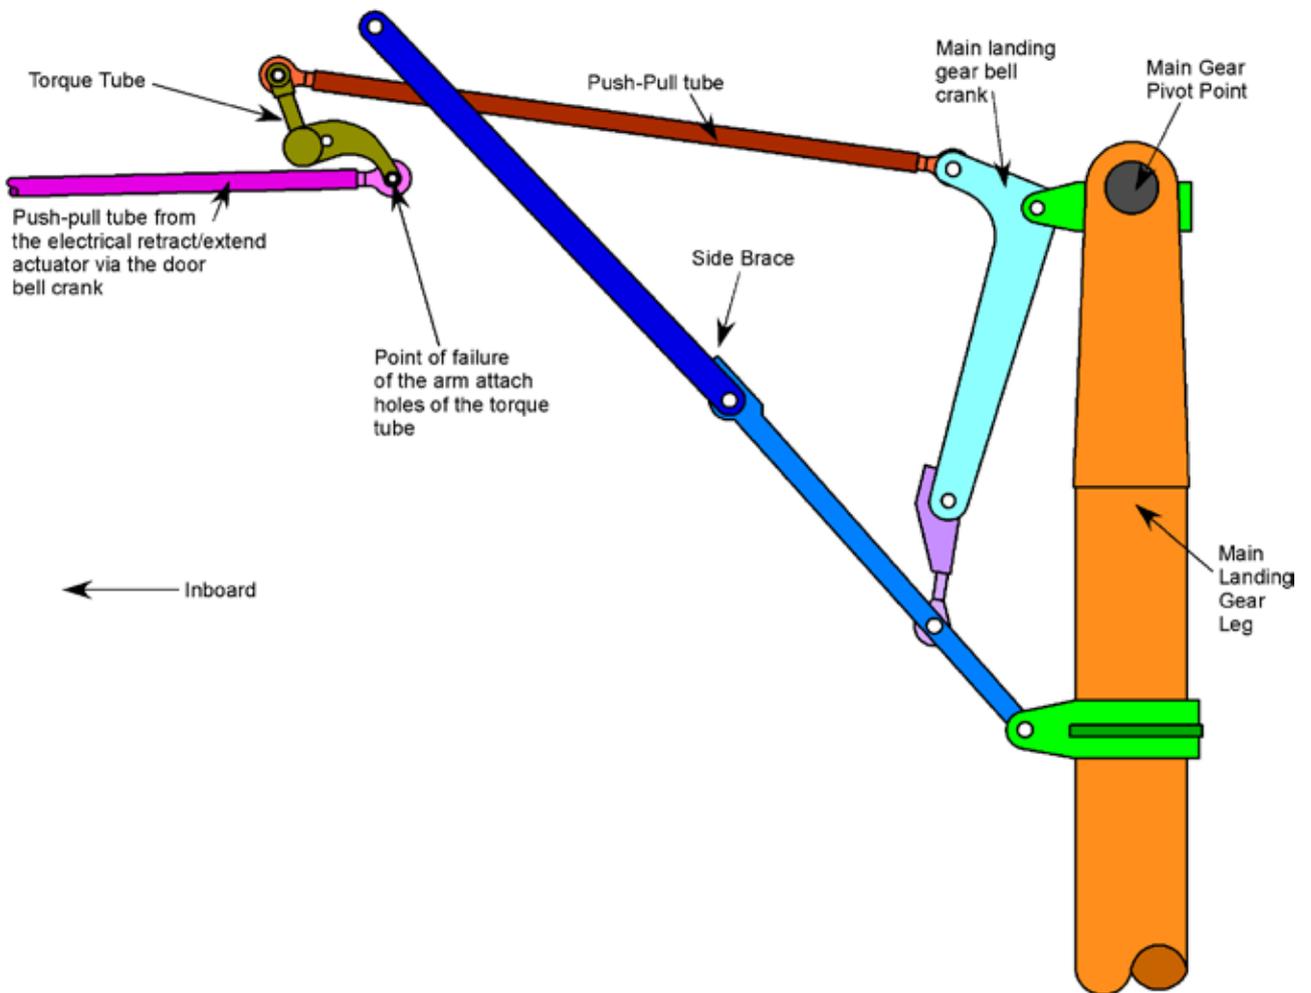
Figure 1

The rod end of the drive push-pull tube fits into an arm assembly of a torque tube and is secured by a nut and bolt through arm attachment holes, (see Figure 1). The torque tube drives a push-pull tube attached to the main landing gear bellcrank, which allows the gear to retract and extend around the main pivot point. To achieve a positive downlock the side brace of the gear is rigged to be over centre when the gear is locked down.

Representative diagram of the right main landing gear extend/retract mechanism
