SERIOUS INCIDENT

Aircraft Type and Registration:	Boeing 777-236, G-YMMP	
No & Type of Engines:	2 Rolls-Royce RB211 Trent 895-17 turbofan engines	
Year of Manufacture:	2001	
Date & Time (UTC):	14 June 2010 at 1617 hrs	
Location:	Singapore International Airport	
Type of Flight:	Commercial Air Transport (Passenger)	
Persons on Board:	Crew - 12	Passengers - 202
Injuries:	Crew - None	Passengers - None
Nature of Damage:	Extensive damage at rear of right engine nacelle and further airframe damage	
Commander's Licence:	Airline Transport Pilot's Licence	
Commander's Age:	44 years	
Commander's Flying Experience:	14,770 hours (of which 4,934 were on type) Last 90 days - 192 hours Last 28 days - 79 hours	
Information Source:	AAIB Field Investigation

Synopsis

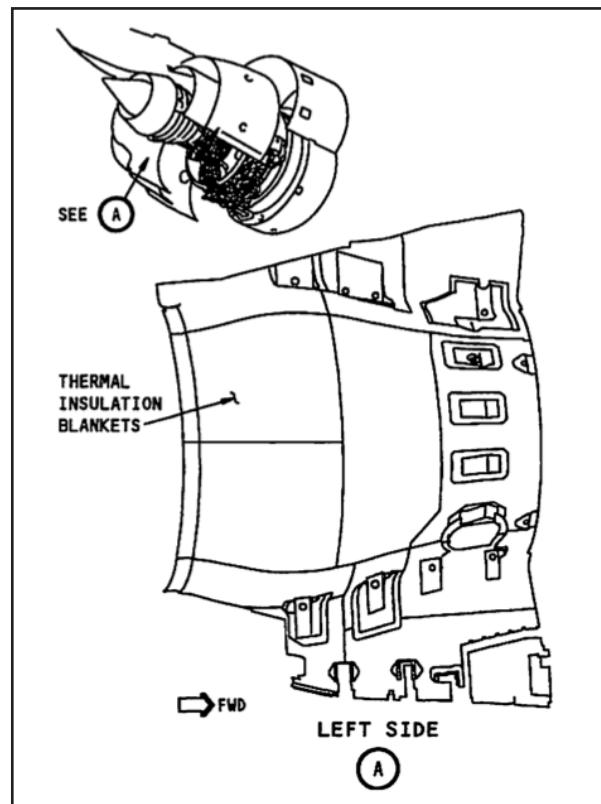
Figure 2

The inner wall of the fan duct cowl (Figures 2 and 3) is a composite material susceptible to:

'radiant heat damage from fires and [normal] engine operation'

Thrust reverser thermal barrier in fan duct cowl
(courtesy Boeing)

The integrity of the blanket-to-blanket seal, the blanket penetration seals and the blanket edge seals is critical to the success of the thermal barrier protection and to the preservation of the structural integrity of the thrust reverser inner wall. The maintenance manual states that large amounts of hot (leaked) compressor air:

'can penetrate through the gaps between the overlapped blankets to cause convective heat damage to the T/R inner wall'

'important to find any holes in the bleed offtake pneumatic ducts, or gaps at pneumatic duct connections, or damaged kiss seals and kiss seal mating surfaces during engine visual inspections.'
