SERIOUS INCIDENT

Aircraft Type and Registration:	Gulfstream G150, D-CKDM
No & Type of Engines:	2 Honeywell TFE731-40AR turbofan engines
Year of Manufacture:	2007
Date & Time (UTC):	6 February 2011 at 1317 hrs
Location:	Royal Air Force Northolt Airport, London
Type of Flight:	Commercial Air Transport (Passenger)
Persons on Board:	Crew - 2 Passengers - 3
Injuries:	Crew - None Passengers - 1 (Minor)
Nature of Damage:	Fire damage to left brakes and tyres, left and right brakes seized
Commander's Licence:	Airline Transport Pilot's Licence
Commander's Age:	32 years
Commander's Flying Experience:	1,750 hours (of which 490 were on type) Last 90 days - 54 hours Last 28 days - 15 hours
Information Source:	AAIB Field Investigation

Synopsis

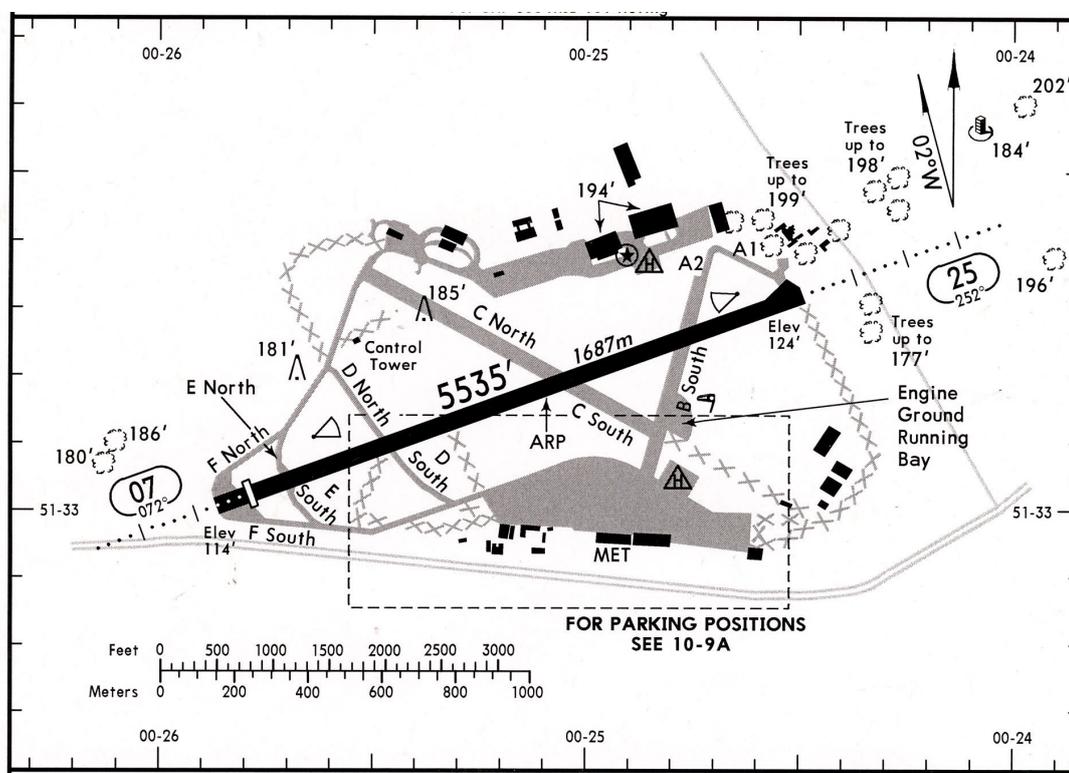
Figure 1

apron, via Taxiway B, and backtracked to line up on the threshold of Runway 25 (Figure 1). The crew carried out the taxi checks, pre-takeoff checks and a briefing before departure.

Northolt Airport
