Report on the investigation of the collision between

***Paula C***

***Darya Gayatri***

on 11 December 2013

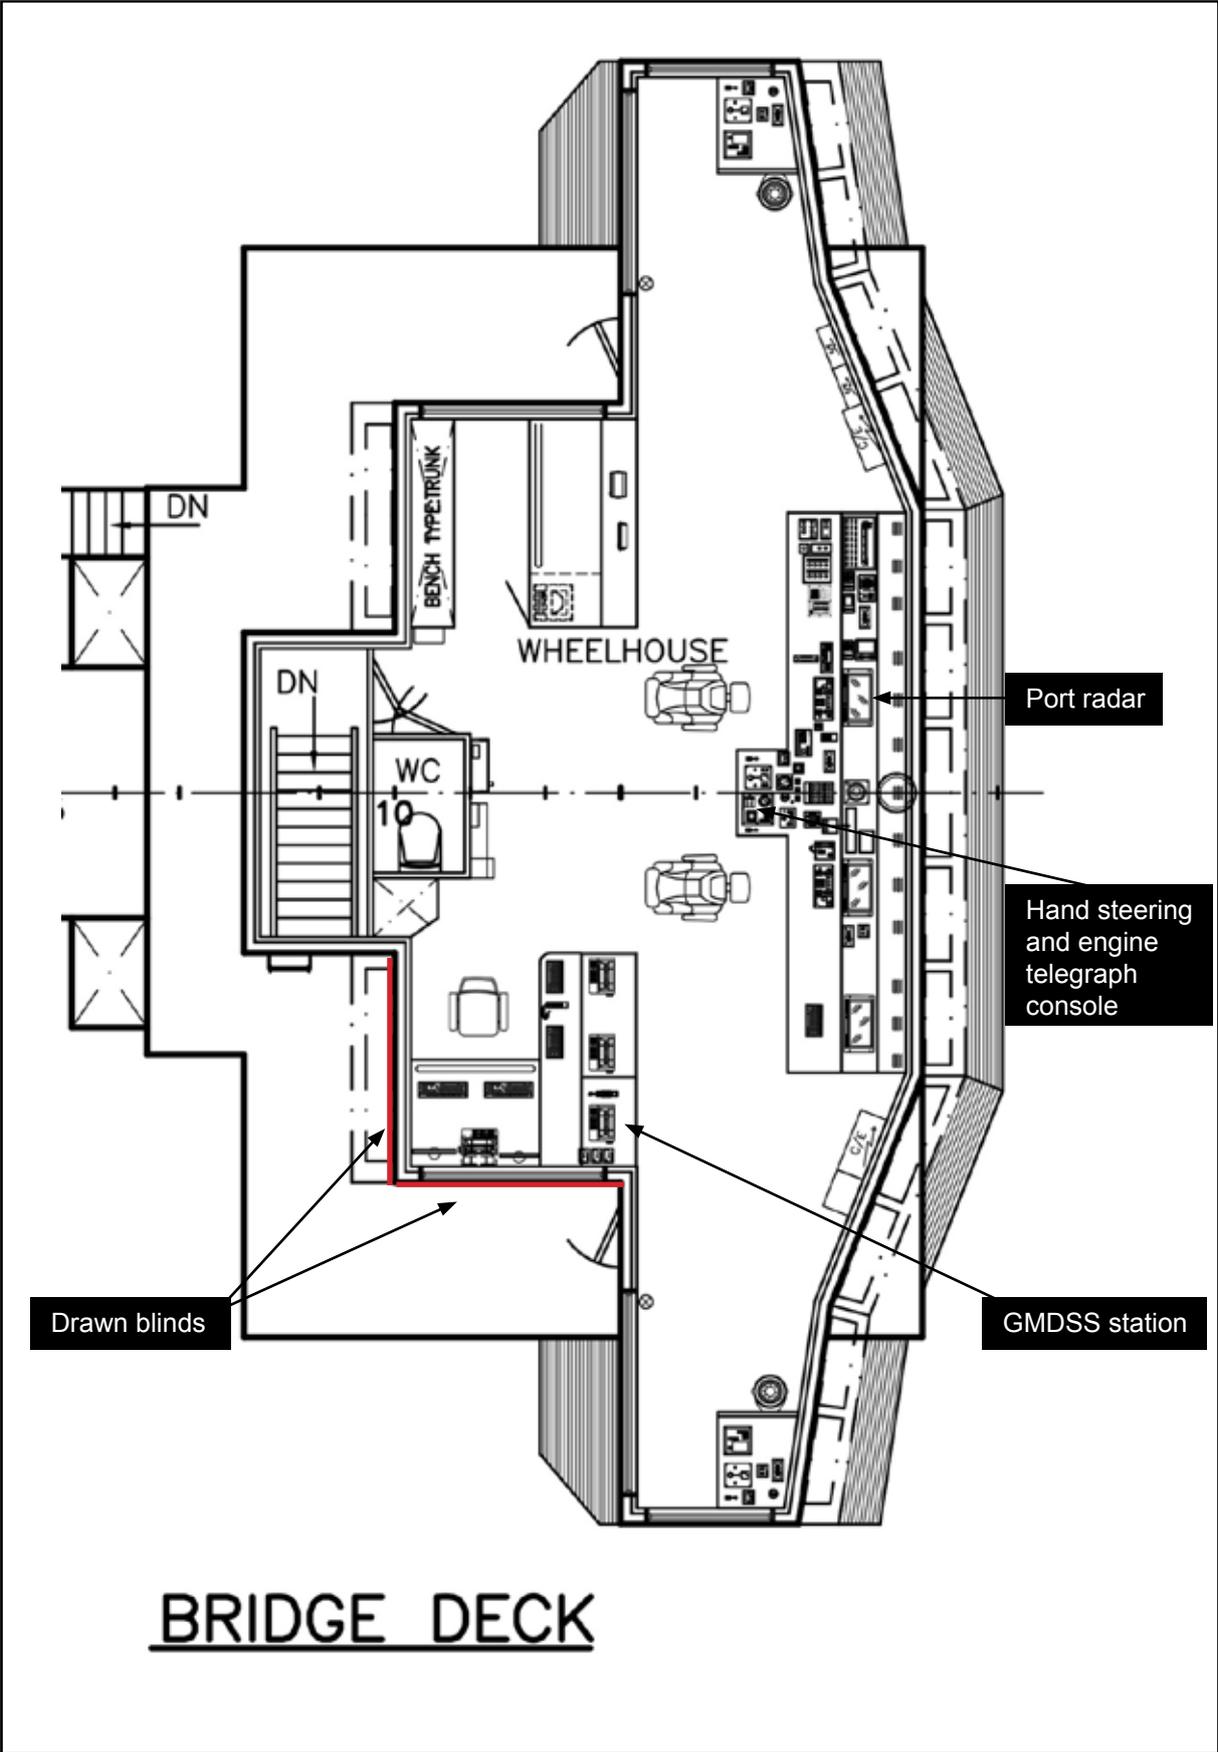
Figure 9: Paula C - bridge layout

*Paula C*'s bridge was fully enclosed (**Figure 9**). The controls for hand-steering, autopilot, steering pumps and the engine telegraph were located on a forward control console on the centreline. The navigational and communications equipment fitted on the bridge included two X-band radars with ARPA, an AIS and a GPS receiver. A Bridge Navigational Watch Alarm System (BNWAS) was also fitted, which was required to be reset every 12 minutes. The BNWAS was not connected to any navigational aids.
