Fatal man overboard while climbing on board the fishing vessel *New Dawn* to access the fishing vessel *Horizon II* at Royal Quays marina, North Shields on 9 November 2013

SUMMARY

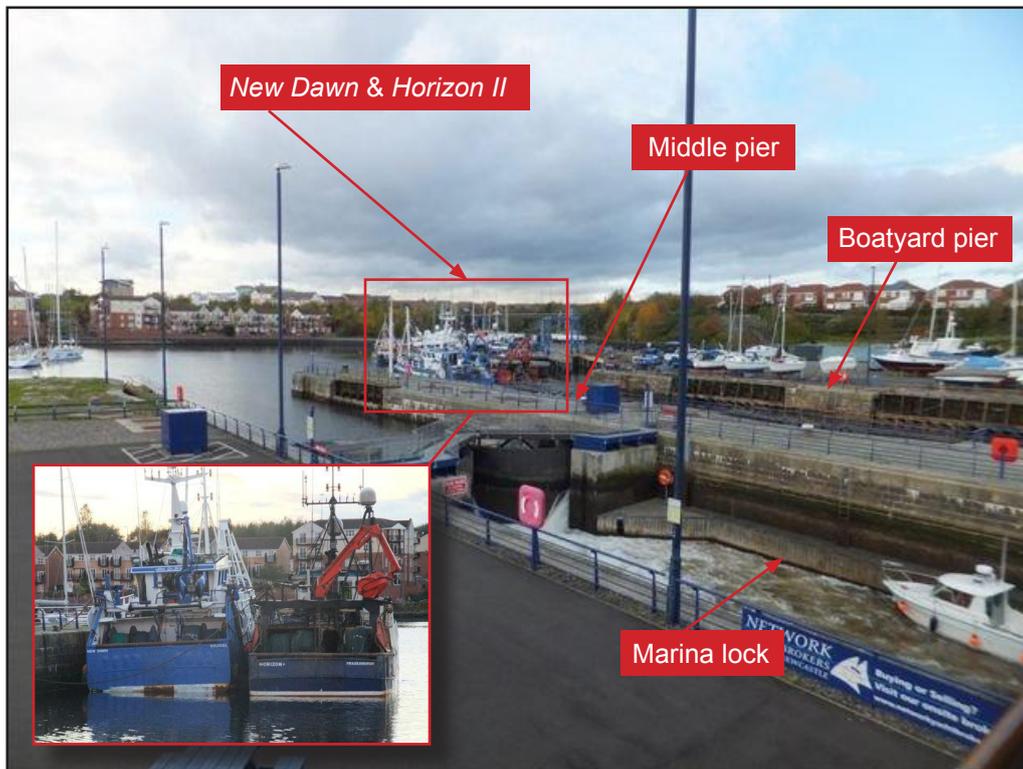
Figure 1: Royal Quays Marina lock and pier

The marina was illuminated at night by high-mounted⁷ 250 watt high pressure sodium lamps that were positioned along the marina car park, the lock entrance and along the boatyard pier (**Figure 1**). The middle pier was not fitted with high level lighting but did receive some illumination from the boatyard and lock entrance lamps. The pontoons for leisure vessels were fitted with low-level lamps at regular intervals.

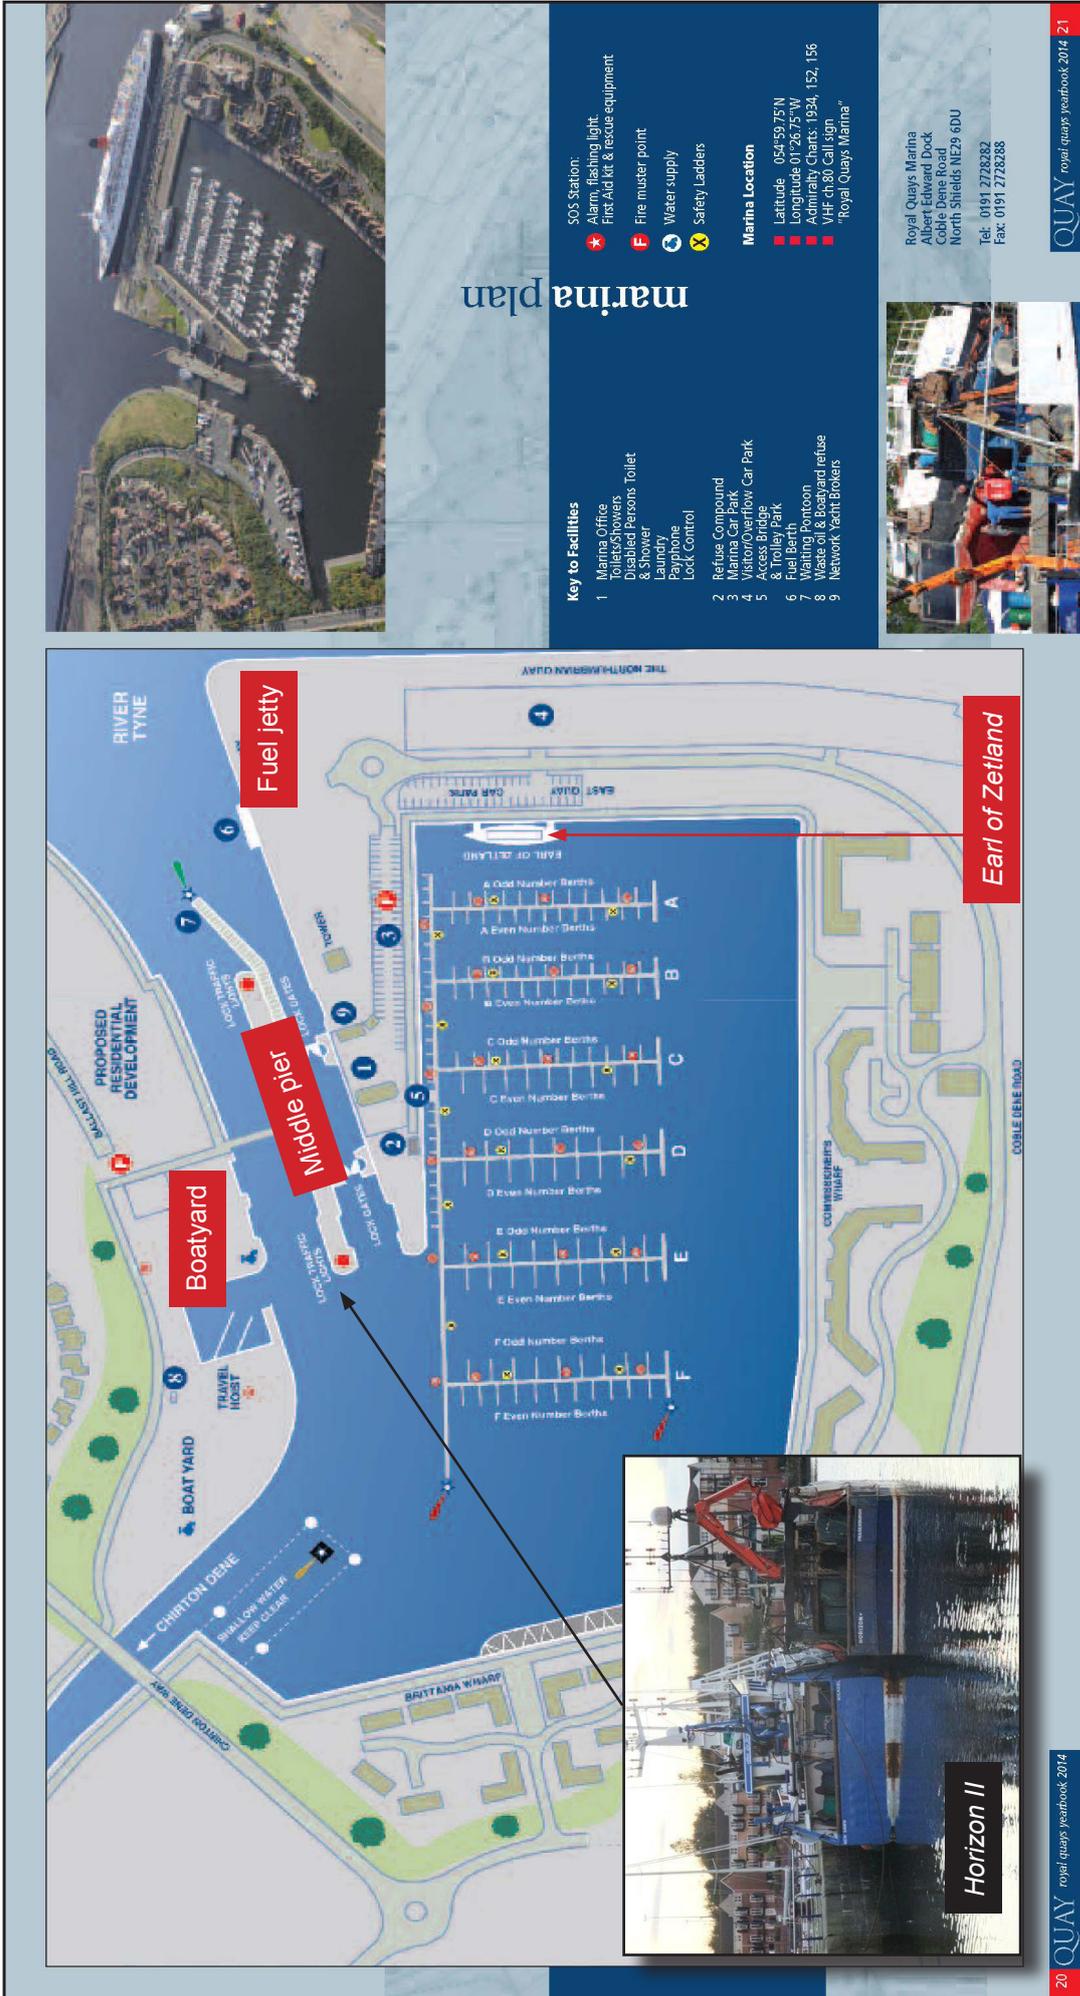
Figure 2: Royal Quays Marina

At about 2100, James left *Horizon II* and walked across the marina to the *Earl of Zetland* floating bar and restaurant (**Figure 2**). During the evening, he drank beer and spirits and chatted with the bar staff and other customers.

James left the *Earl of Zetland* with the bar owner, the bar owner's partner and three other people who lived in the houses next to the boatyard (**Figure 2**). The berthing master met the group at the marina office and escorted them across the lock to the boatyard security gate. When the berthing master opened the boatyard gate to allow the *Earl of Zetland's* owner into the boatyard, James started to make his way back to the middle pier.

The ILB was manoeuvred back into the lock, where a paramedic boarded and started to perform CPR³ on James. Once outside of the marina lock, the ILB was brought alongside the fuel jetty (**Figure 2**) and James was carried to a waiting ambulance. He was rushed to hospital, but could not be resuscitated and, at 0305, was pronounced dead.

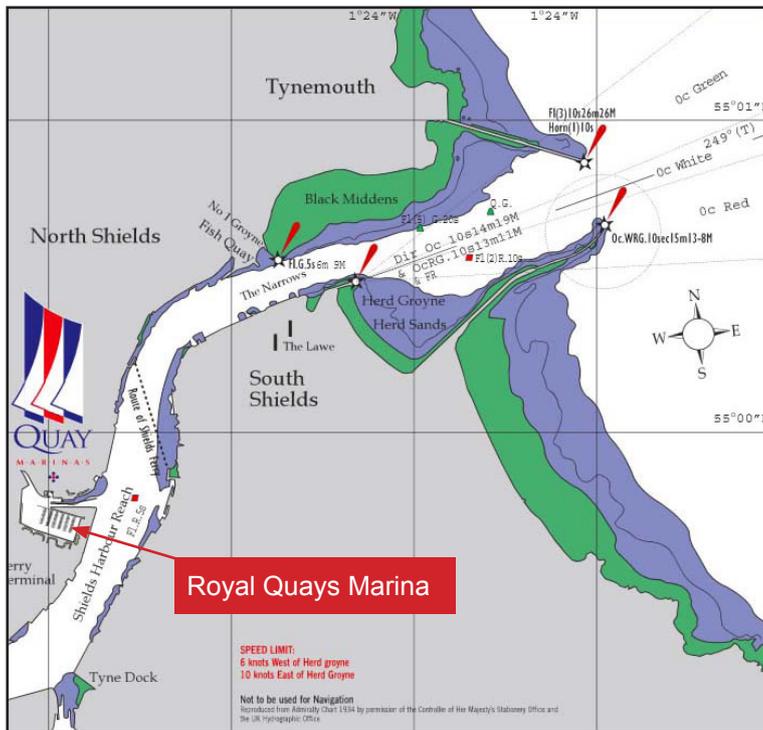
Figure 7: Location of Royal Quay’s Marina on River Tyne

Royal Quays marina is located along the north side of Shields Harbour Reach, on the River Tyne (**Figure 7**), and is one of seven UK marinas owned by Quay Marinas Ltd. The marina has 350 pontoon berths for its leisure customers, a boatyard, a lock, a fuel pontoon and a range of other facilities. Vessels too large to berth on a pontoon but small enough to enter the marina are accommodated on the quay walls and on the middle pier. Vessels that are too large to transit the lock can be accommodated at the marina’s tidal berths adjacent to the lock entrance. Fishing vessel owners consider the marina a safe place to berth, where vessels can be left unmanned for long periods of time within a secure area.
