FV PROSPECT

Grounding on Skibby Baas and foundering in the north entrance to Lerwick Harbour, Shetland Islands

5 August 2013

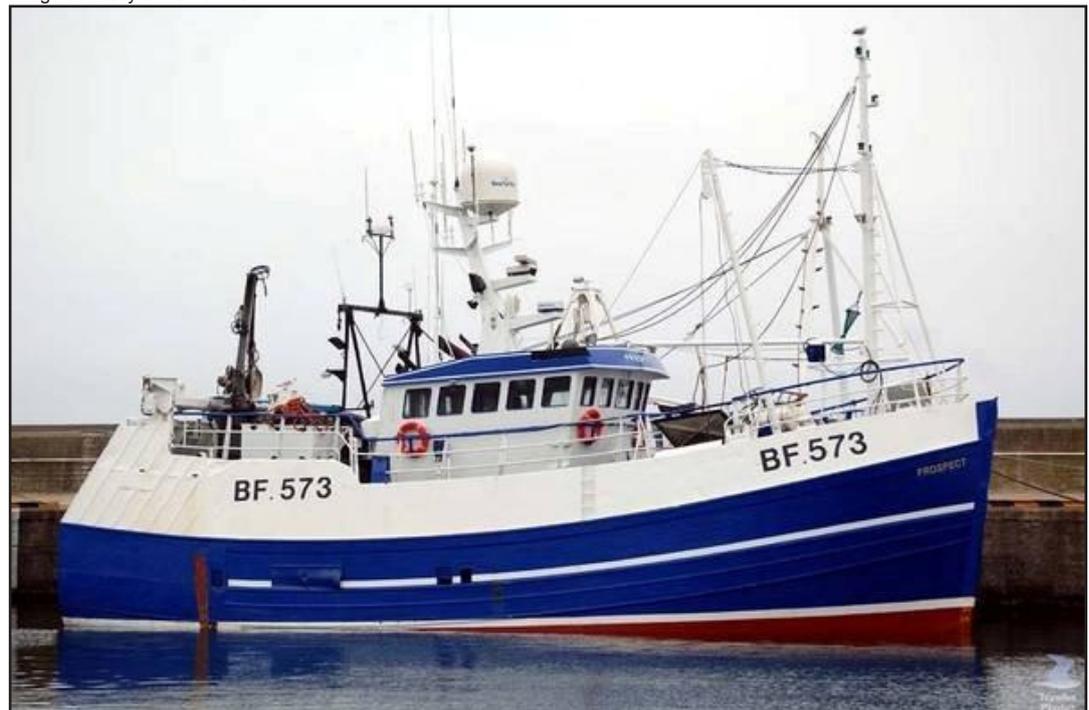
Figure 1: Prospect

At 1835 (UTC+1¹) on 5 August 2013, the twin-rig stern trawler *Prospect* (**Figure 1**) grounded on Skibby Baas rocks in the north entrance to Lerwick Harbour while on passage towards its intended fishing grounds. The hull was penetrated, causing the fish hold to immediately flood. The pumps were unable to cope with the water ingress and, after *Prospect* floated free from the rocks on the rising tide, the vessel adopted an angle of loll. The skipper and three crewmen transferred to the Lerwick all weather lifeboat (ALB) as its crew prepared to take *Prospect* under tow with the aid of the Lerwick Port Authority's (LPA) tug *Knab*. A short time later *Prospect* foundered in 15m of water. There were no injuries or pollution. The vessel was salvaged but declared a constructive total loss.
