Report on the investigation of  
the fire on board  
***Celtic Carrier***

24 miles west of Cape Trafalgar, Spain  
on 26 April 2013

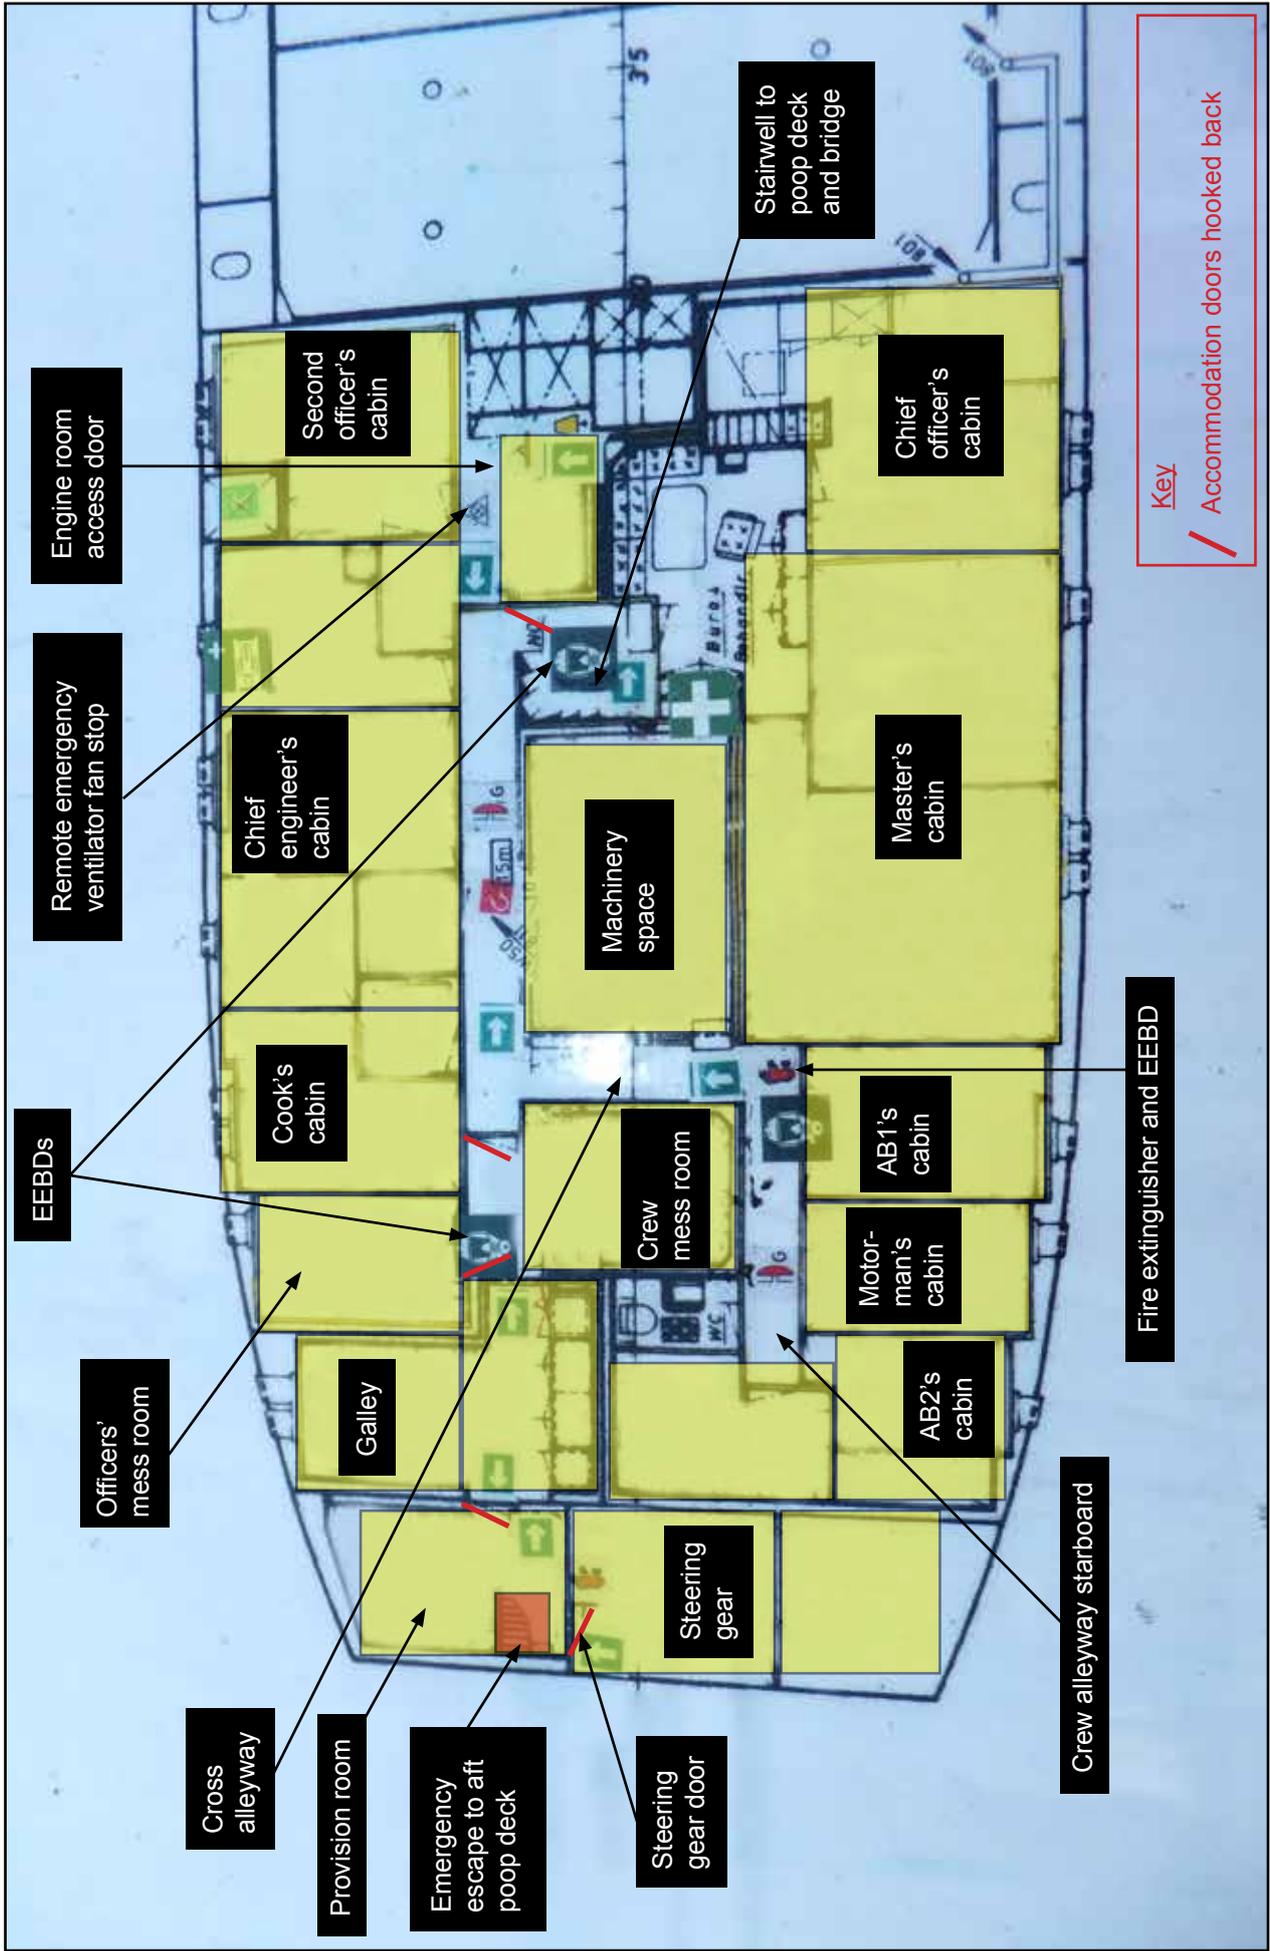
Figure 1: Deck 2 accommodation layout

On 25 April, while alongside in Gibraltar, able seaman No 2 (AB2<sup>1</sup>) consumed several alcoholic drinks ashore before returning to the ship and having dinner at 1700. He assisted with the unmooring operation when *Celtic Carrier* sailed from Gibraltar, and then watched television alone in the crew mess room (**Figure 1**) until 2300 when he went to his cabin (**Figures 1 and 2**).

AB2 opened his cabin door and, still in his underwear, ran along the alleyway, through the open doorway of the forward stairwell, and up the stairs to the bridge (**Figure 1**). He did not close his cabin door properly as he left.

The accommodation ventilation fans were situated on the poop deck and supplied fresh air to the accommodation spaces (**Figure 5**). The ventilation fire dampers were located on the starboard and aft sides of the accommodation block on the poop deck. A remote emergency ventilation fan stop was situated on Deck 2 adjacent to the 2/O's cabin (**Figure 1**).

By the time the fire alarm had been sounded on the bridge and other crew members had been alerted, the alleyway on Deck 2 had filled with smoke. In accordance with MGN 71(M) (**Paragraph 1.6.2**), the Emergency Muster List required the crew to muster with warm clothing and their lifejackets to hand. Although some considered there was sufficient time to dress before evacuating their cabin, none of them took a lifejacket, and AB1 considered it safer to evacuate through his open cabin porthole than via the alleyway. No one considered using an EEBD to assist their breathing, and no attempt was made by anyone to activate the remote emergency ventilation fan stop adjacent to the 2/O's cabin or to close the open held back internal doors in an attempt to contain the fire (**Figure 1**).

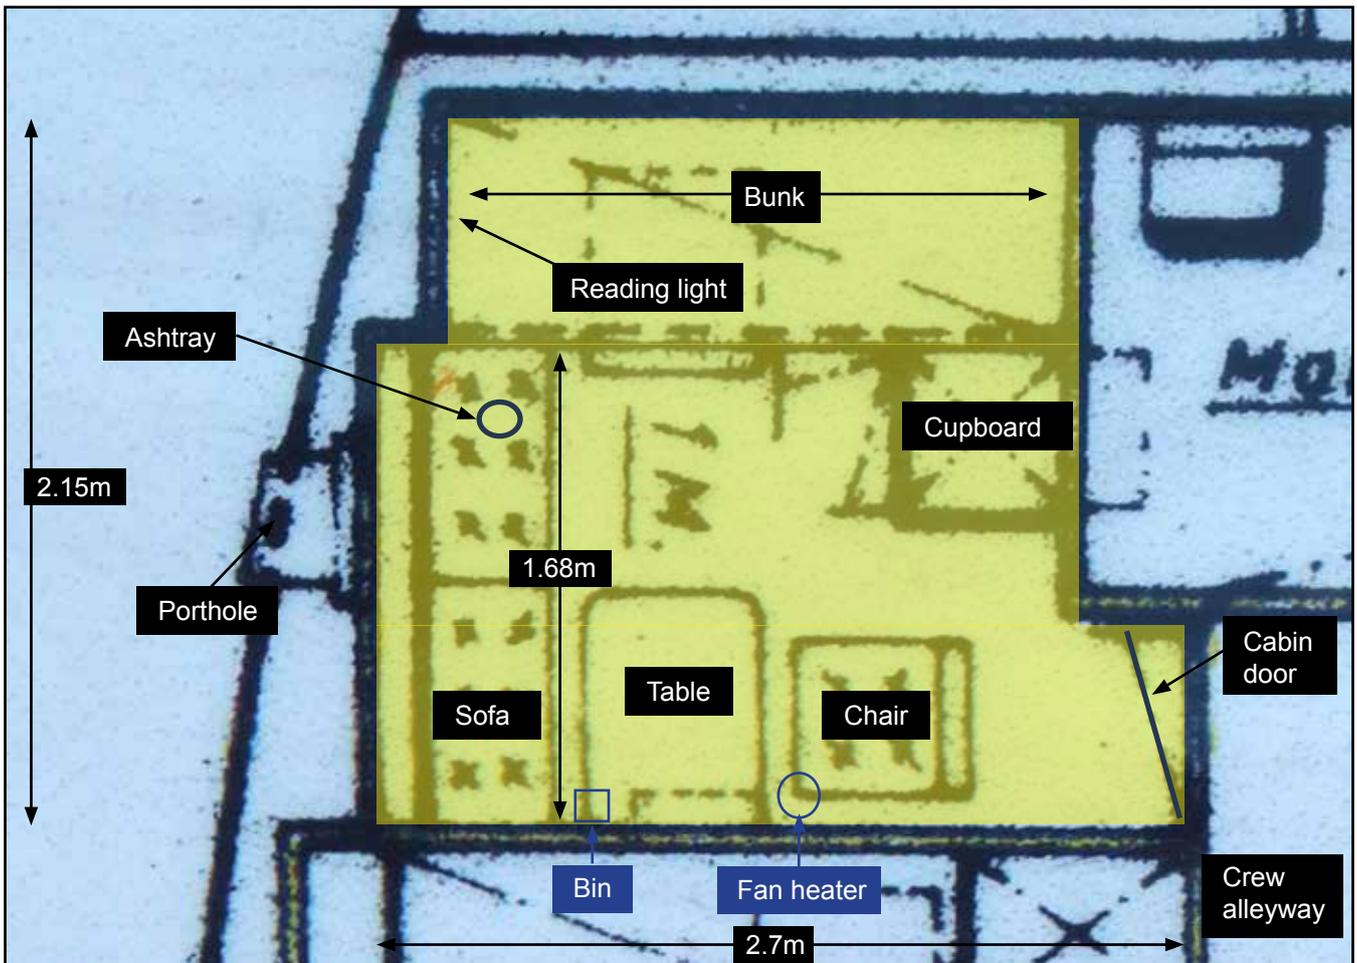
Figure 3: Layout of AB2's cabin

In his cabin, AB2 opened the porthole and then sat on the sofa (**Figure 3**) drinking beer and smoking cigarettes. He then closed his cabin door, got undressed, moved a glass ashtray from the cabin table to the sofa and climbed into bed. Sitting in bed with the reading light above his head switched on, AB2 continued to drink and smoke, reaching out with his right hand to use the ashtray, before eventually falling asleep.

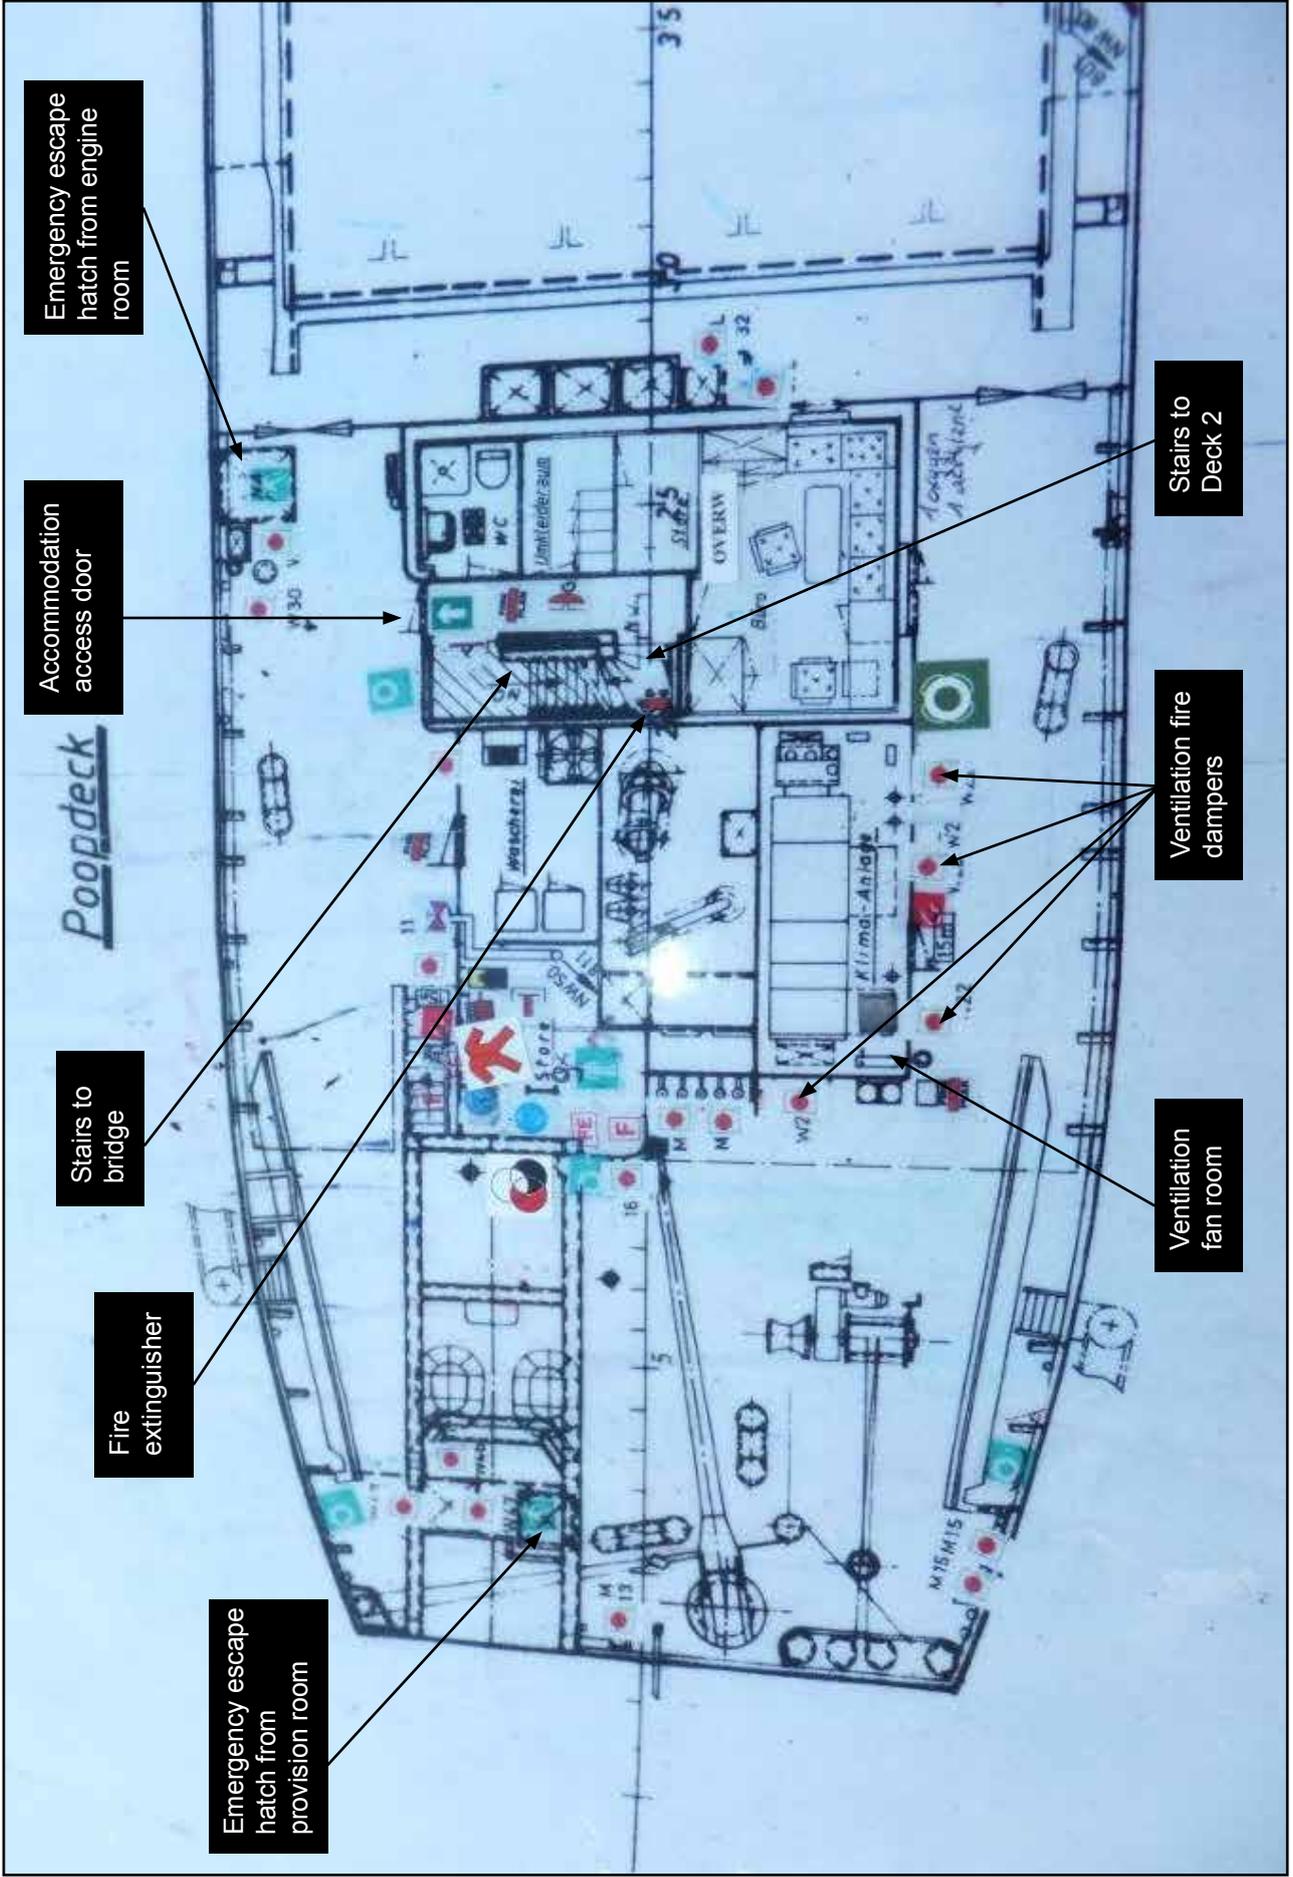
Figure 5: Layout of poopdeck

The C/E and motorman entered the engine control room via the emergency escape hatch on the forward port side of the poop deck (**Figure 5**). The C/E stopped the accommodation ventilation fans, turned off the electrical power to the accommodation, and started the fire/ballast pump and emergency generator.

The emergency escape route from Deck 2 was in the provision room, aft of the galley, via a vertical ladder and watertight hatch to the poop deck (**Figures 1 and 5**). Escape from the poop deck accommodation was via an external door on the port side. The main access and egress route from the engine control room was located on the alleyway on Deck 2: the engine room emergency escape to the poop deck was located on the forward port side of the engine room.
