## Foundering of FV *JCK* with the loss of her skipper; Tor Bay, 28 January 2013

### SUMMARY

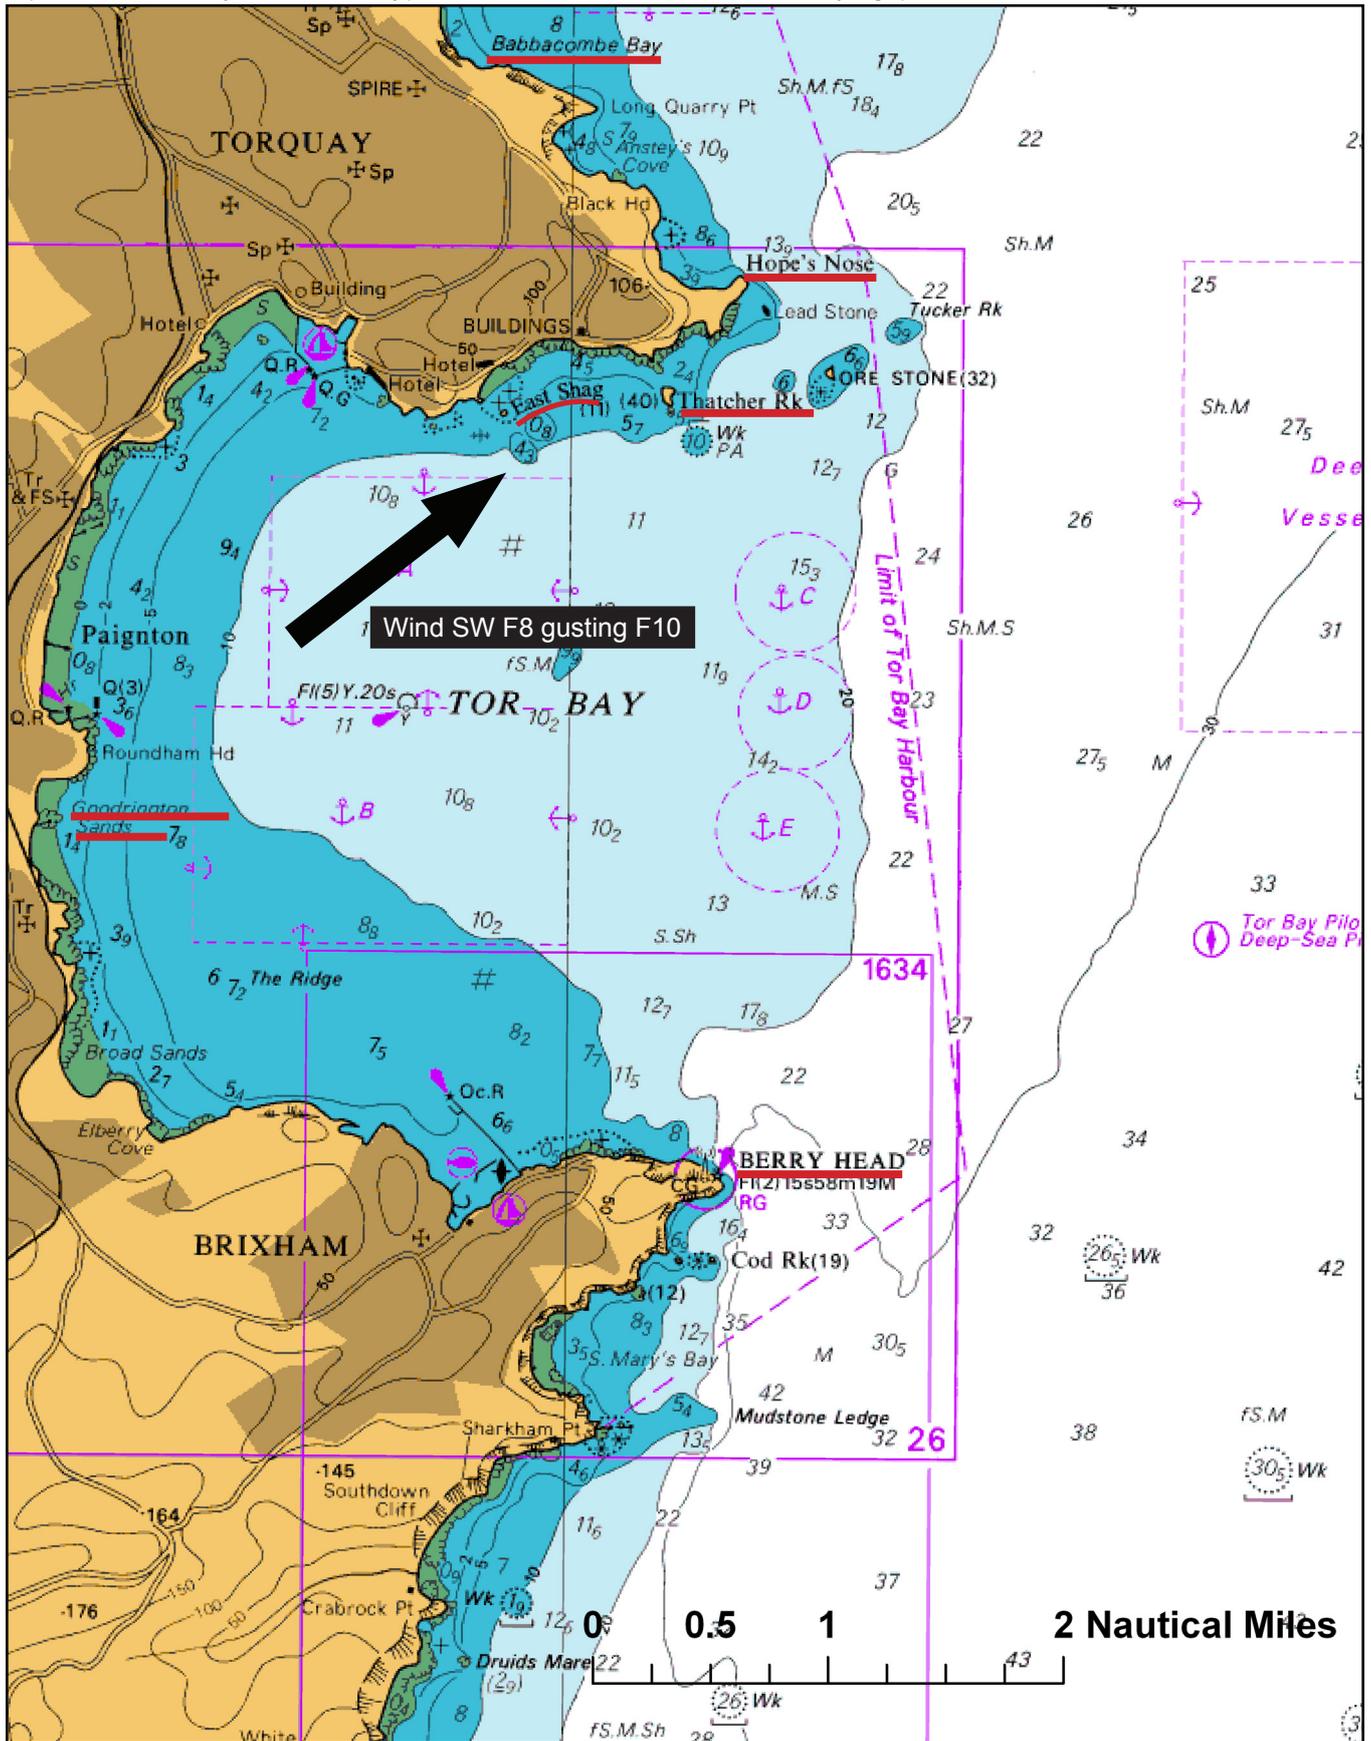
Figure 2: Tor Bay showing salient points of reference

*JCK* and *Bold Venture* arrived at Babbacombe Bay (**Figure 2**) at about 0815, where the skippers commenced hauling their nets which had been set in the area the previous day. Fishing was good and, after hauling, the two boats secured to a mooring buoy off Babbacombe pier (**Figure 3**) to fleet<sup>1</sup> their nets, which then took several hours.

At about 1710 *Bold Venture*'s skipper stopped fleeting his herring net and headed towards Hope's Nose (**Figure 2**) to check the conditions beyond the shelter of the land, while Andrew shot his herring net. *Bold Venture*'s skipper returned, and explained to Andrew that he did not like the look of the conditions. Andrew considered this, but thought that both vessels should proceed to Hope's Nose to review the sea conditions.

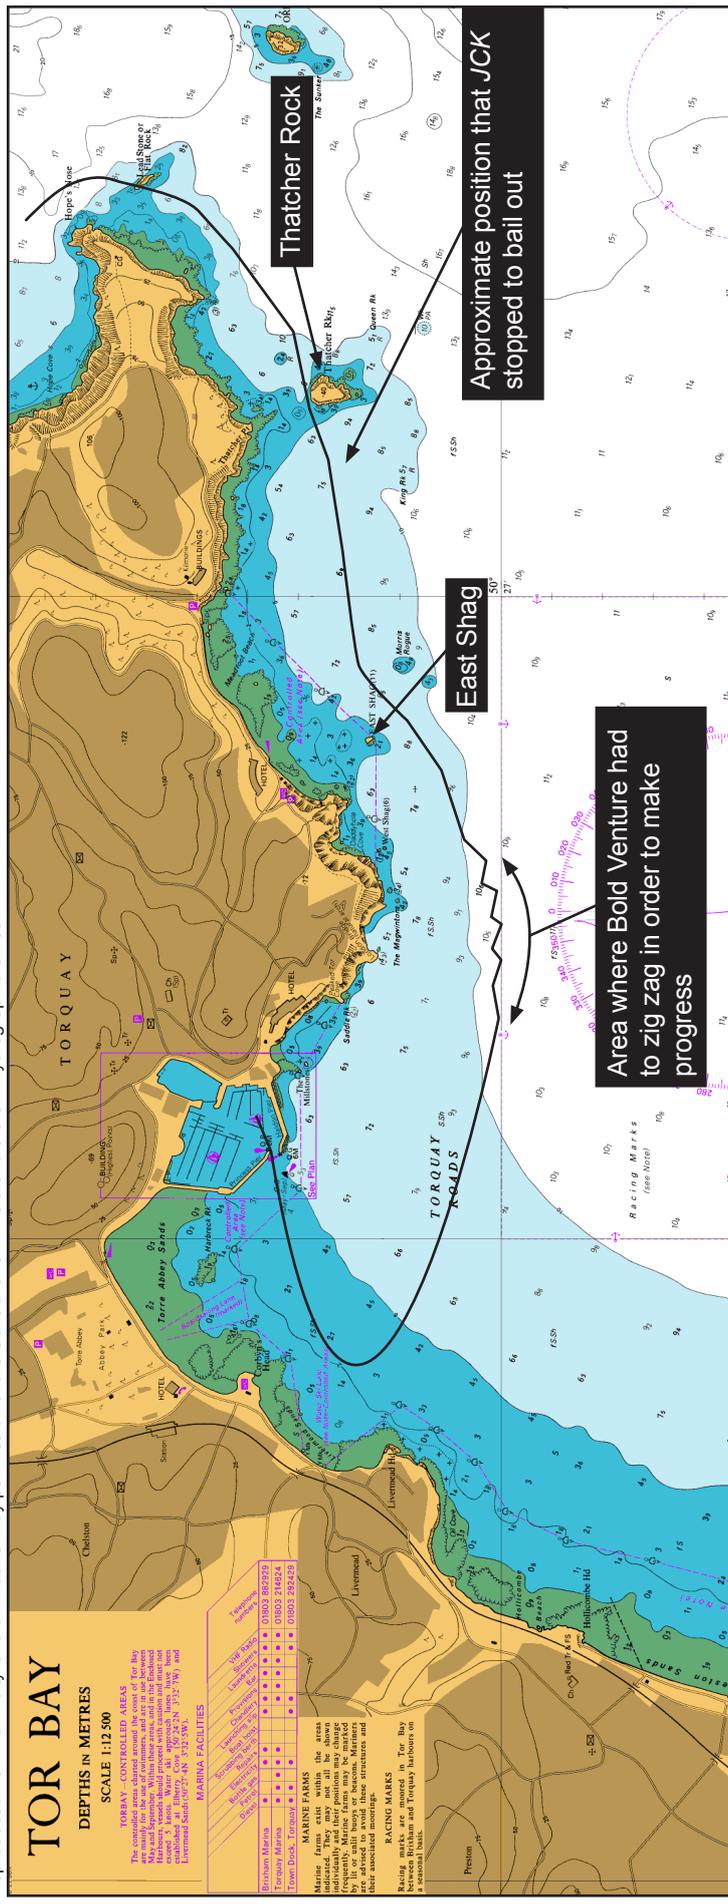
Figure 4a: Bold Venture's approximate track from Hope's Nose to Torquay

In late twilight the boats rounded Hope's Nose with *JCK* in the lead and *Bold Venture* following. Between Lead Stone and Thatcher Rock the boats encountered strong south-westerly winds and heavy seas, resulting in both shipping significant amounts of water. Nevertheless, they continued between Thatcher Rock and the land, gaining a brief lee from Thatcher Rock (**Figures 4a and 4b**).

After clearing East Shag (**Figures 4a and 4b**) conditions worsened, with wind gusts exceeding 50 knots at times. *Bold Venture*'s skipper was forced to tack his vessel in a zig-zag fashion as waves crashed down on the boat, often blinding him with sea spray. During this time *Bold Venture*'s skipper did not dare look behind; terrified to take his eyes from the oncoming seas he made a conscious decision to not stop and bail out, despite his boat shipping large quantities of water.

The wind direction was forecast to be offshore in Tor Bay, which gave the skippers some peace of mind before they sailed. However, during south-westerly winds there is a fetch of 3.5 nautical miles between the Goodrington shore (**Figures 4a** and **4b**) and Thatcher Rock, causing high waves to develop towards the Thatcher Rock area. Given Andrew's experience and local knowledge it is doubtful that he was not aware of this fetch and the associated wave heights with south-westerly winds in the area.
