**Engine room fire on board
FV AMY HARRIS III
South of the Isle of Arran
16 January 2013**

SUMMARY

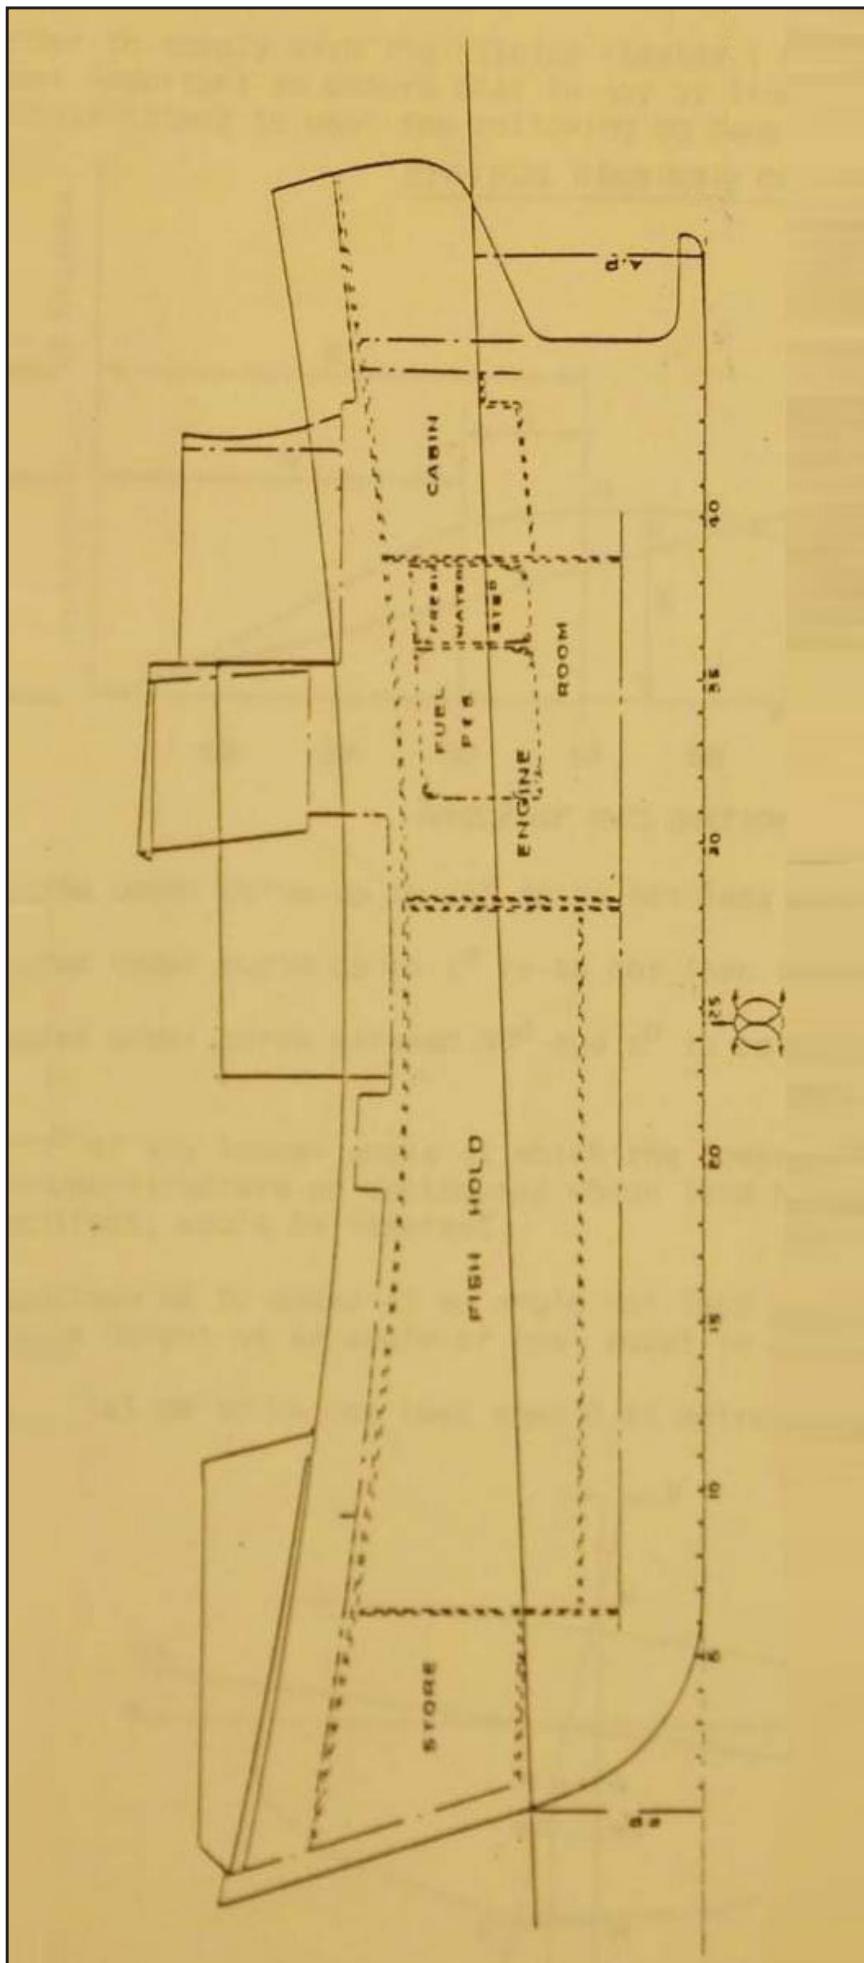
Figure 1: Profile of Amy Harris III

Built in 1971, *Amy Harris III* was a Campbeltown registered, wooden, twin-rig prawn stern trawler, which had been under her current ownership for the past 12 years. A profile drawing is at **Figure 1**.
