Capsize while beam trawling **BETTY G** Lyme Bay 23 July 2012

SUMMARY

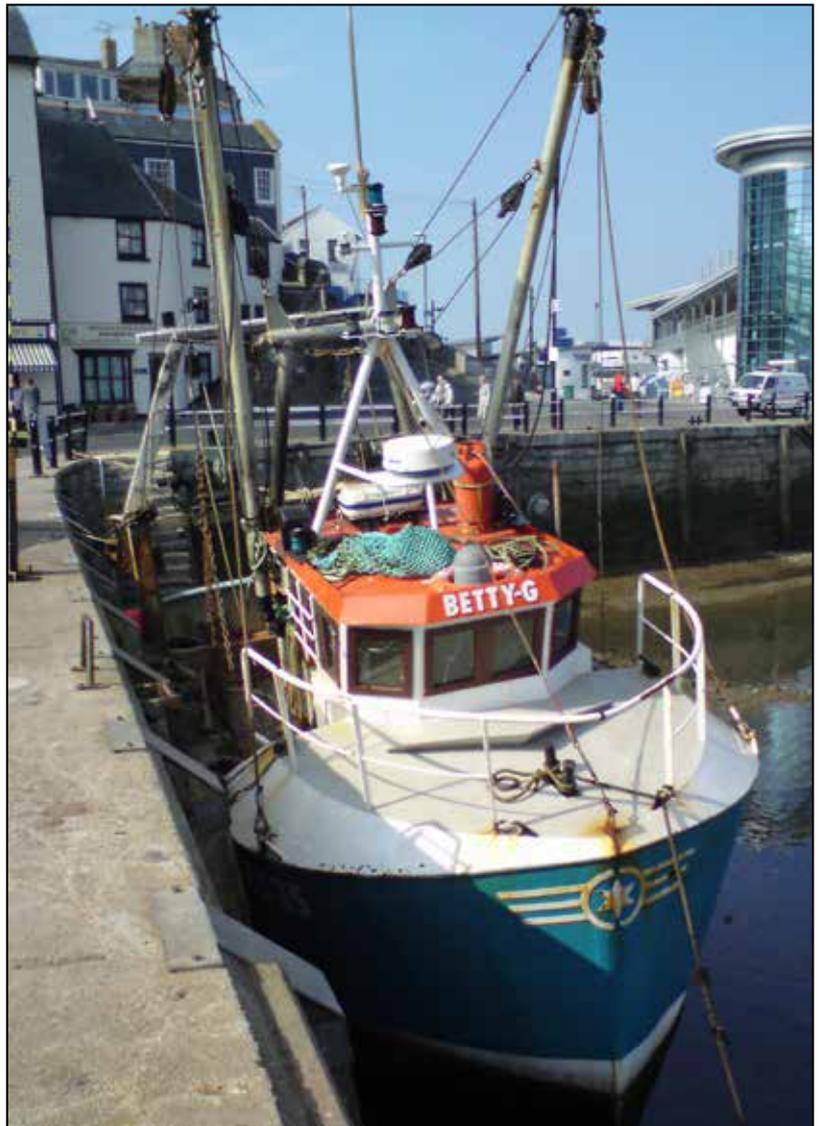
Figure 1: *Betty G*

Betty G (Figure 1) was built in 2001 at Newbury Engineering Ltd, Newhaven. She was a multipurpose vessel, being able to scallop dredge, and also beam and stern trawl. The vessel was fitted with a Cummins NT 855M 145kW main engine that provided propulsion and electrical power, as well as driving hydraulic pumps and a bilge/deck wash pump. The engine was overhauled in November 2011, and the 3.5 tonne main hydraulic winch was refurbished at the same time.
