## Fatal injury to a crew member on board **E.R.ATHINA** at anchor off Aberdeen 10 June 2012

### SUMMARY

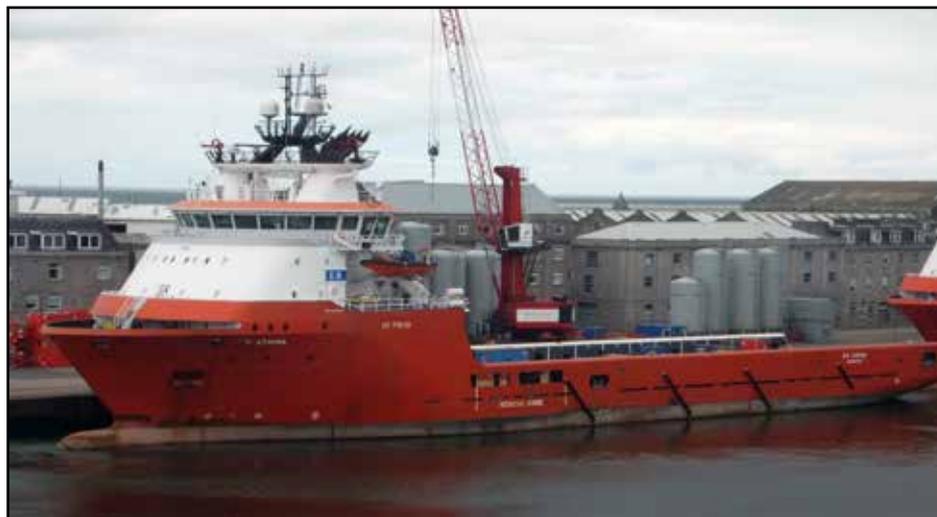
*E.R. Athina*

The FRC was moving up and down on the swell, which was also setting the boat under the cutaway or counter section of *E.R. Athina's* hull (**Figures 1 and 3**). Pjero and the OS had to crouch due to the reduced headroom under the counter, and they also had to push against *E.R. Athina's* side to prevent the FRC from being damaged. The FRC's crew were concerned with the situation, so Pjero asked the chief officer to take in the slack in the bow and stern lines to try and reduce the FRC's movement. At about the same time, the chief officer and the master realised that Pjero was experiencing difficulties and asked him if the painting task was feasible. Pjero replied that it was.
