Boatyard invoices for works carried out to *Purbeck Isle's* hull during 2011 maintenance period and the out of water emergency repairs undertaken in December 2011 and February 2012

Wooden boat surveyor's report

***Purbeck Isle*: Foundering resulting in the loss of three lives**

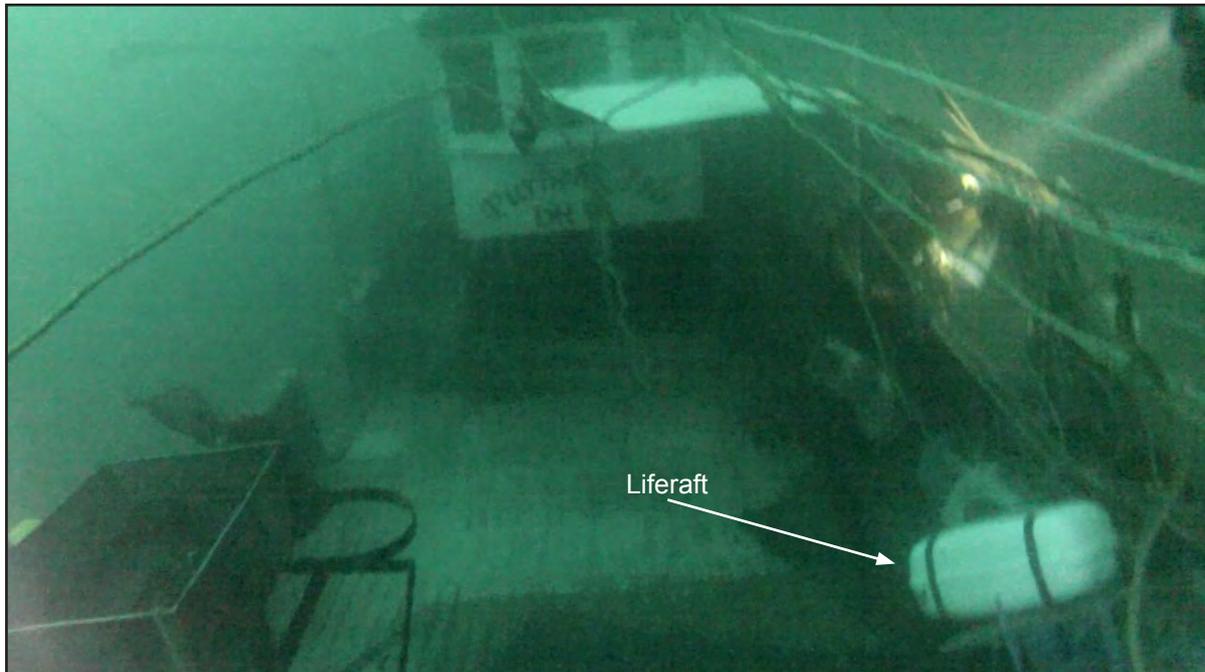
On 17 May 2012, the skipper of the UK registered fishing vessel *Purbeck Isle* and his two young crewmen died because the vessel's liferaft failed to float free and automatically inflate when the 11.6m wooden potting vessel sank suddenly off the coast of Portland, England.

1. Liferafts are stowed and secured in accordance with the guidance provided in MGN 343 (M+F) (www.dft.gov.uk/MCA/).
2. They follow the instructions provided by liferaft and HRU manufacturers.
