Report on the investigation of
the collision between

Stena Feronia and Union Moon

in Belfast Lough
on 7 March 2012

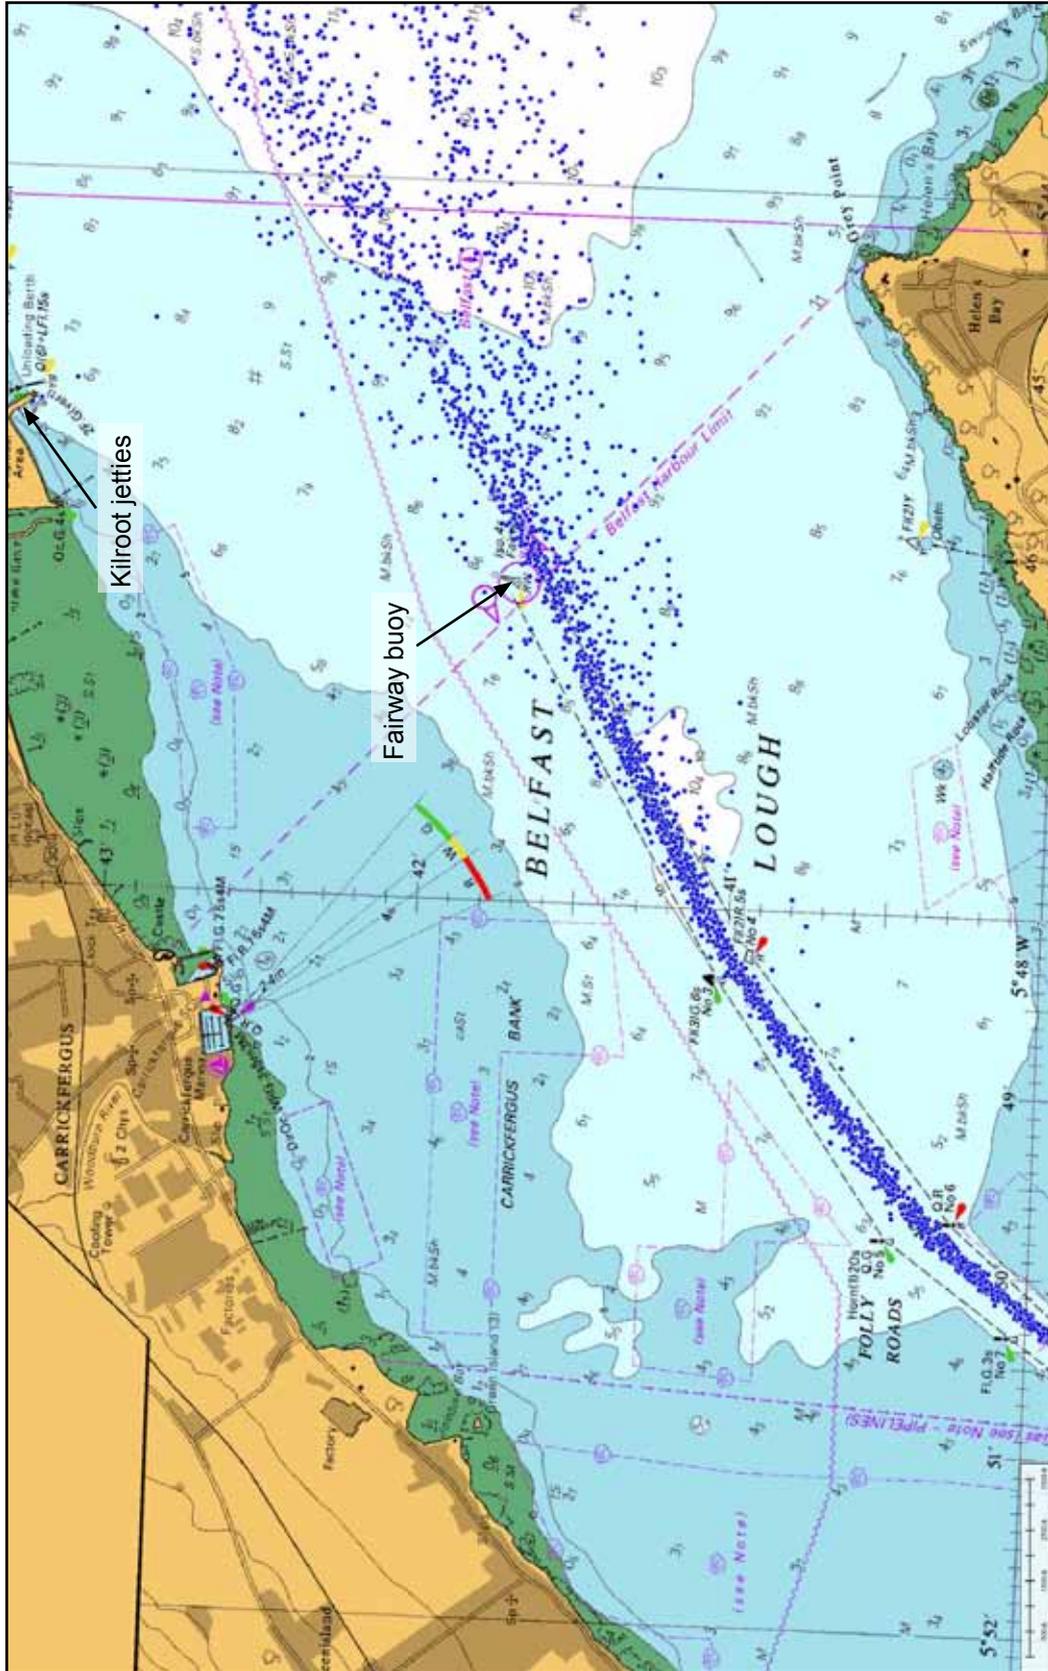
Figure 8: Tracks of ships over 50m LOA leaving Belfast

The AIS tracks of vessels over 50m LOA, entering and leaving Belfast over a 5-month period between 1 November 2011 and 31 March 2012, show that the vast majority of ships leaving the port pass to the south of the buoy and leave it on their port side (**Figure 8**). Vessels entering the port pass either side of the buoy with no clear trend either way (**Figure 9**).

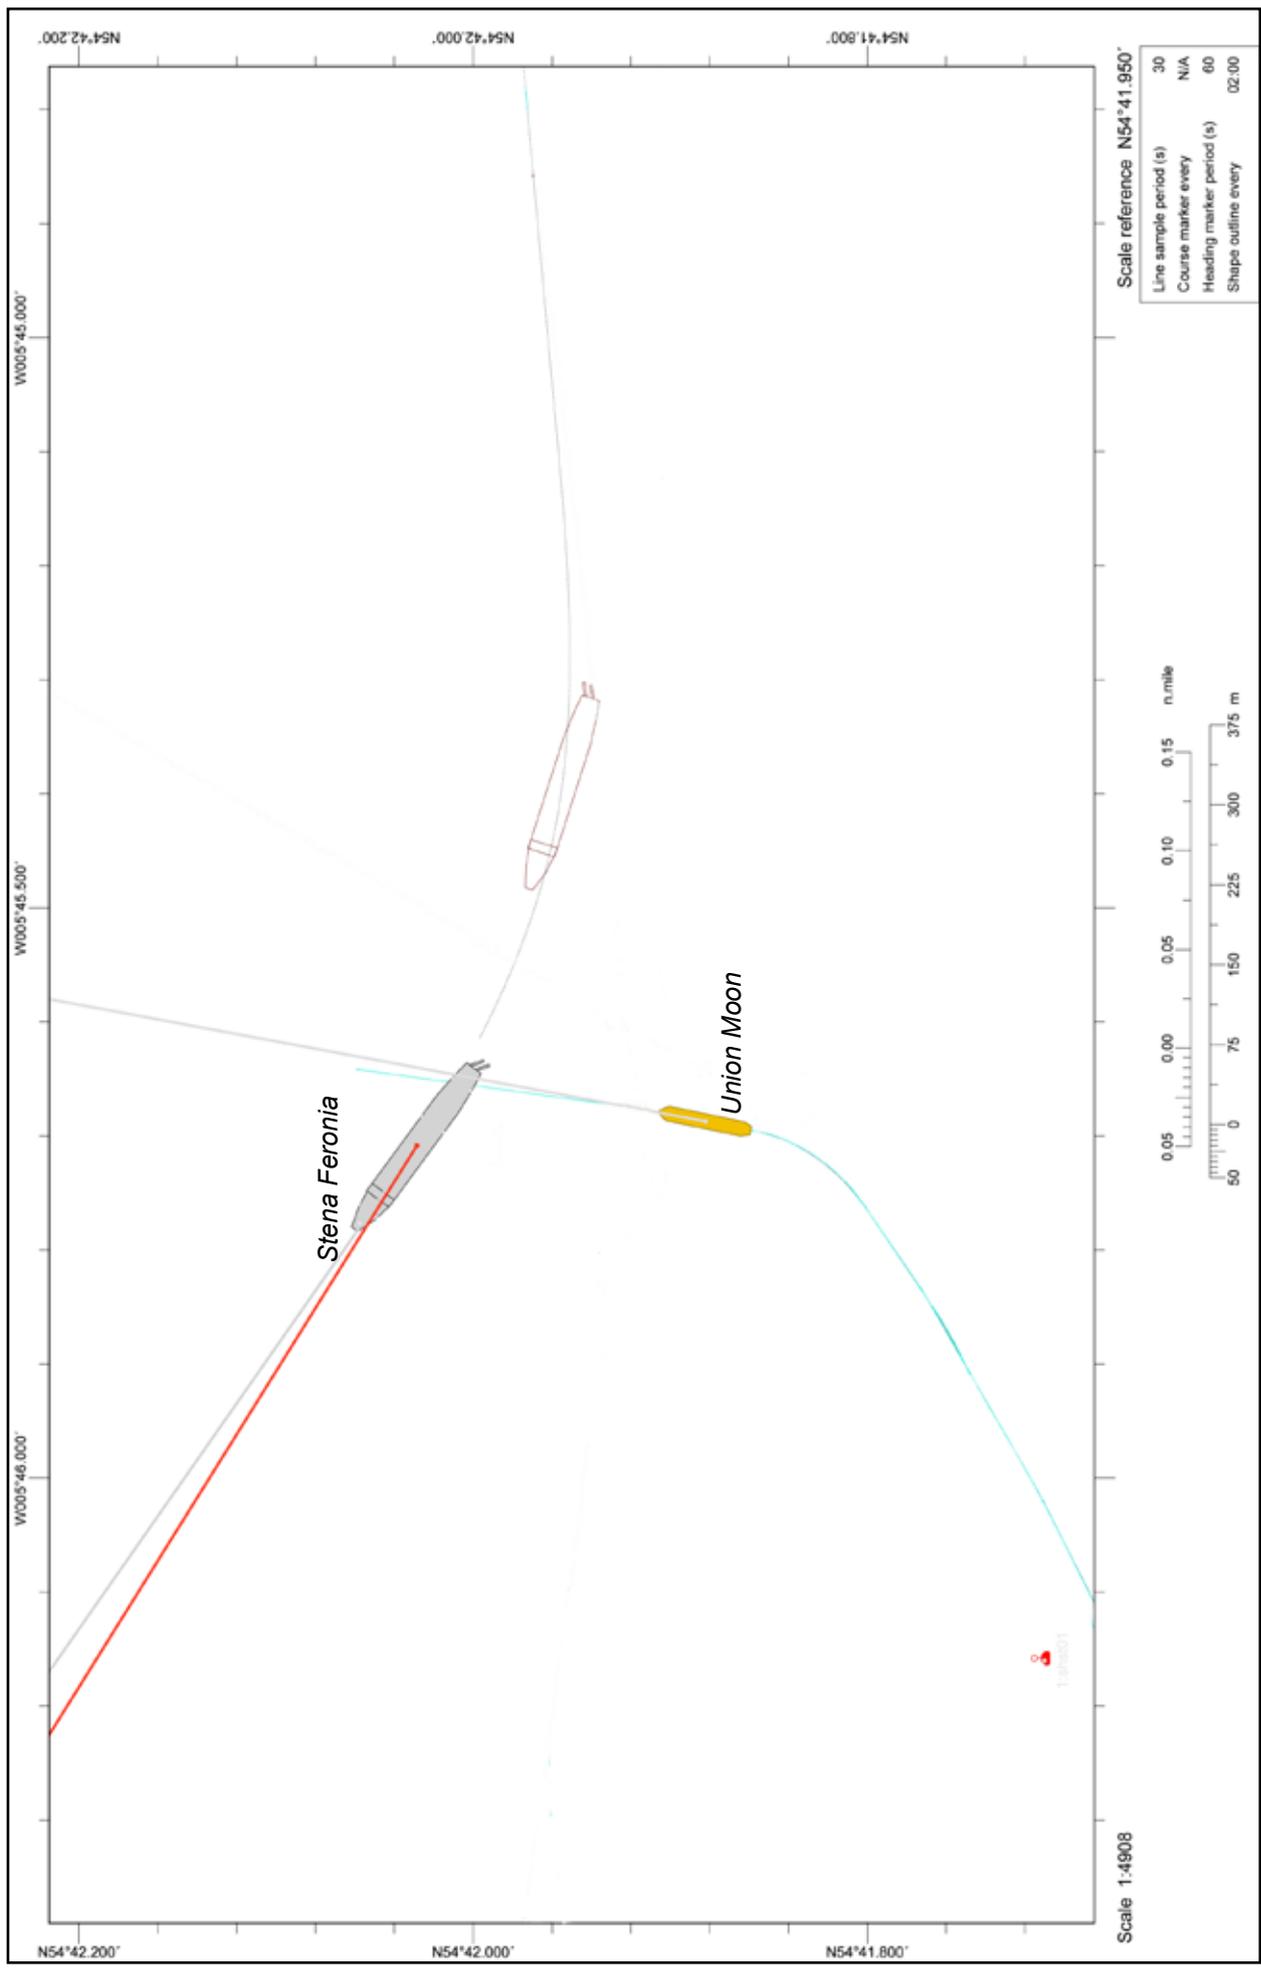
Figure 10: First trial manoeuvre

Altering course at this point resulted in *Stena Feronia* passing at a distance of some 200m ahead of *Union Moon* (**Figure 10**).
