Inspection report (with addendum)

“HEATHER ANNE”

of the port of Fowey, FY126, GT 11.67, whilst shored up on the Queens Wharf in Falmouth Docks, Cornwall, for the purpose of assisting with an investigation following the vessels sinking on the 20th December 2011.

Stability Assessment
Investigation into capsizing of FV 'Heather Anne'
Marine Accident Investigation Branch

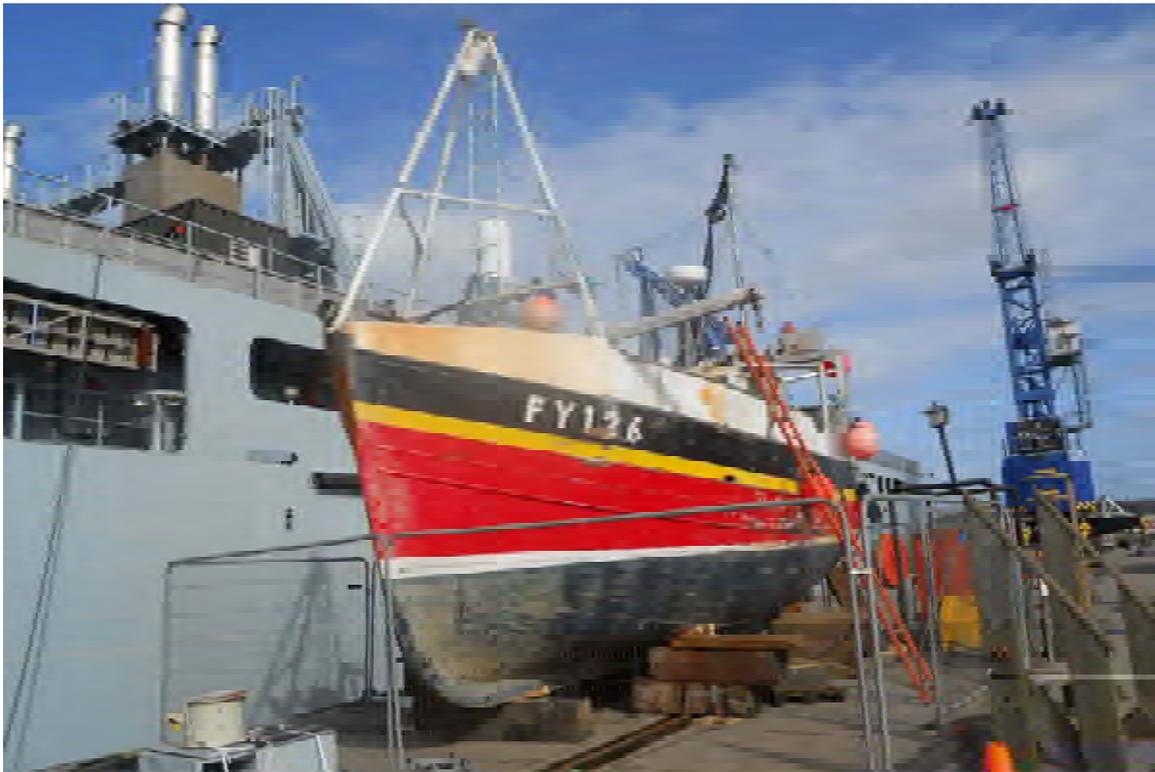
1 - Vessel on quayside in Falmouth Docks..JPG

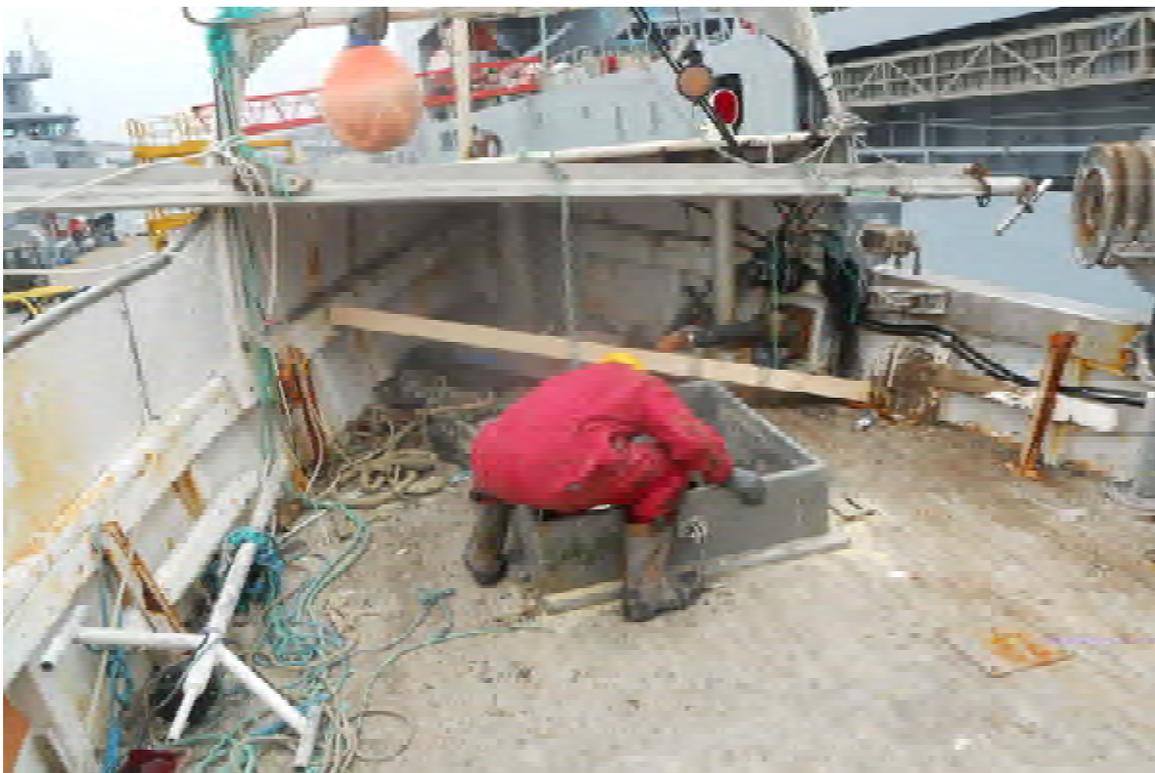
2 - Fore deck.JPG

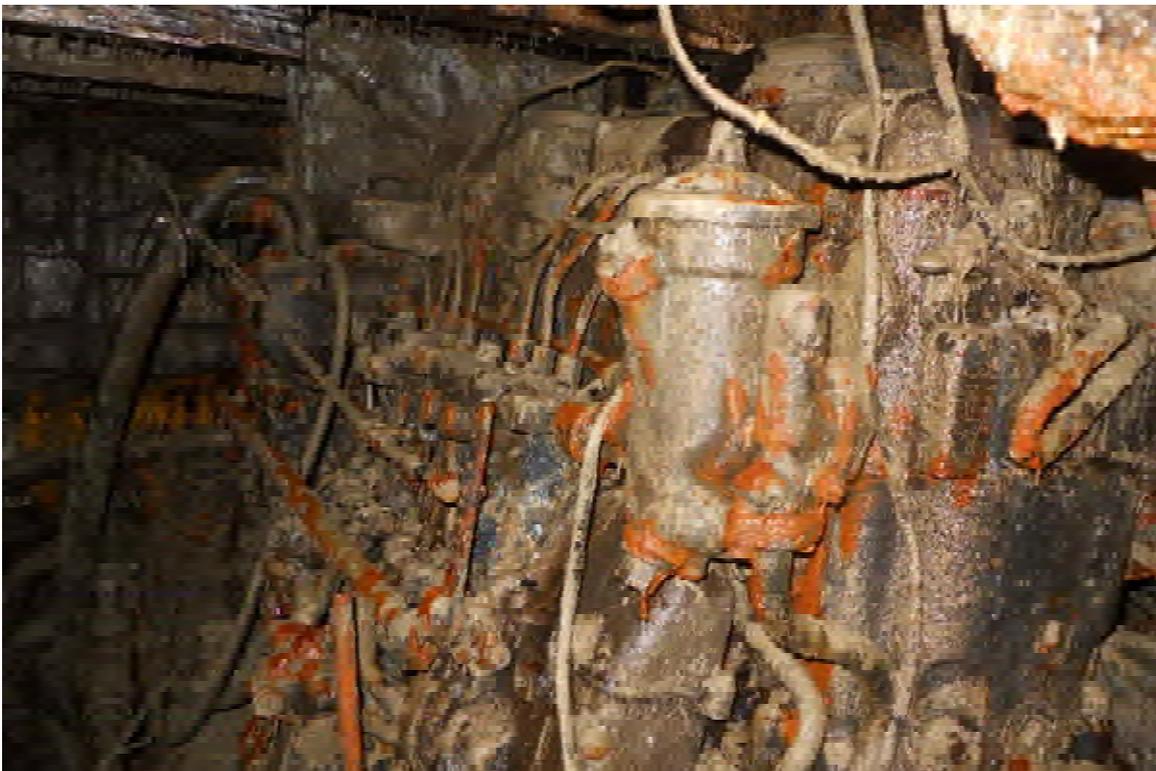
6 - Main engine port side.JPG

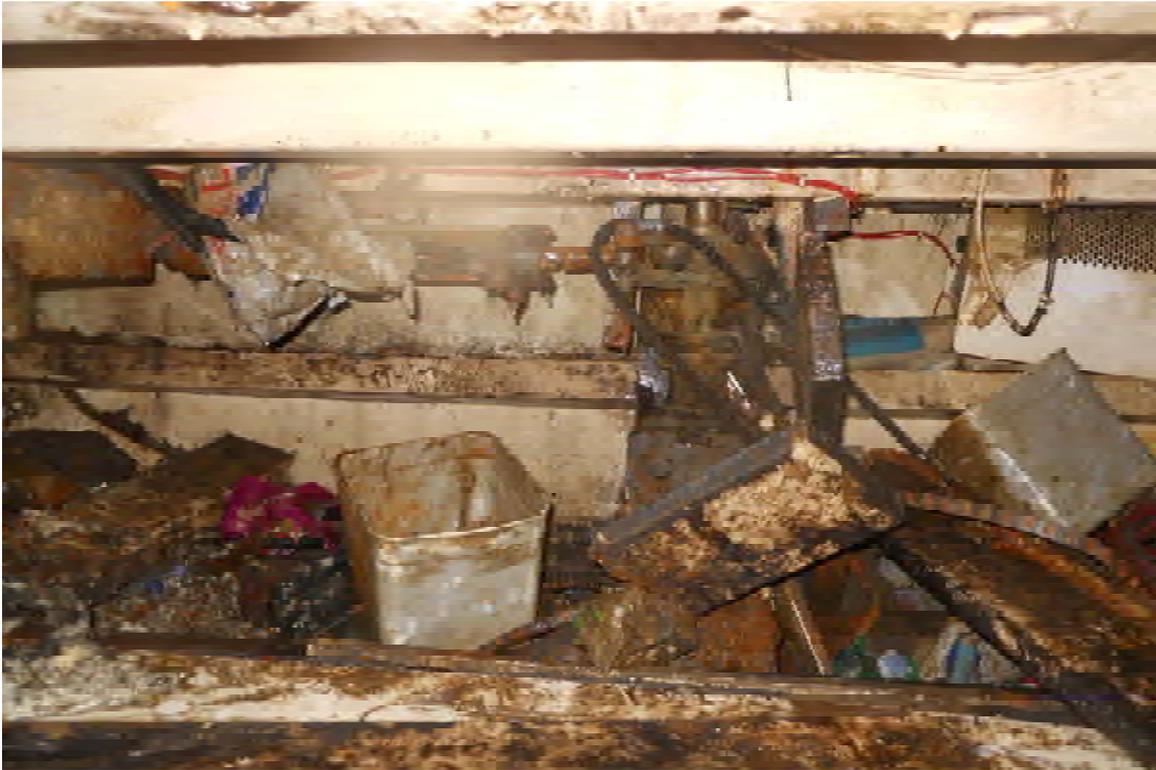
7 - Accommodation space looking aft.JPG

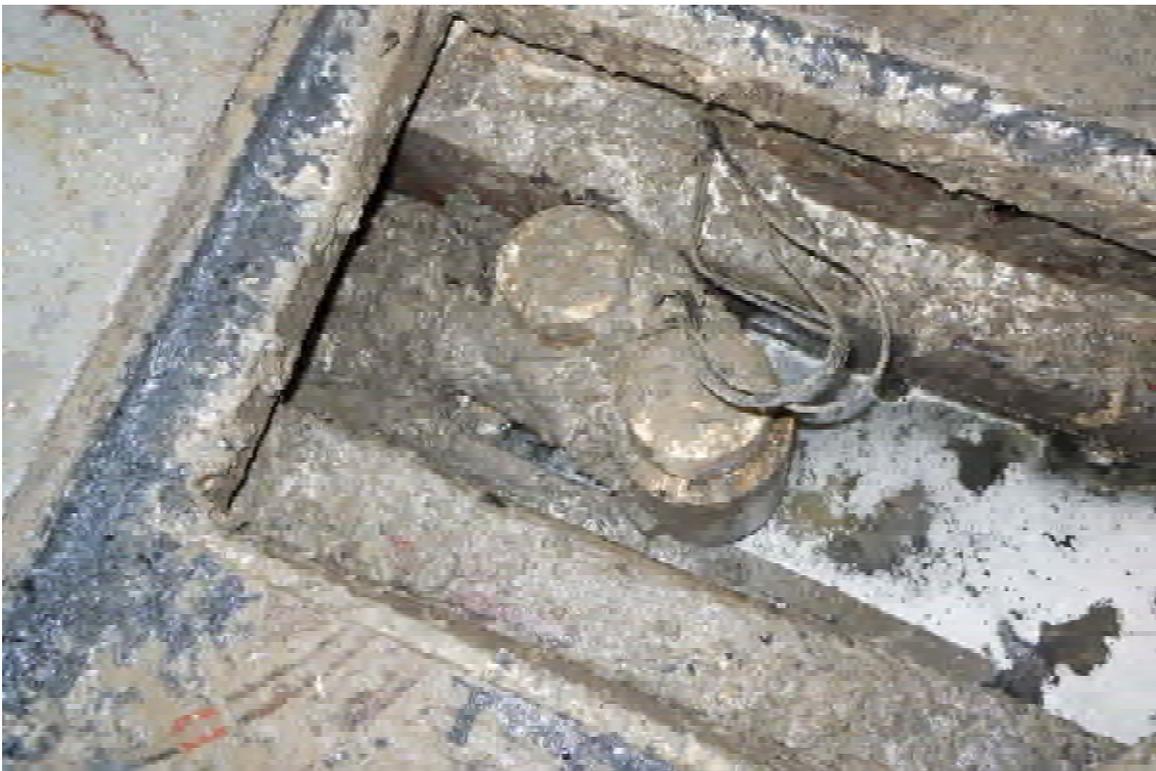
8 - Hold double bilge pump.JPG

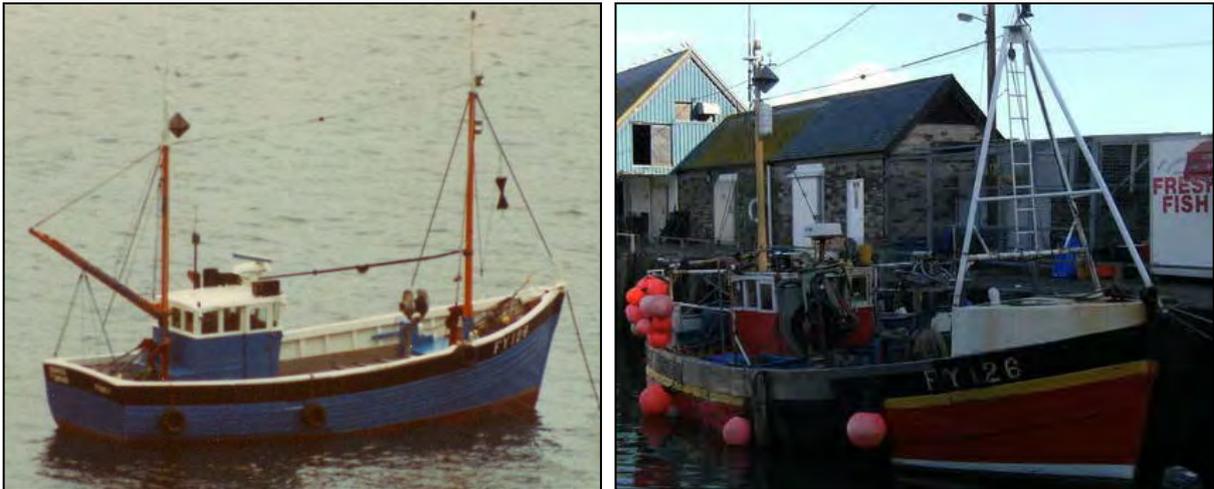
Diagram 5 – Photographs of Heather Anne in 1972 and 2008

Comparison of the originally intended 5 tonne maximum catch weight with the estimated weight of about 10 tonnes on board when the accident occurred indicate that the boat was probably being worked more intensively in later years. Photographs taken shortly after launch in 1972 and in 2008 before the accident (see diagram 5 below) tend to confirm this, pointing to significant weight gains both loaded and unloaded accompanied by a rise in the centre of gravity.

Heather Anne in 1972 (then named Aquarius II), shortly after launch *Heather Anne in 2008*

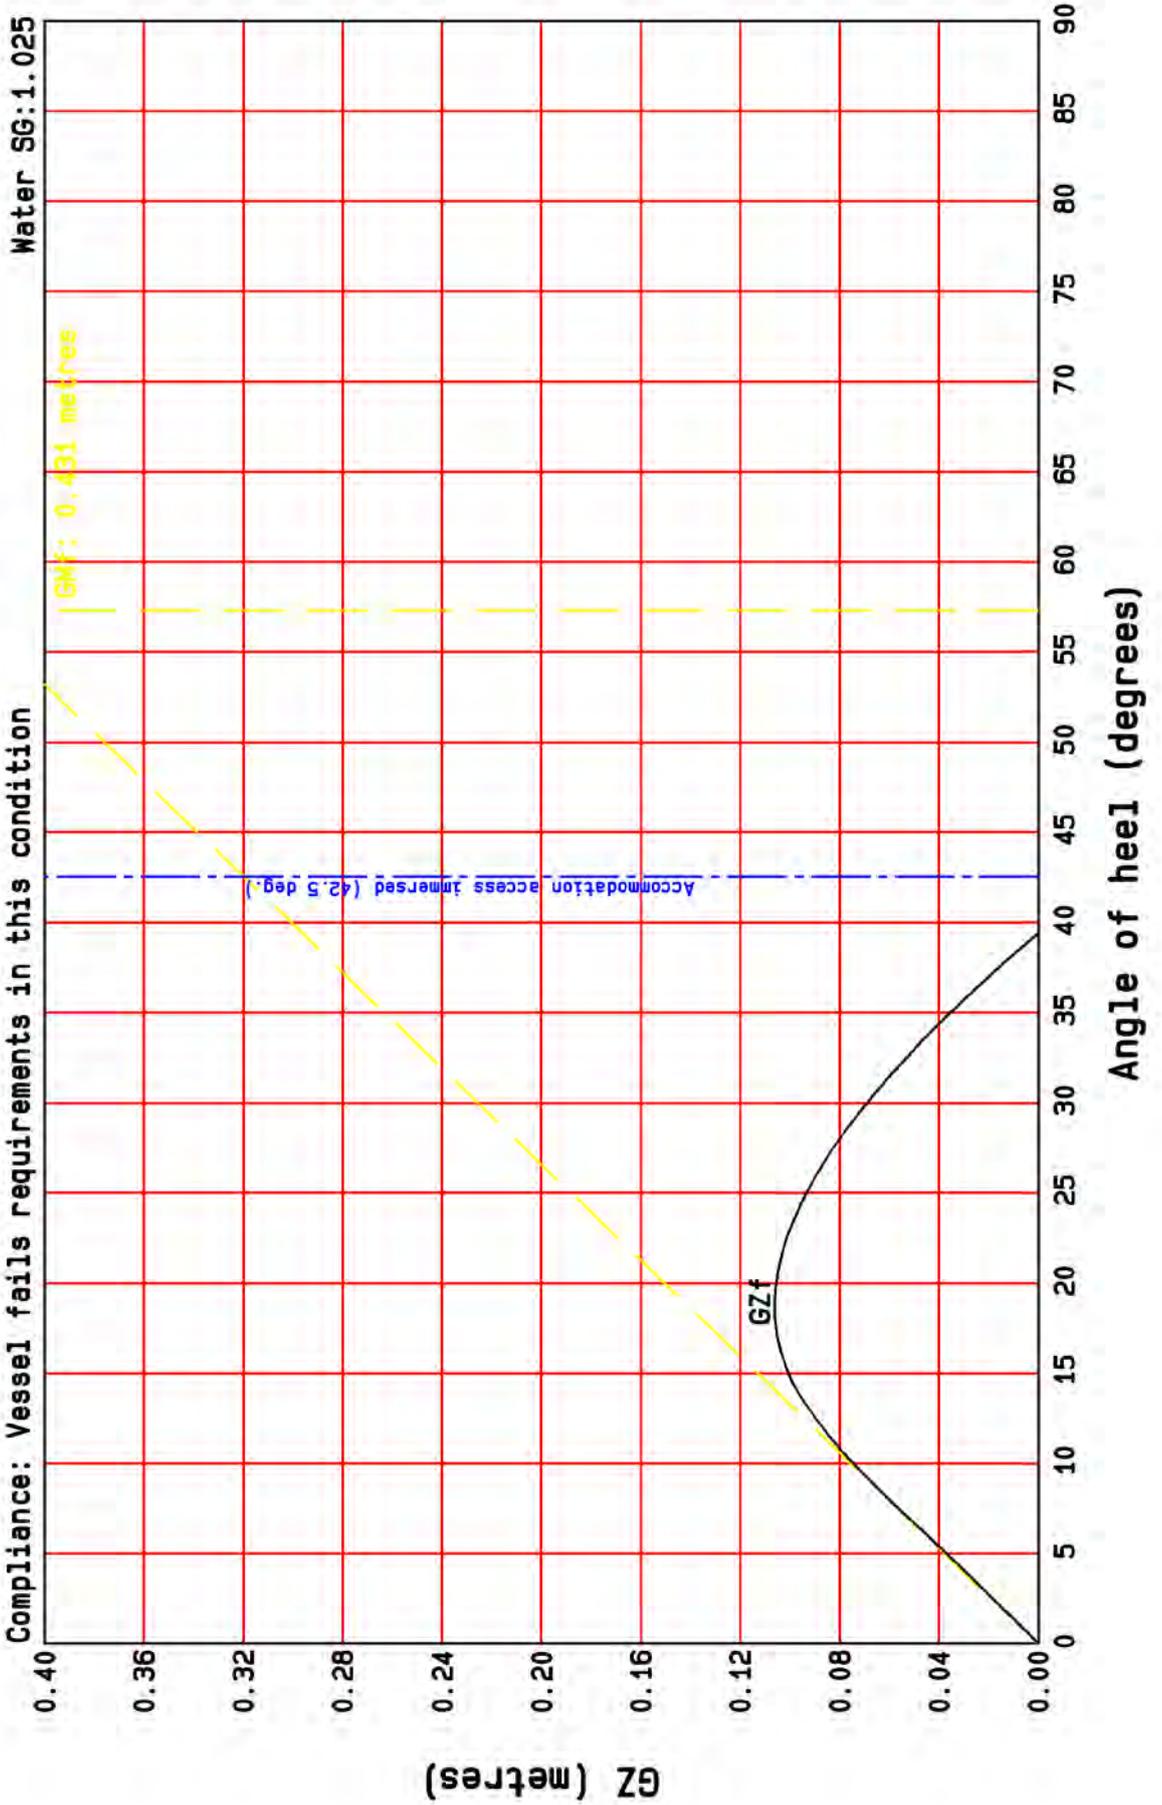
Condition.: Depart Grounds, 50% consumables, 5 tonnes catch, 2 crew
State.....: Intact including appendages
Compliance: Vessel fails requirements in this condition

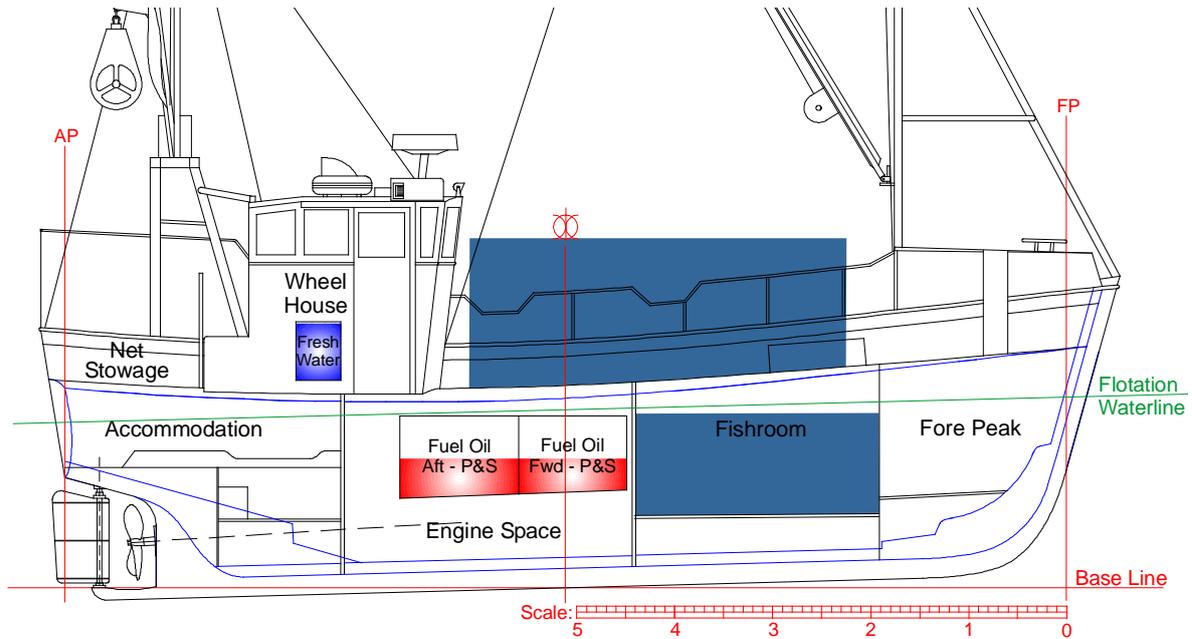
Vessel.....: *FV Heather Anne*
 Condition.: *Estimated December 2011 accident condition*
 State.....: *Intact including appendages*
 Water SG...: *1.025*
 Compliance: *Vessel fails requirements in this condition*

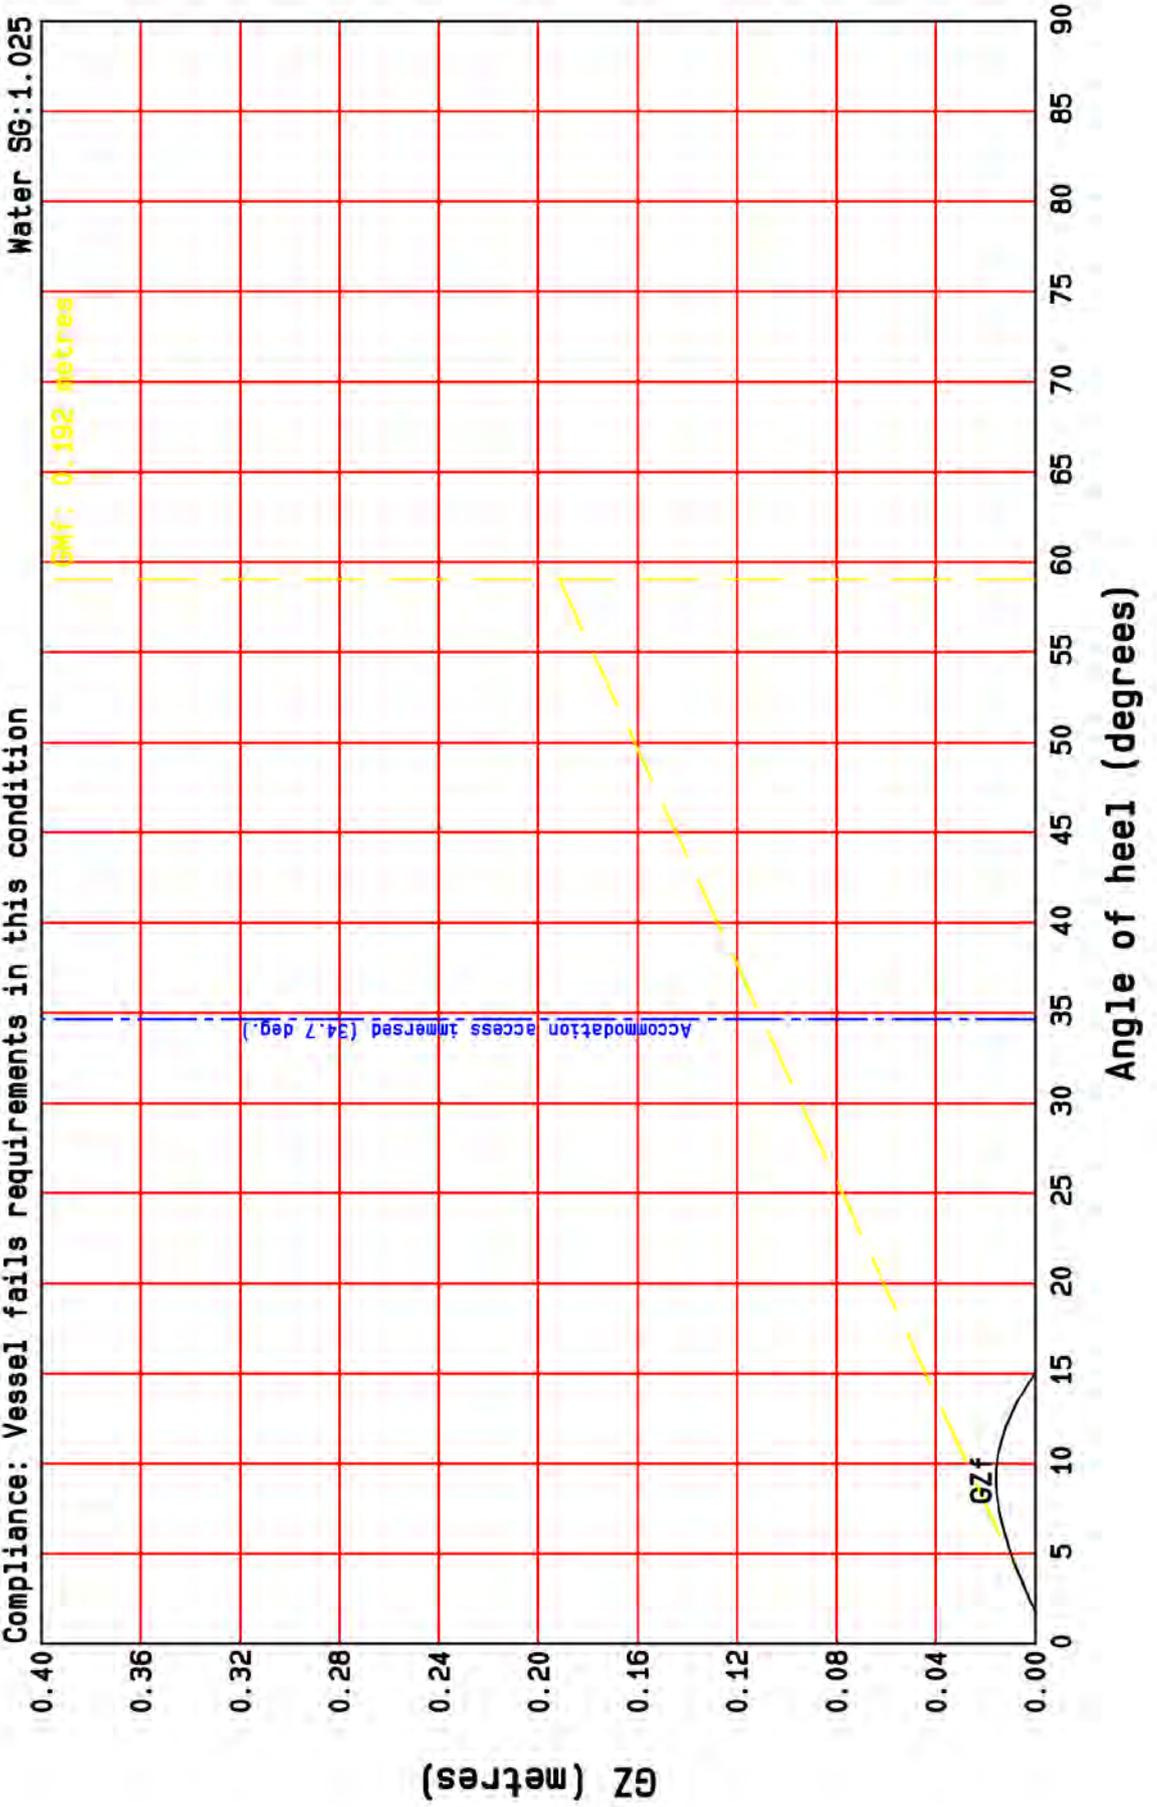
Condition.: Estimated December 2012 accident condition
State.....: Intact including appendages
Compliance: Vessel fails requirements in this condition

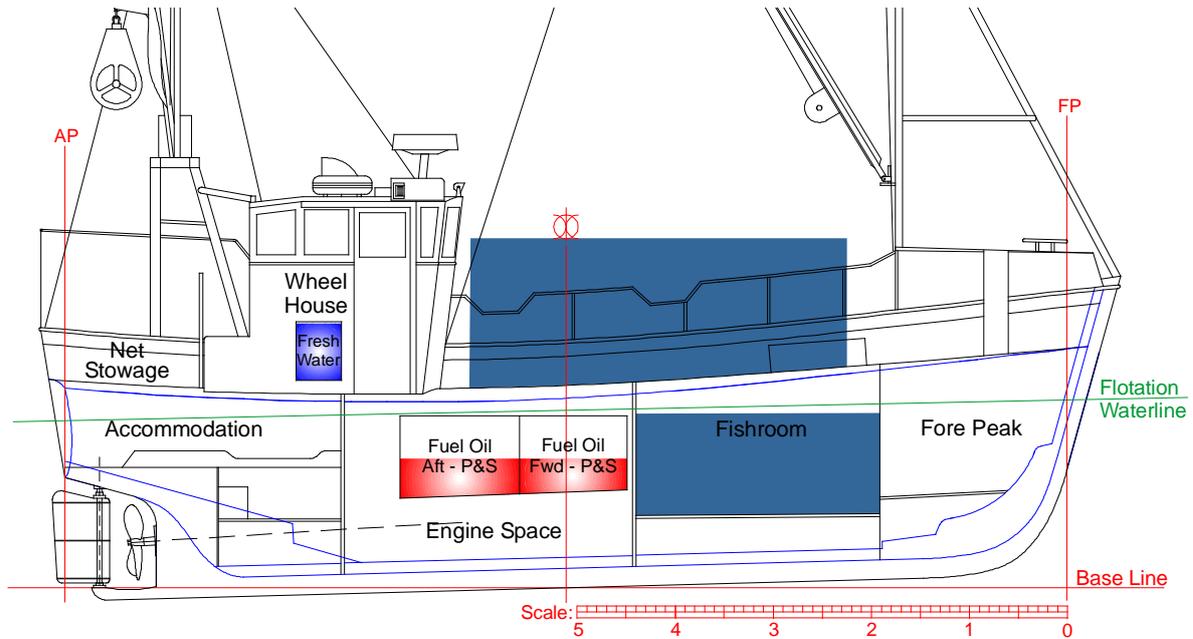
Vessel.....: *FV Heather Anne*
 Condition.: *Estimated January 2011 near-accident condition*
 State.....: *Intact including appendages*
 Water SG...: *1.025*
 Compliance: *Vessel fails requirements in this condition*

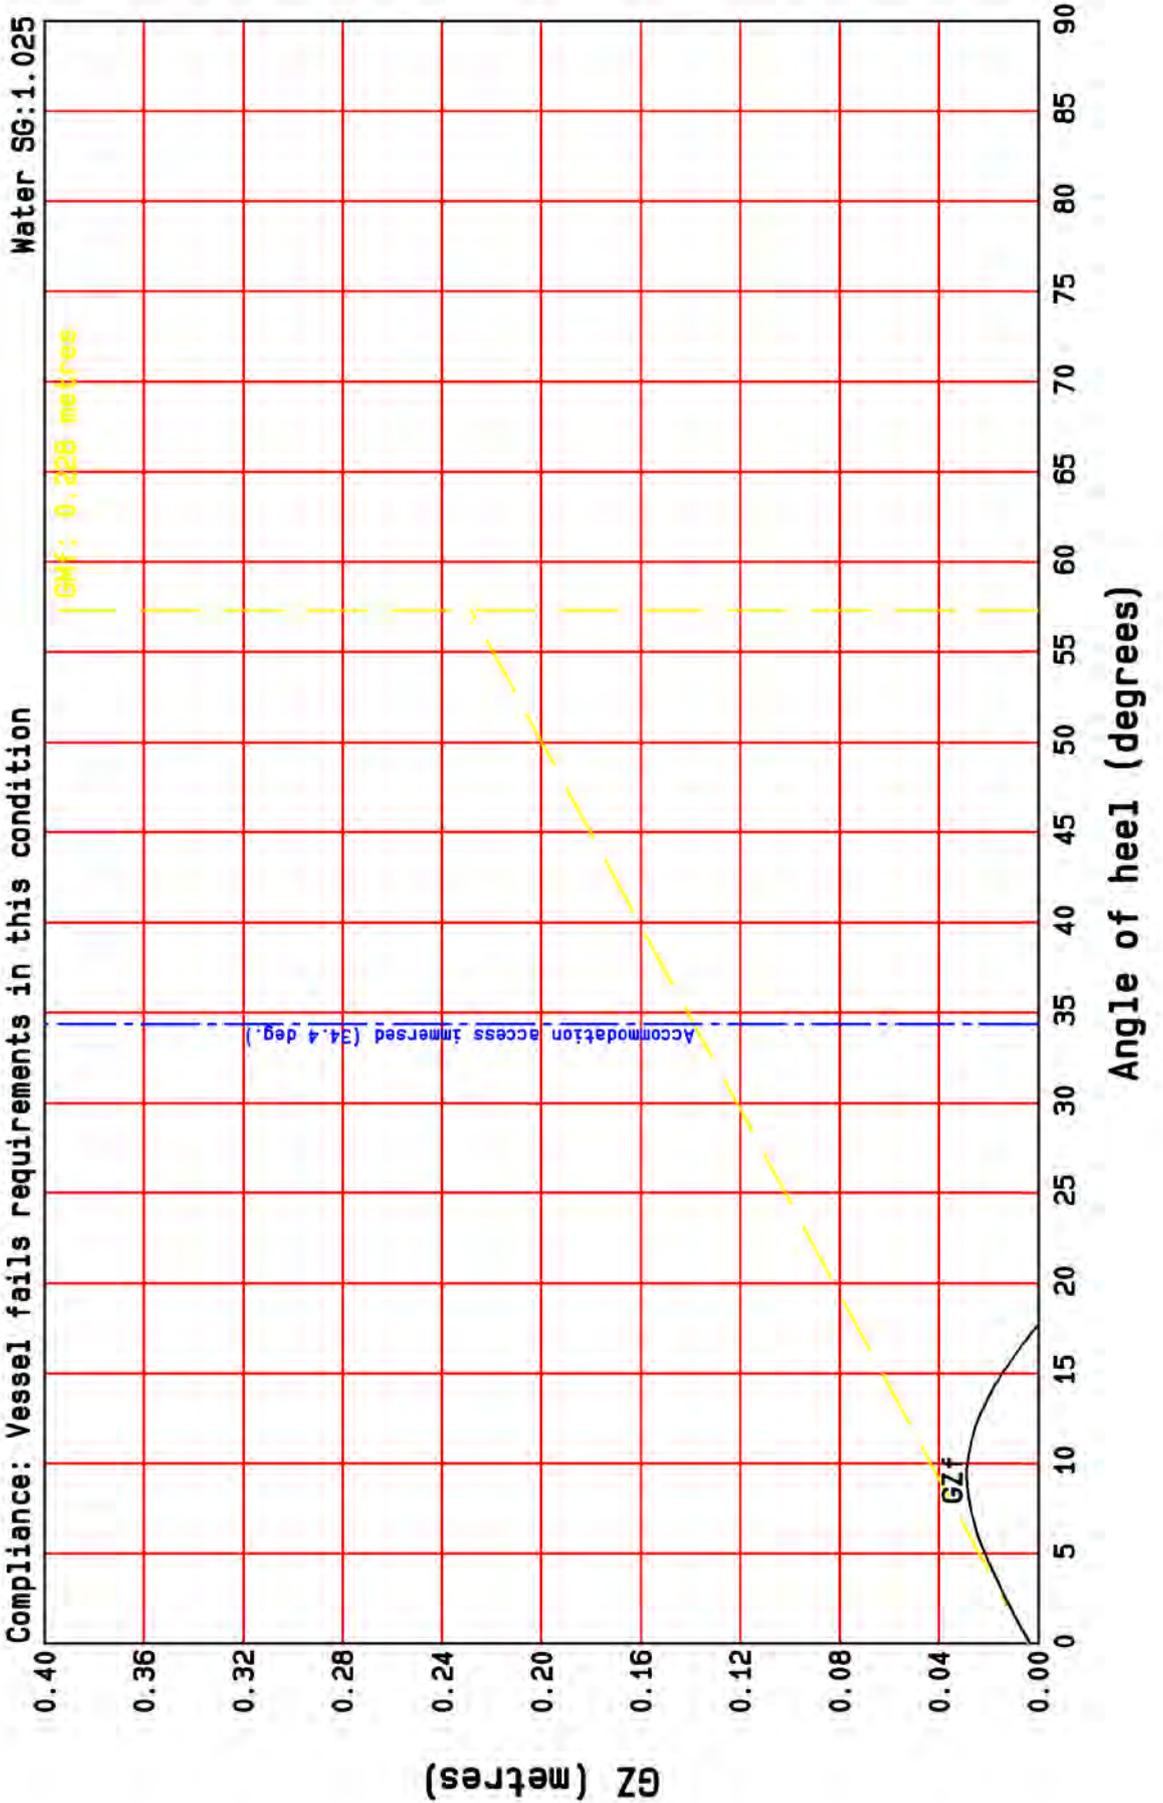
Condition.: Estimated January 2011 near-accident condition
State.....: Intact including appendages
Compliance: Vessel fails requirements in this condition
