Report on the investigation of  
windlass damage, grounding and accident to person  
on the ro-ro ferry

***Norcape***

Firth of Clyde and Troon, Scotland

on 26-27 November 2011

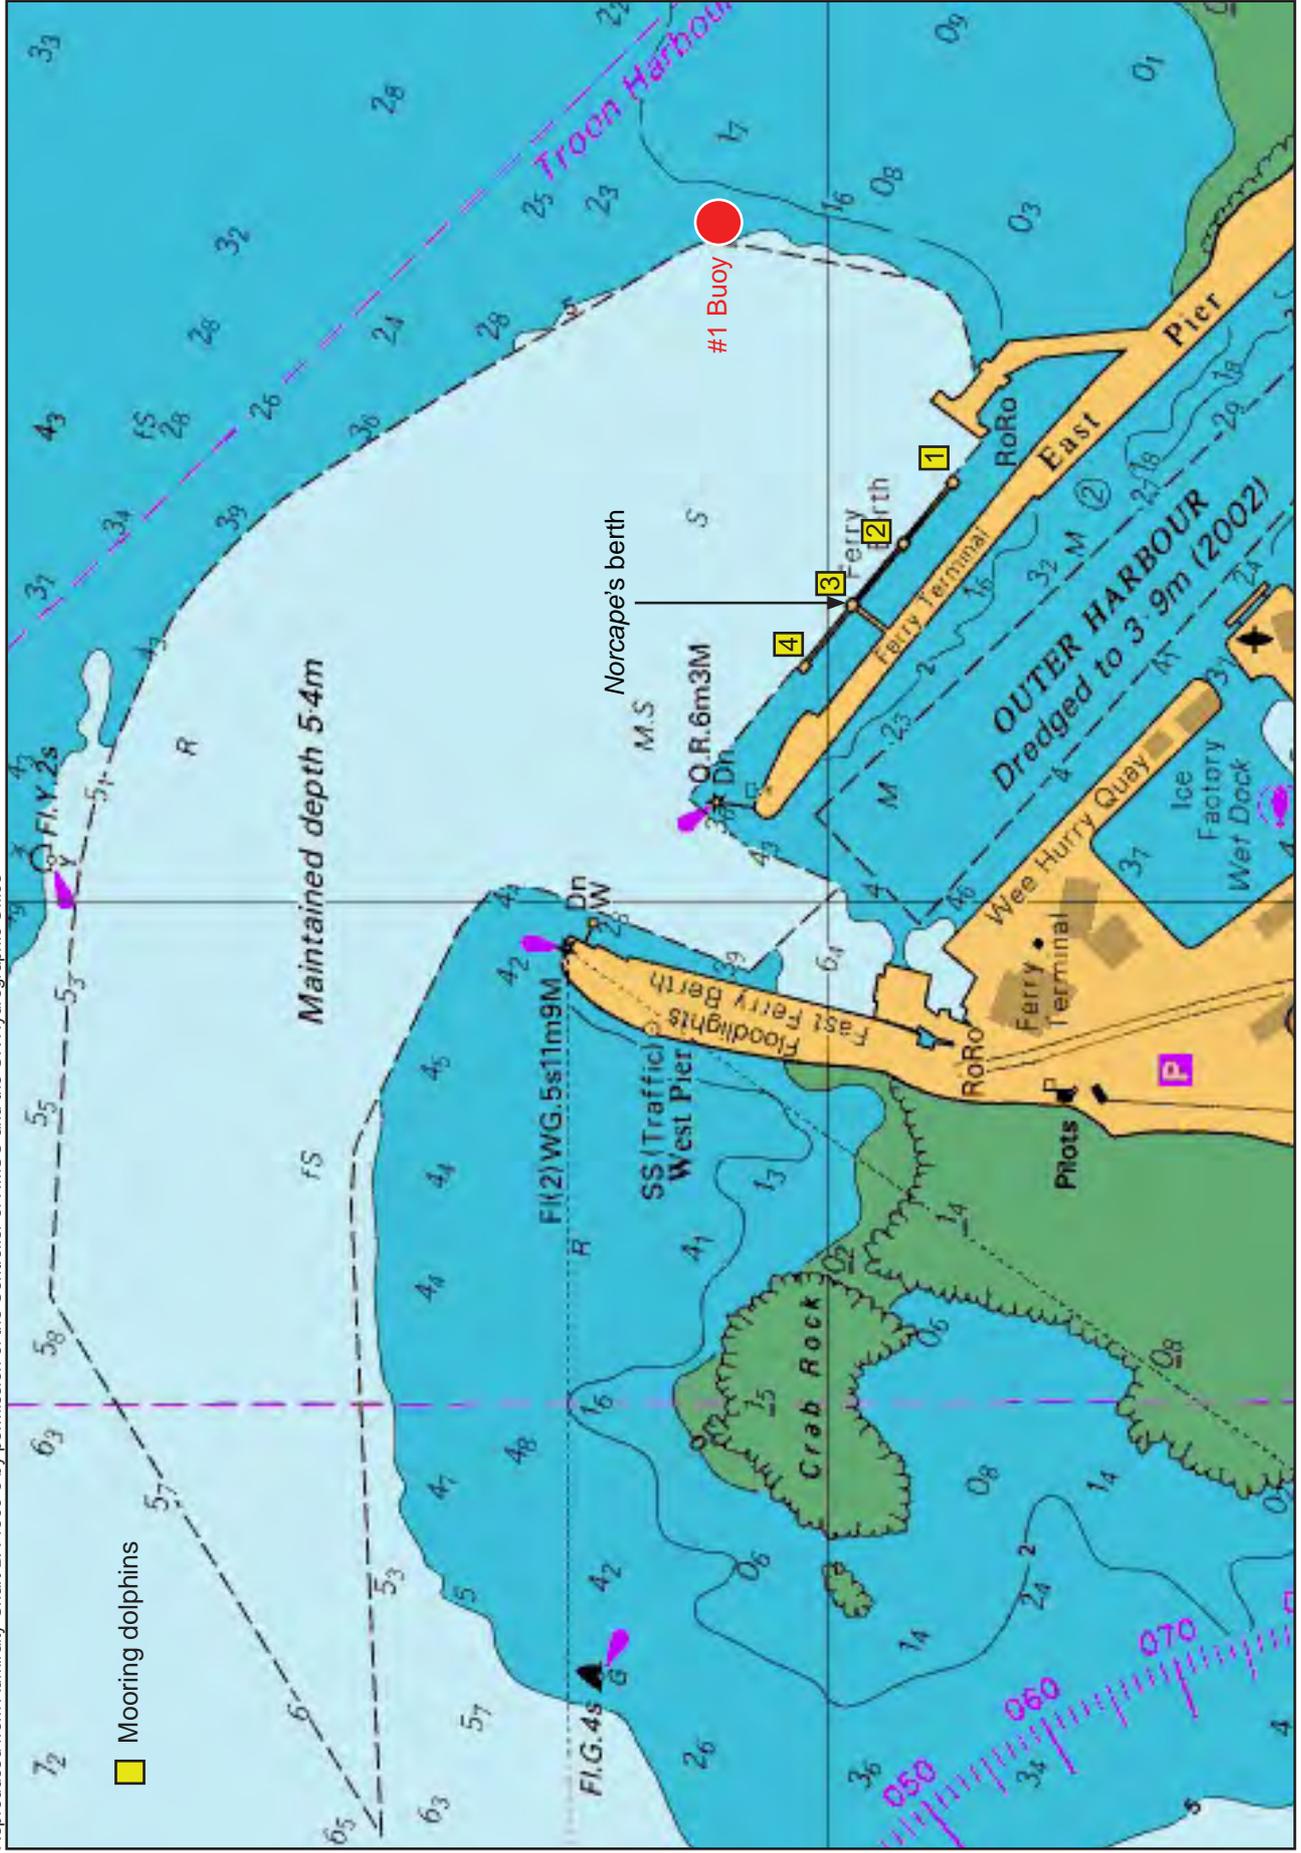
Figure 1: P&O berth, Troon

At 2326 an aft backspring mooring line was sent ashore from the vessel's port quarter to No 2 dolphin and was made fast (**Figure 1**). Both bow thrusters, which were each rated at approximately 9t bp, were then set at full power in an attempt to bring the vessel alongside by moving her bow to port, into the wind. At this time, *Norcape's* anemometer recorded the wind as south-westerly 35-40kts.

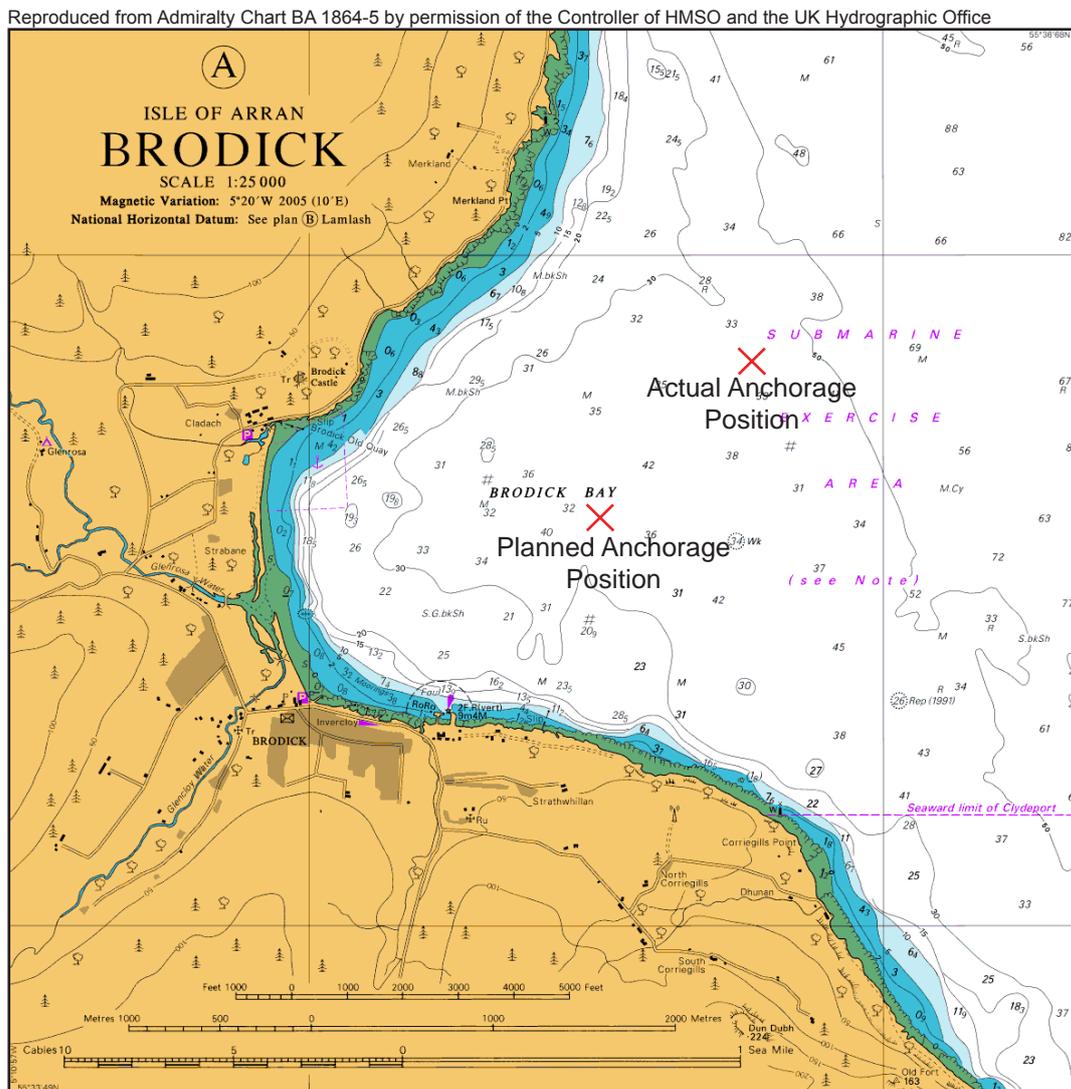
**Figure 3: Brodick Bay, Isle of Arran**

At 0350 *Norcape* approached her anchorage position in Brodick Bay. Due to the presence of another vessel in the bay it was necessary to re-plan the anchoring position. The revised position was 1.4 miles from Brodick pier (**Figure 3**), which was 0.75 miles further to seaward than the originally planned position.

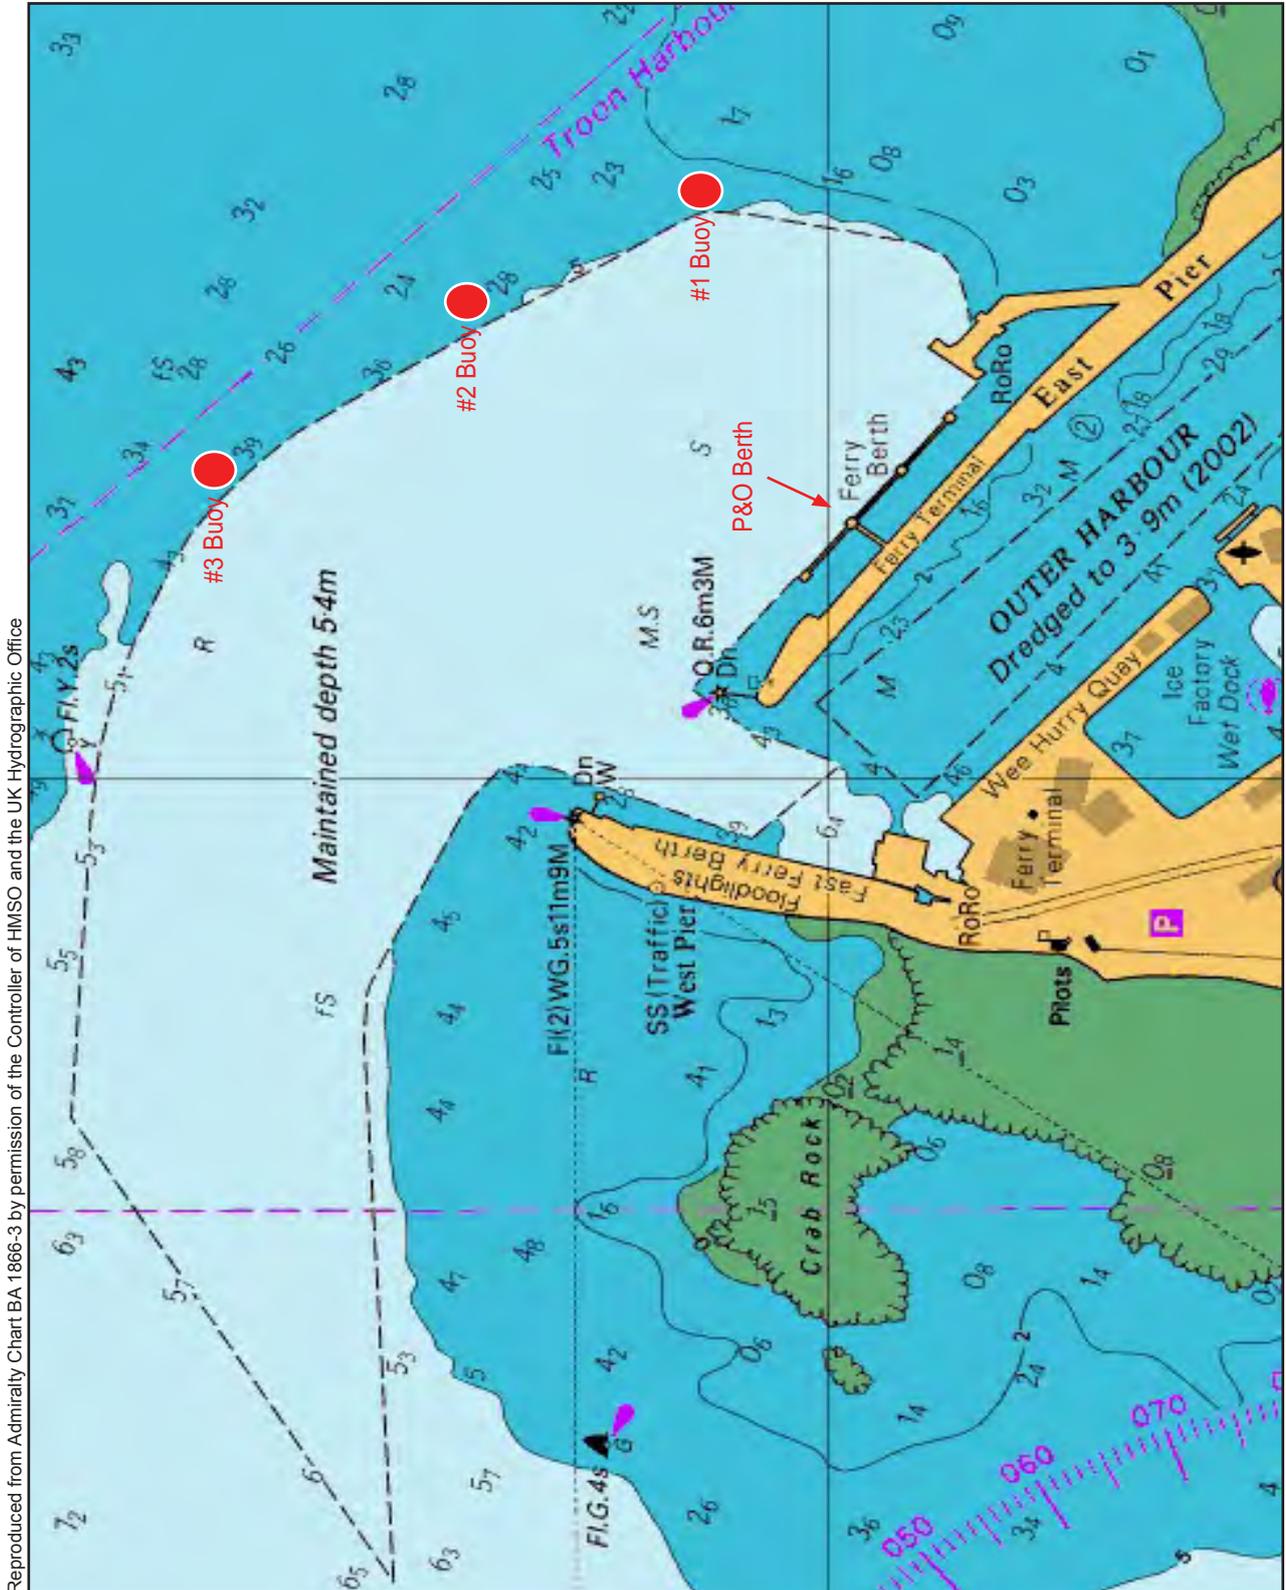
Figure 9: P&O Berth, showing approximate locations of buoys marking edge of dredged area

*Norcape*'s stern was lying close to No 1 buoy (Figure 9), which marked the edge of the dredged turning circle when the attempt to refloat began.

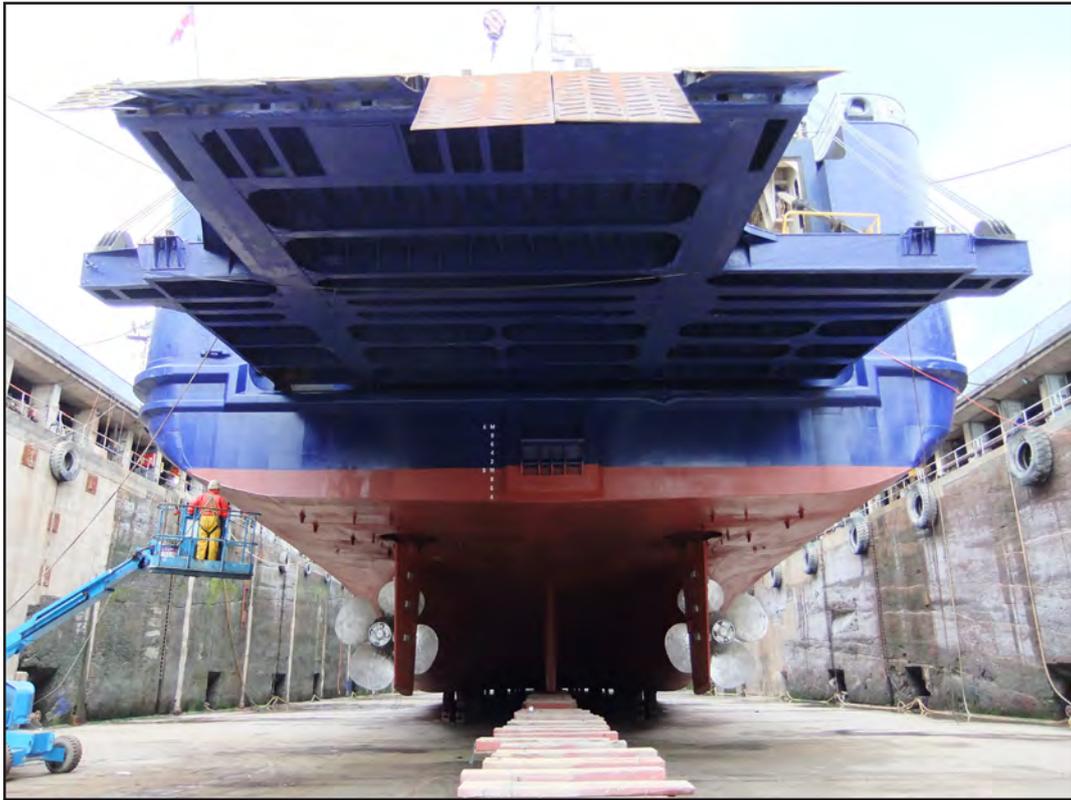
**Figure 11: Norcape showing offset rudders**

*Norcape* had a reputation within the P&O Ferries fleet as being a vessel which was quite difficult to manoeuvre. The vessel's rudder/propeller configuration, with offset rudders (**Figure 11**), was different to the more conventional, in-line configuration fitted on *European Mariner* (**Figure 12**).

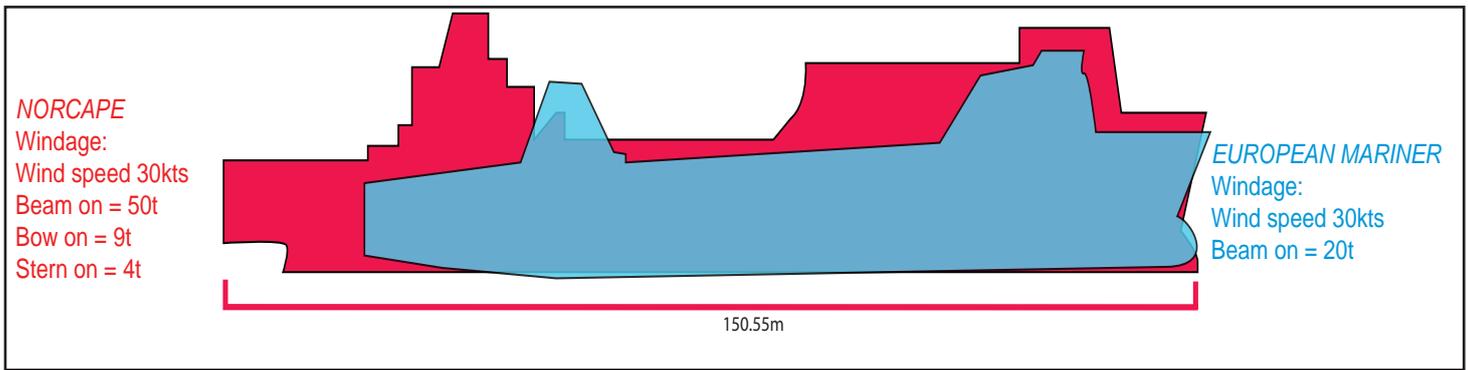
**Figure 13:** Silhouette comparisons of *Norcape* and *European Mariner*

*Norcape's* tonnage, 14087gt, was considerably larger than *European Mariner*, 5897gt. The vessels' profiles were also significantly different (**Figure 13**); *Norcape* had a larger cross-sectional area, which gave her a larger windage area than *European Mariner*. The total power developed by the engines and bow thrusters of both vessels was:
