MV PRIDE OF CALAIS

Machinery failure leading to contact with berth Calais, France 22 October 2011

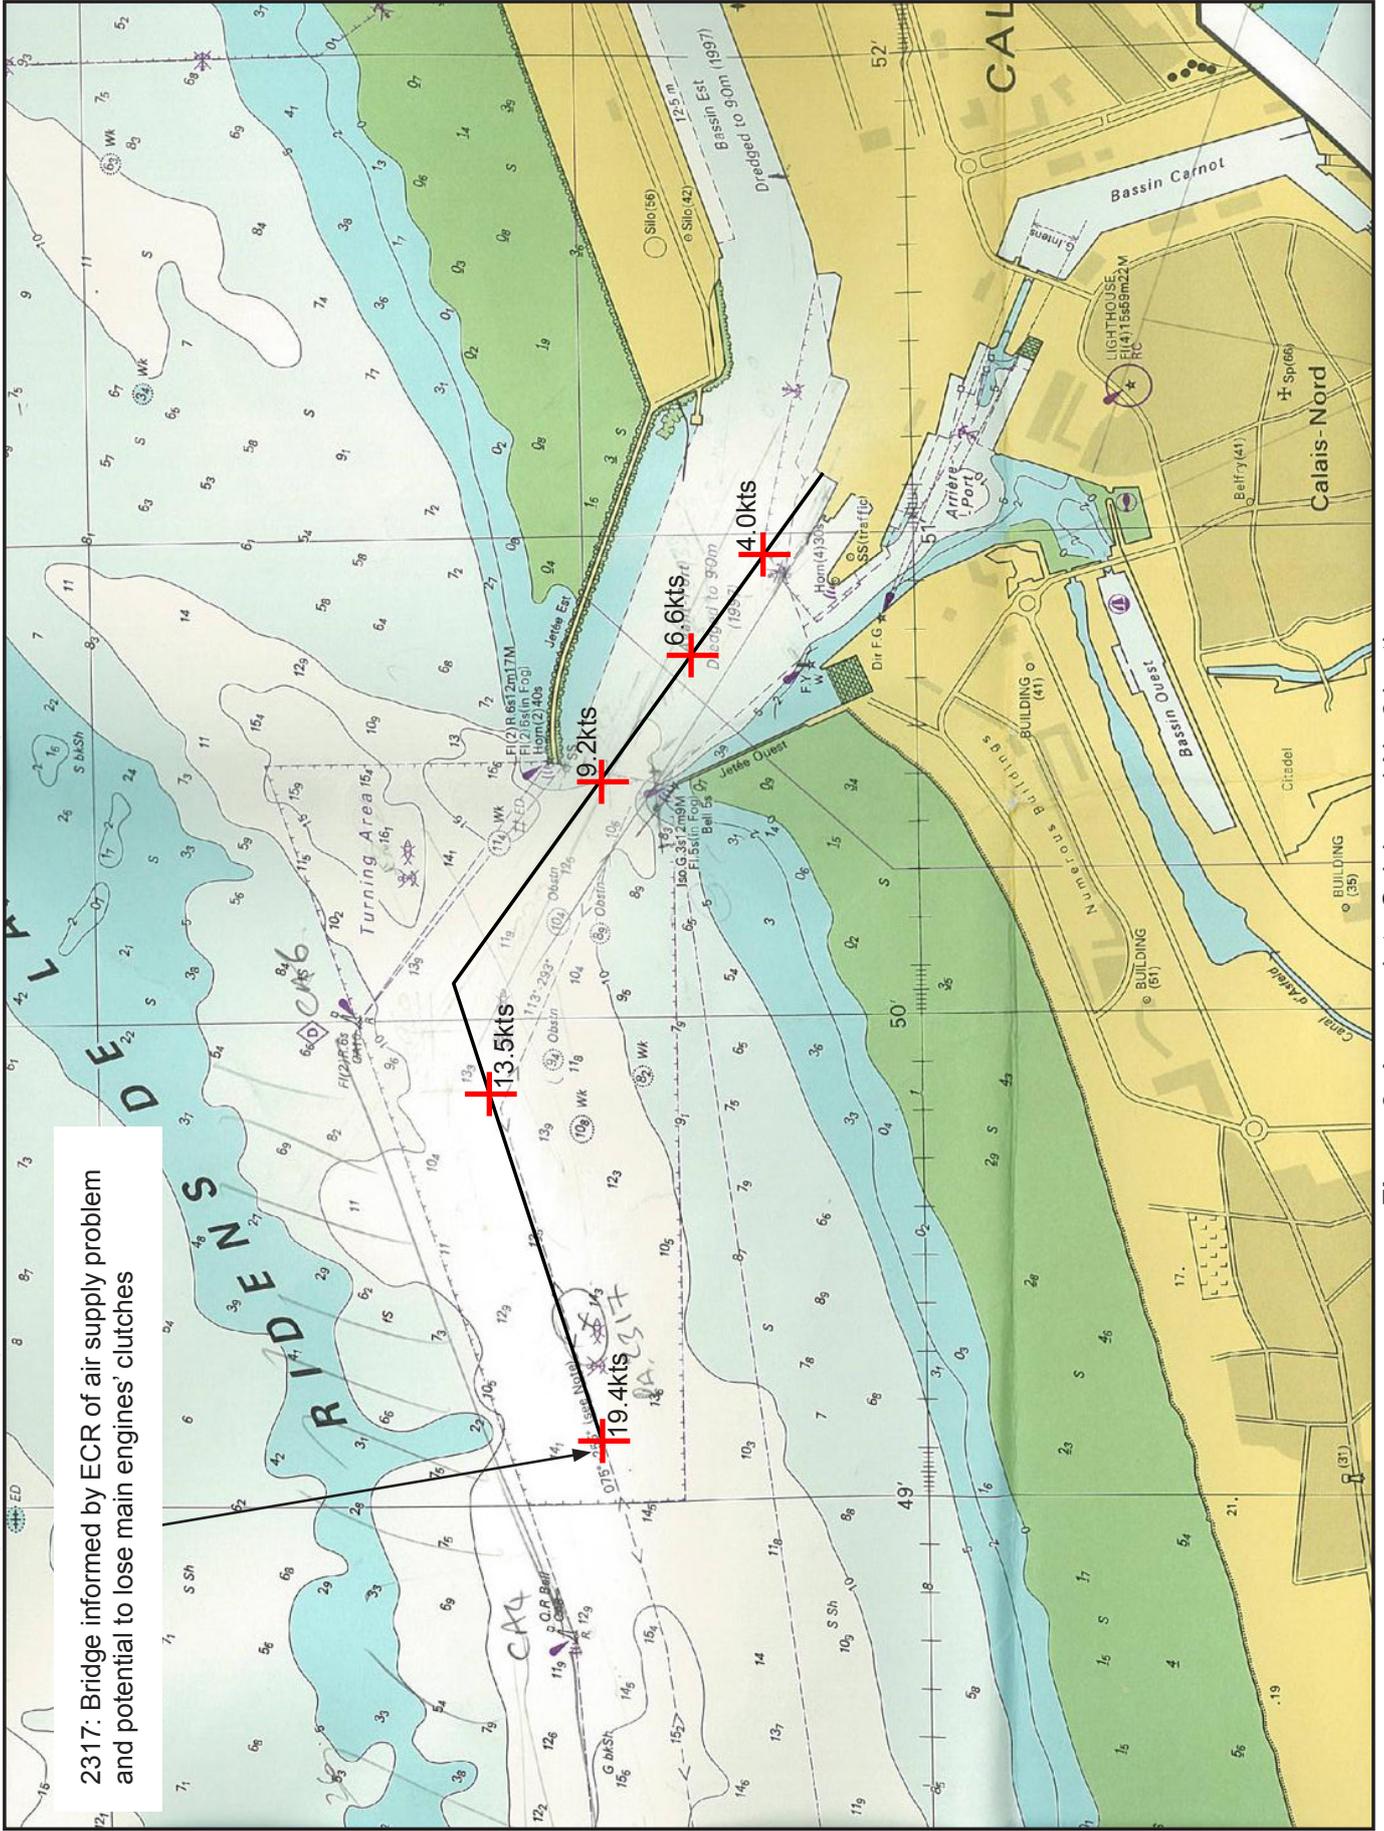
Figure 3: Approach to Calais and No 6 berth

At 2321, the master ordered an announcement to be made instructing the passengers to remain in the accommodation and not to proceed to the stairways leading to the vehicle decks. *Pride of Calais* was now 3.2 cables from her intended berth (**Figure 3**), travelling at a speed of 7.3kts.

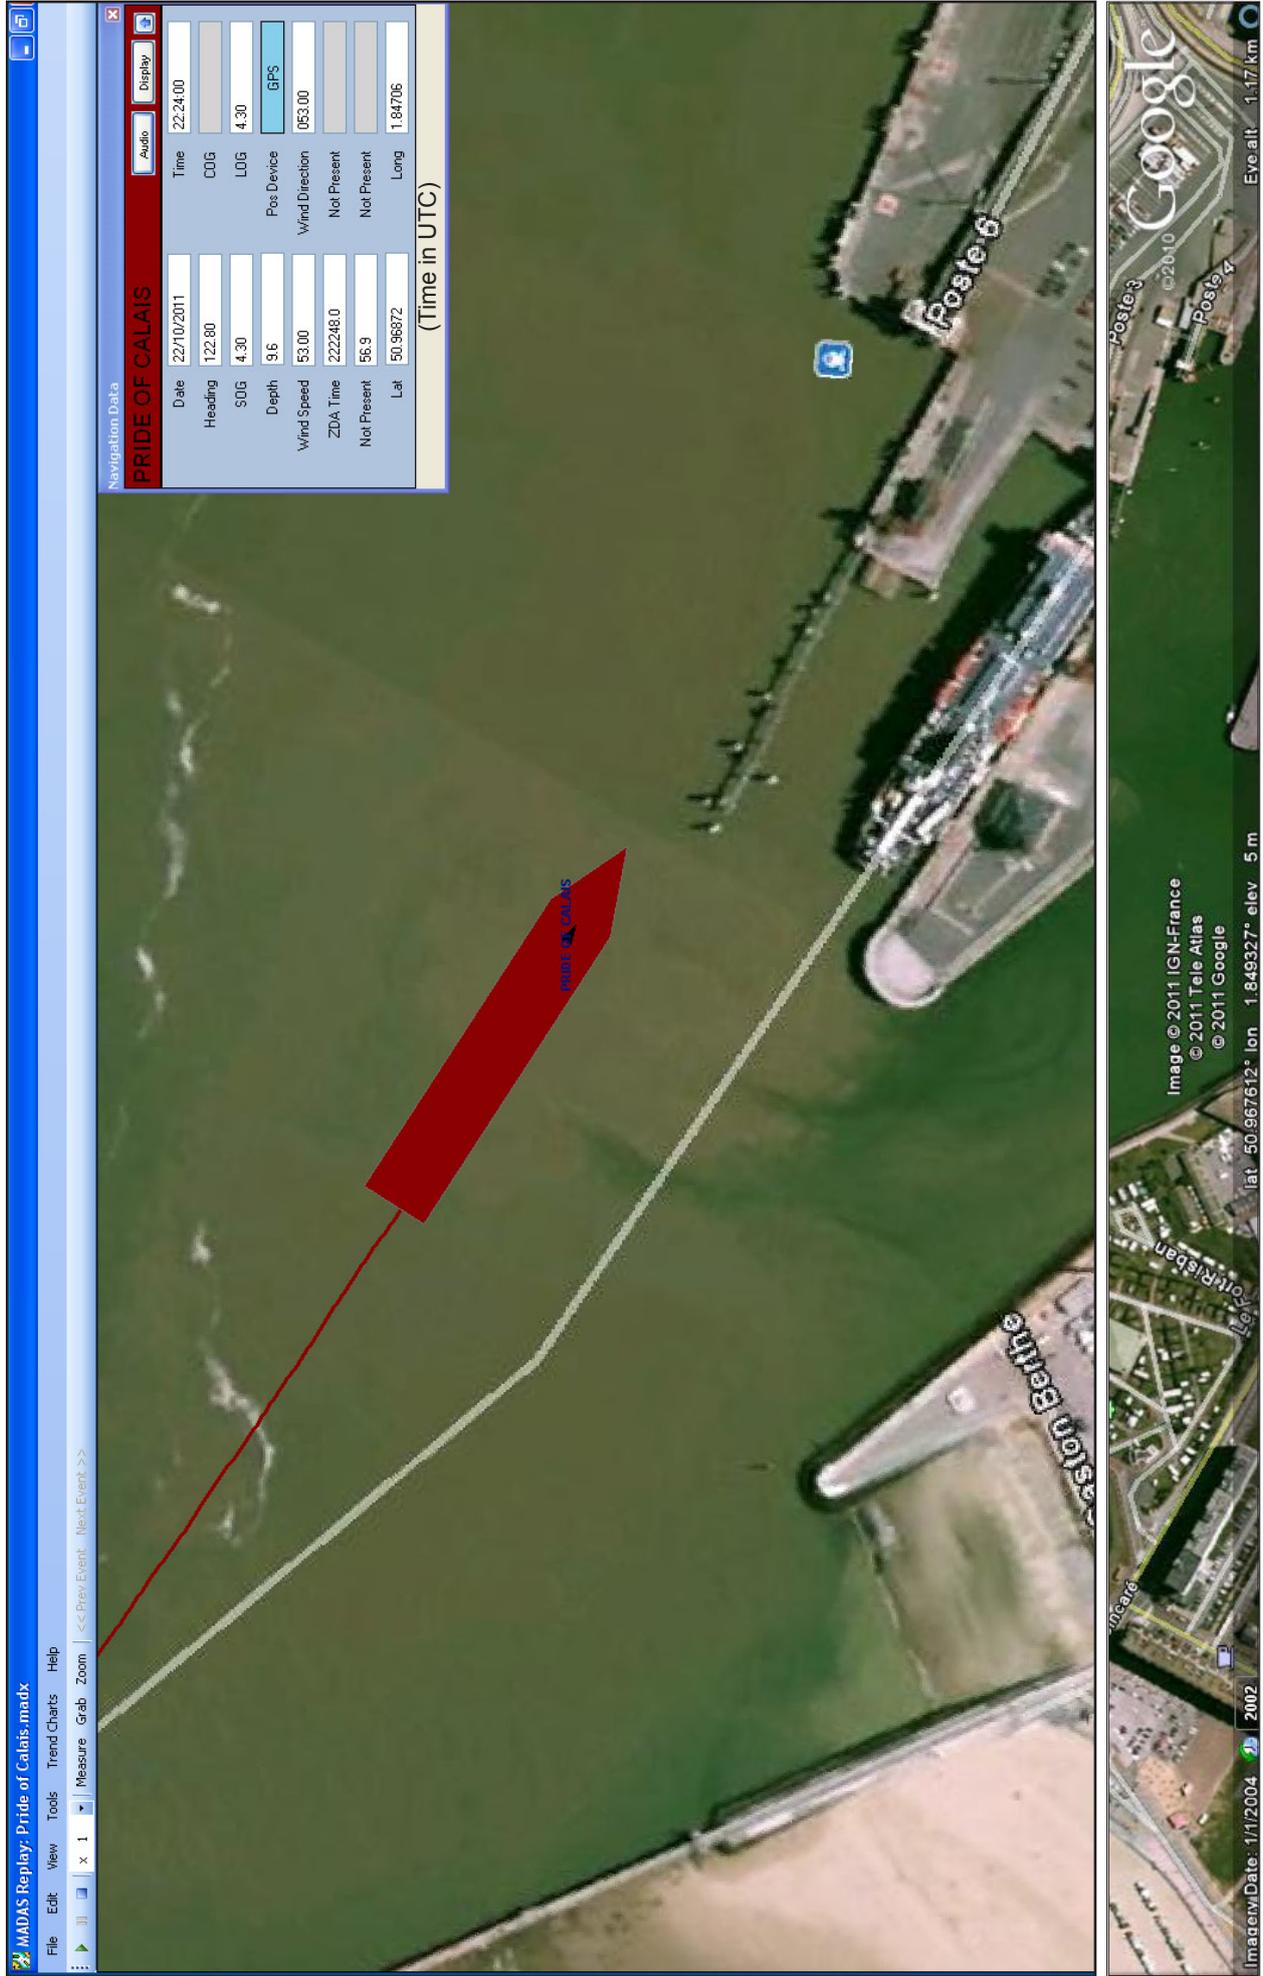
At 2324, *Pride of Calais* was just over a ship's length from the berth travelling at a speed of 4.3kts (**Figure 4**). At 2325, an announcement was made

Figure 4: Approach to No 6 berth Calais at the time of port and starboard main engines' clutches disengaging
