Report on the investigation of the steering  
control failure and subsequent contact  
on board the high-speed catamaran

***Moon Clipper***

on the River Thames, London

5 October 2011

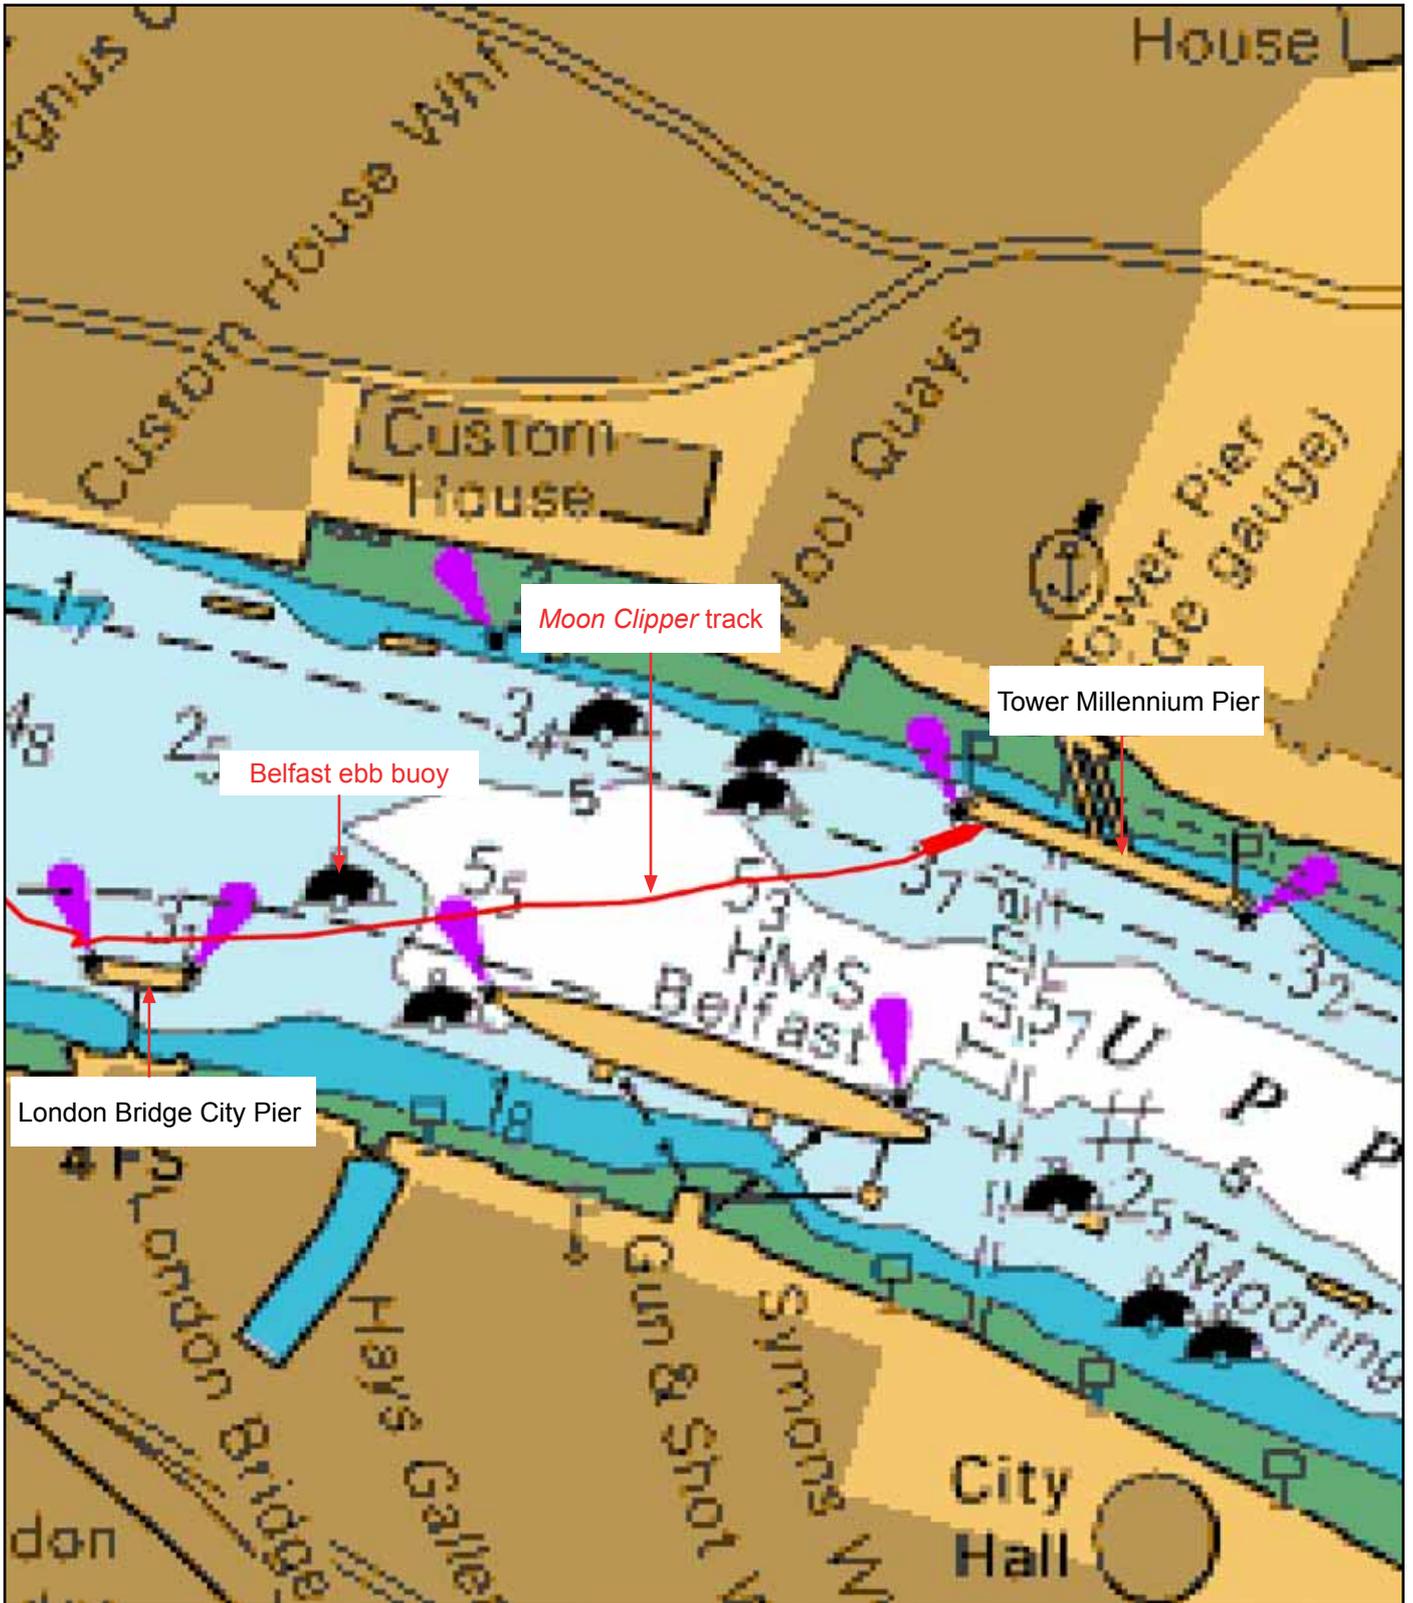
Figure 5: Moon Clipper's passage between London Bridge City Pier and Tower Millennium Pier

At 1849, the mate released the mooring rope and the master manoeuvred *Moon Clipper* off the berth. *Moon Clipper* was running about 3 minutes behind schedule, and once clear of the pier, the master increased speed quickly to 12 knots and navigated his way between the historic warship, *HMS Belfast*, and the Belfast ebb buoy (**Figure 5**).

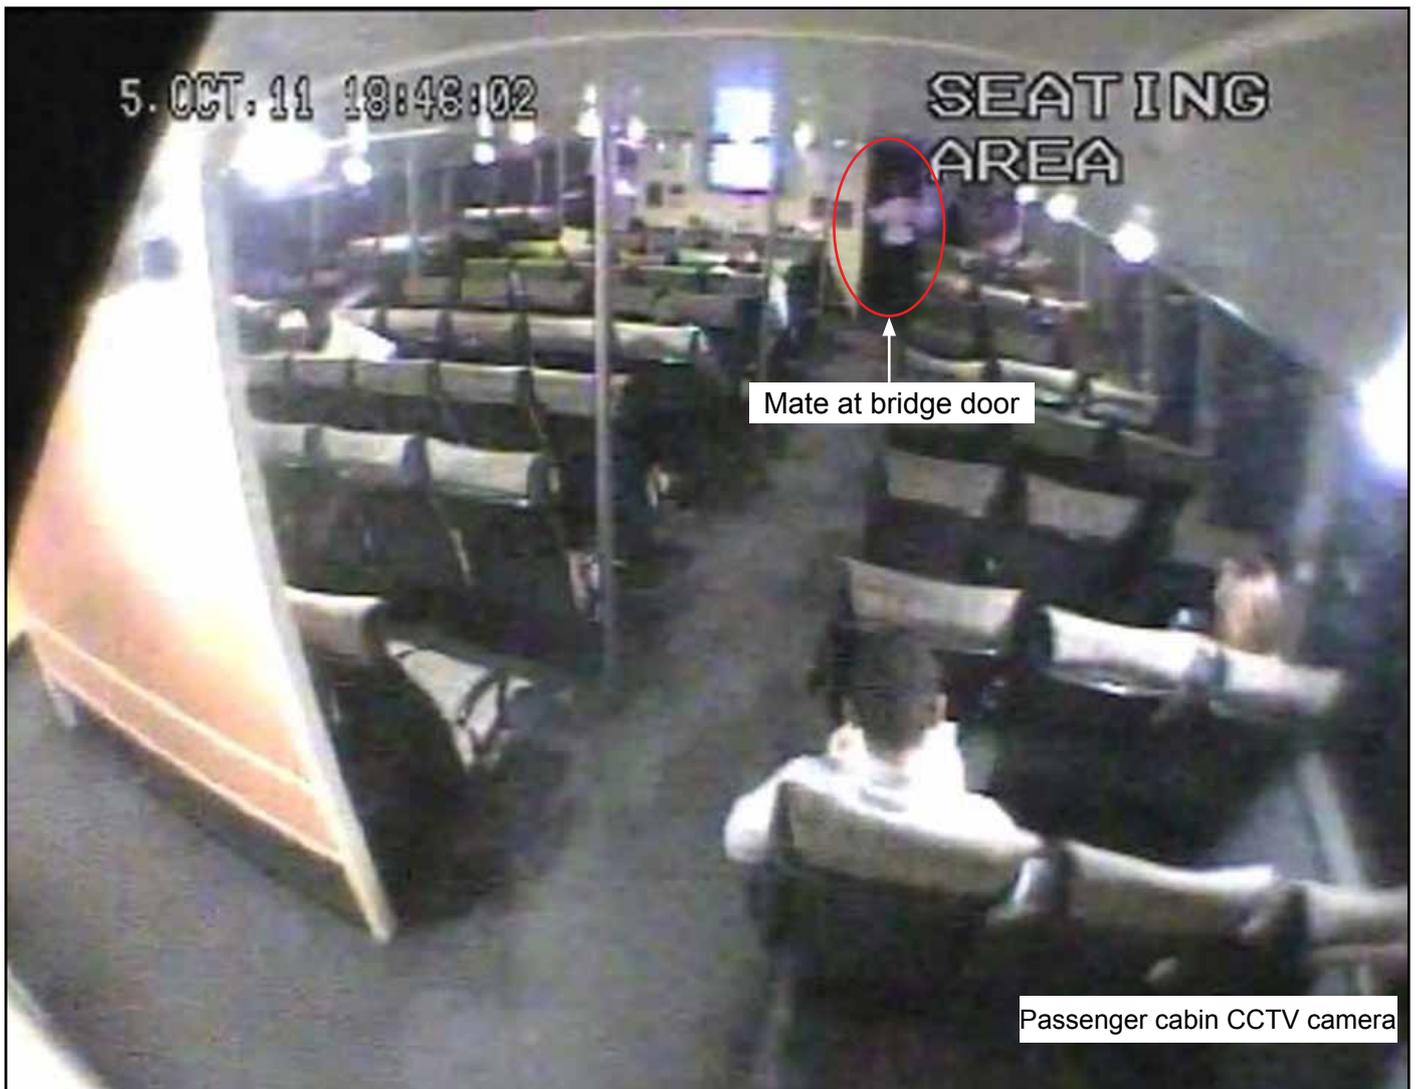
**Figure 6:** Mate shouting passenger figures to the master  
(CCTV time local + 3 minutes)

As the mate passed through the passenger cabin on his way to the port forward mooring deck, he opened the door to the bridge and shouted the passenger figures up to the master (**Figure 6**). The master set a course for the lower (east) end of Tower Millennium Pier, entered the passenger figures into the River Thames automatic identification system (AIS) (**Figure 7**) and then wrote them in the company's passenger log (**Annex A**).

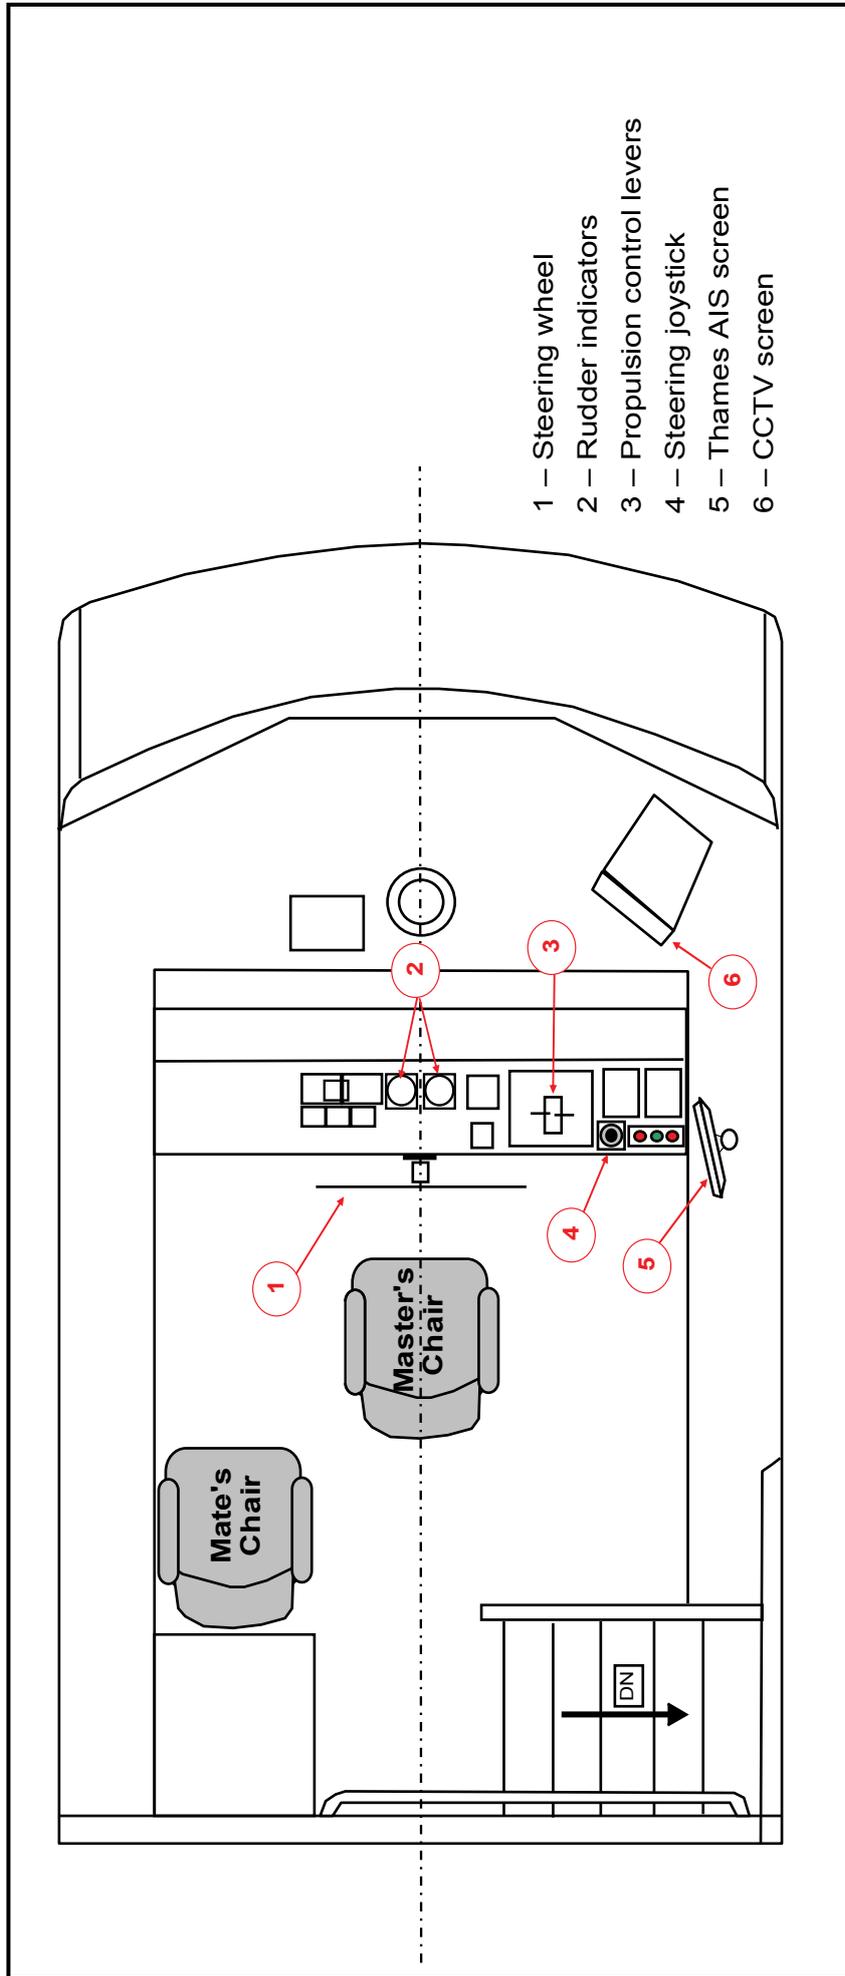
Figure 13: Bridge layout

combined gearbox and engine speed control levers were offset slightly to starboard. The steering joystick was positioned outboard of the propulsion control levers and could not be easily reached from the seated position. The propulsion and steering controls on board Thames Clippers' River Runner 200 craft were positioned on the armrests of the master's chair.

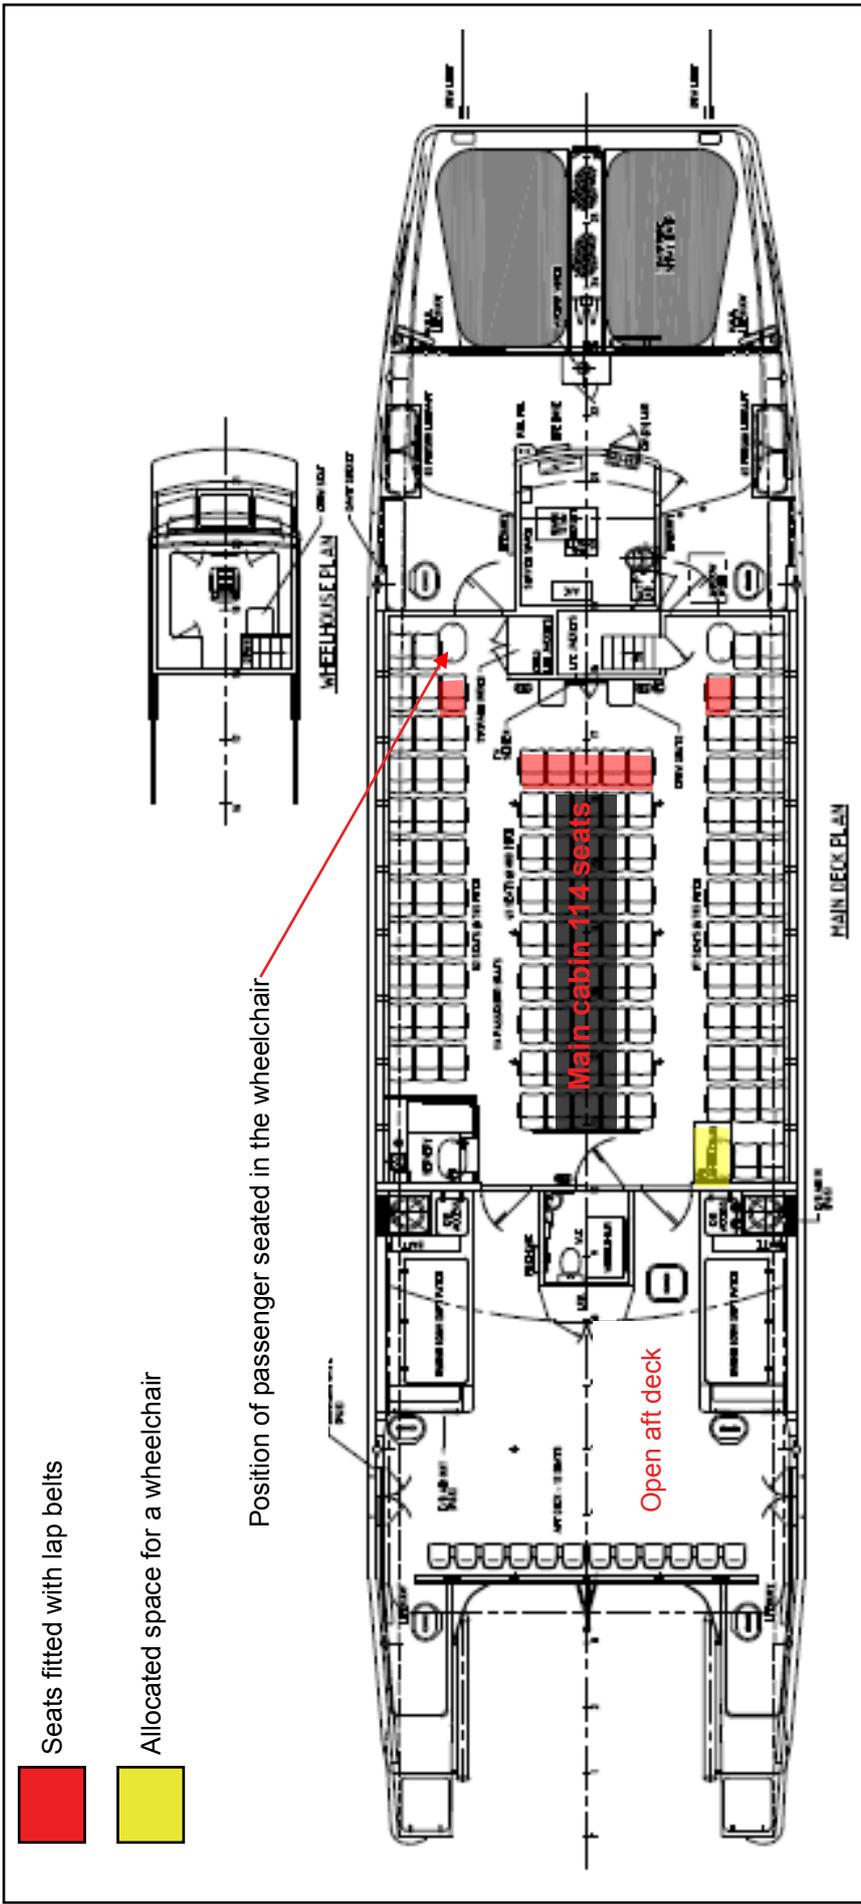
**Figure 17:** Seating arrangements in the passenger cabin

A total of 114 passenger seats had been fitted in the main passenger cabin (**Figure 17**) on board *Moon Clipper*. There was a steel handrail (**Figure 18**) on the back of each seat, and lap belts had been fitted to seven of the seats in the front row. According to the vessel's safety plans, a space next to the cabin's starboard aft access door had been allocated for use by a wheelchair using passenger. The passenger who was thrown from his wheelchair was seated close to the port forward access door.
