Report on the investigation of the
fatal accident to a crewman
on board
the fishing vessel

Starlight Rays PD230

126nm NNE of Aberdeen
on 25 August 2011

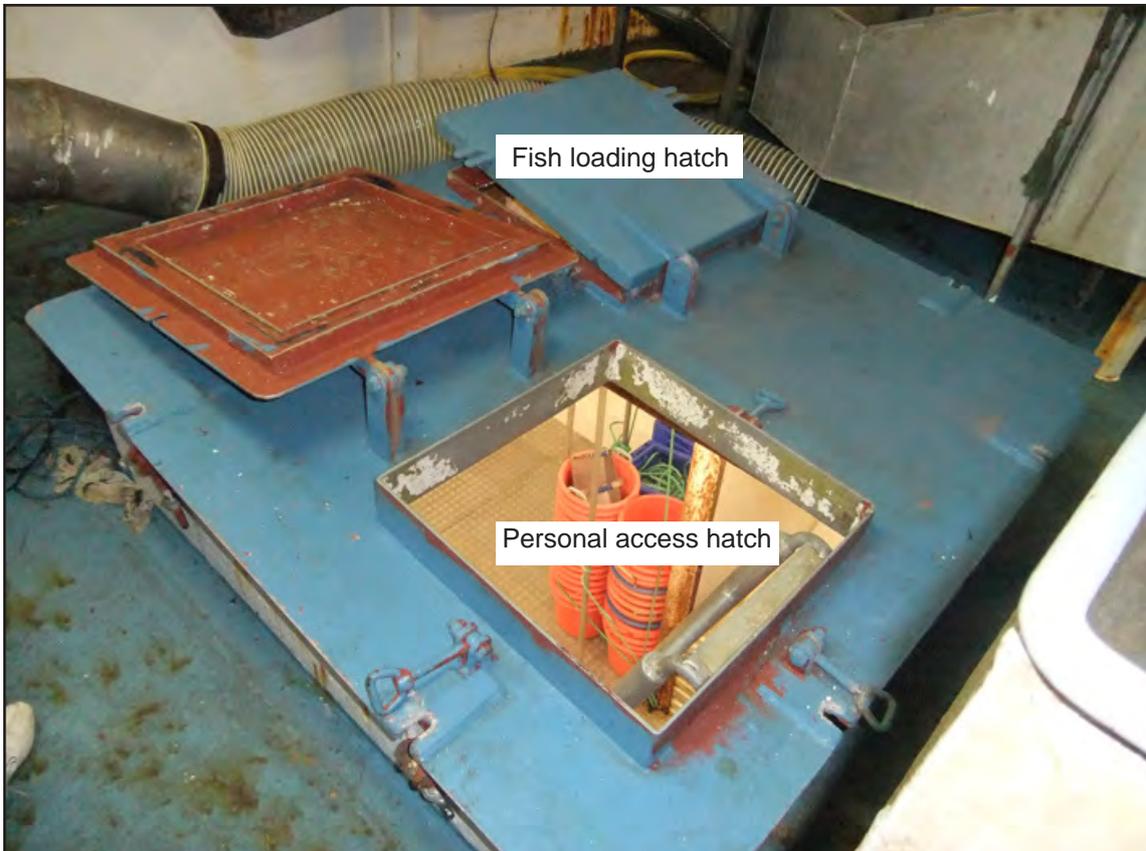
Figure 2: Access hatch from the processing deck to the fish hold

At around 1015 the skipper went to the wheelhouse and the watchkeeper went to bed. A short time afterwards, the engineer collected the suction and discharge hoses (**Figure 1**) for the portable petrol engine-driven salvage pump (subsequently referred to as 'the pump') from the chain locker and took them to the access hatch into the fish hold on the processing deck. The crewman helped the engineer carry the pump through the small access hatch that was let into the main hatch lid (**Figure 2**) and down the ladder into the fish hold.

The refrigerated fish hold had an internal volume of 167m³. The hold had no forced ventilation system and its only natural ventilation was via the hatch opening(s). The main hatch cover contained two smaller hatches: one for loading fish and the other for crew access (**Figure 2**). At the time of the accident, the hold contained refrigeration pipework, a seawater slush ice tank, an ice storage bay and empty fish boxes (**Figure 11**). The fish hold had a bilge well at the aft end that connected to the fixed bilge pumping system. The bow thruster space was accessed via a hatch at the forward end of the hold.

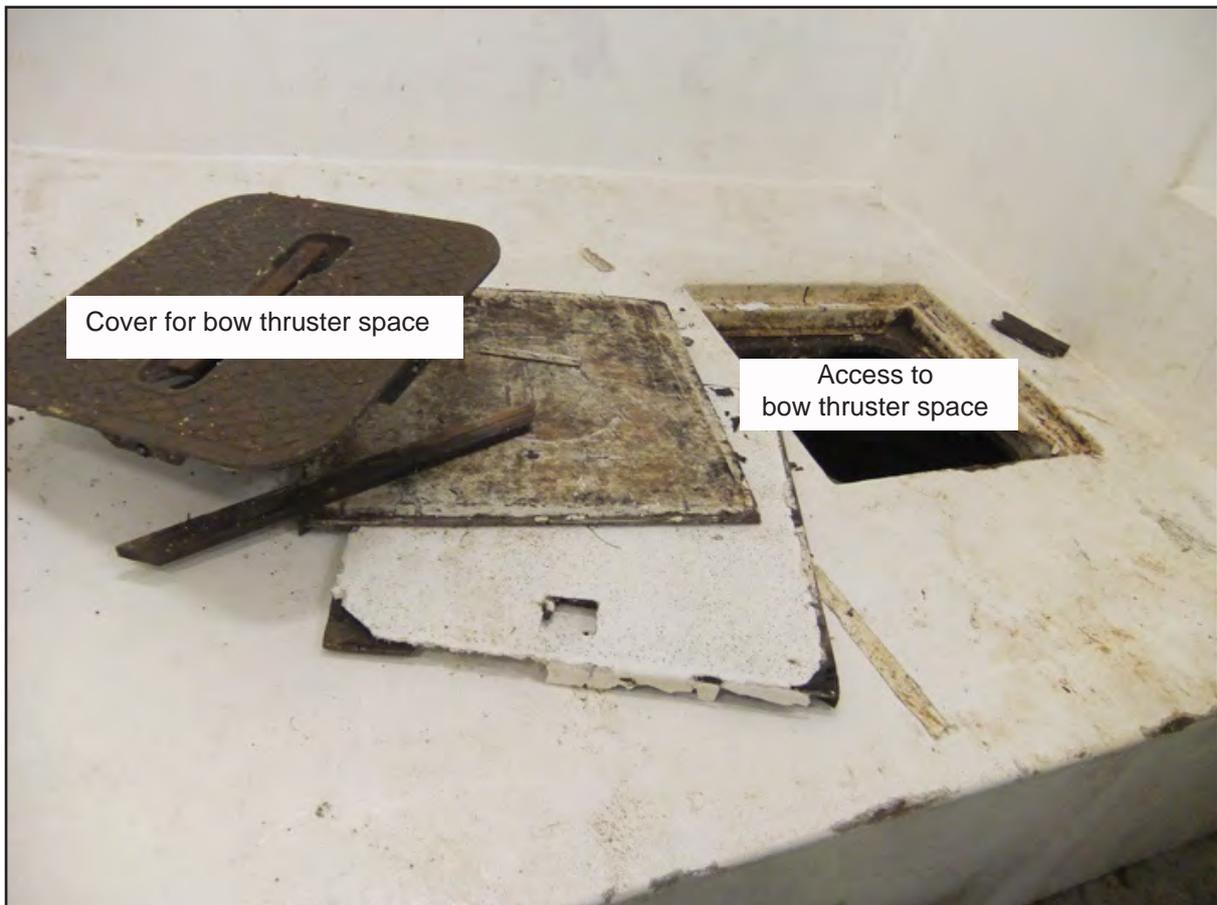
Figure 3: Bow thruster space and cover

The engineer carried the pump over to the access hatch into the bow thruster space that was at the forward end of the fish hold and connected the suction and discharge hoses to the pump. The engineer and crewman then unbolting and removed the bow thruster space access hatch (**Figure 3**) and placed the suction hose into the oily water that was inside. The crewman took the free end of the discharge hose back up the ladder, onto the processing deck and fed the flexible hose out through a tonnage valve¹ on the starboard side.

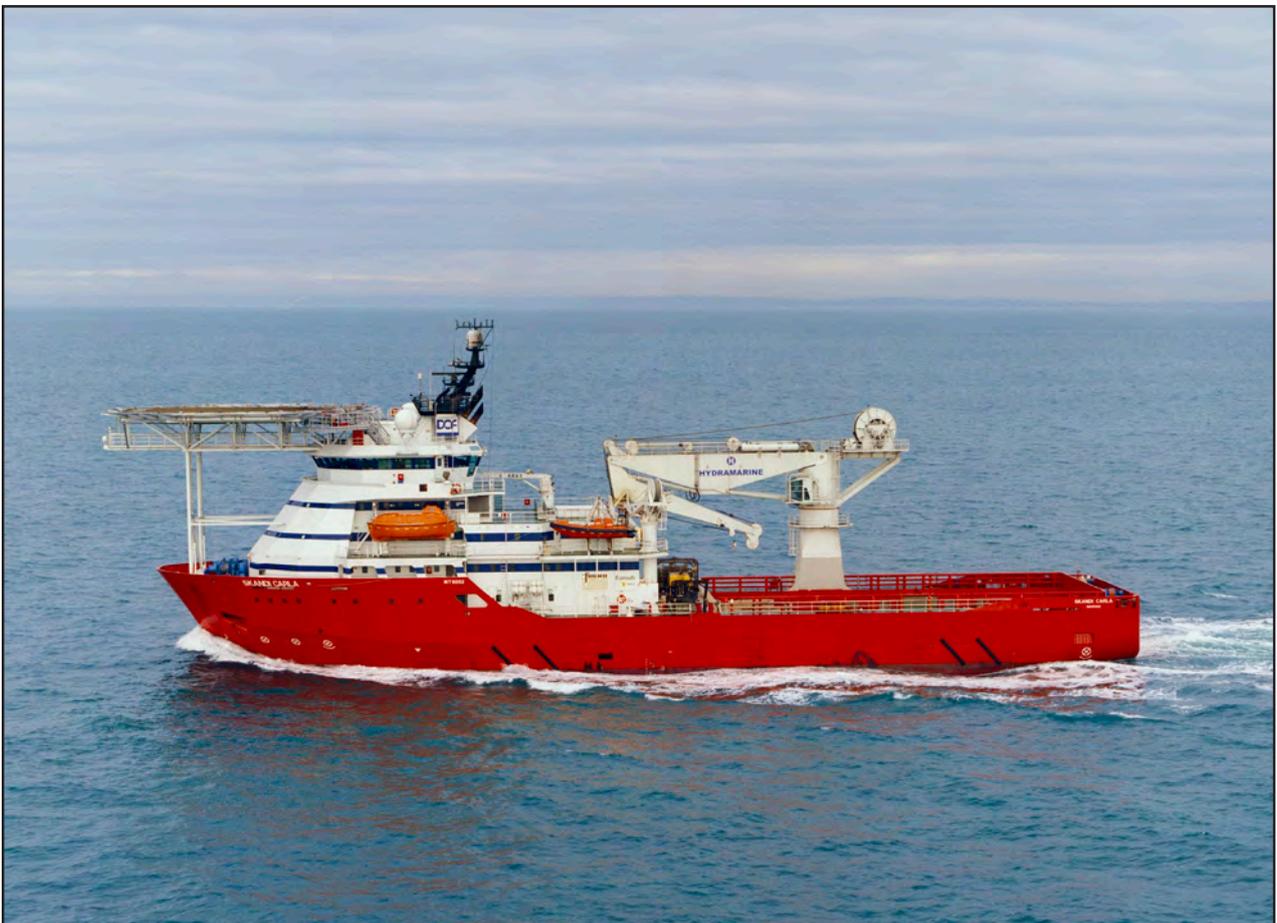
Figure 5: *Skandi Carla*

At 1500 the skipper went to the wheelhouse and called *Skandi Carla* (**Figure 5**) by very high frequency (VHF) radio. He told *Skandi Carla's* OOW that he needed medical assistance for the engineer, who had collapsed in the fish hold possibly due to the effects of carbon monoxide (CO).

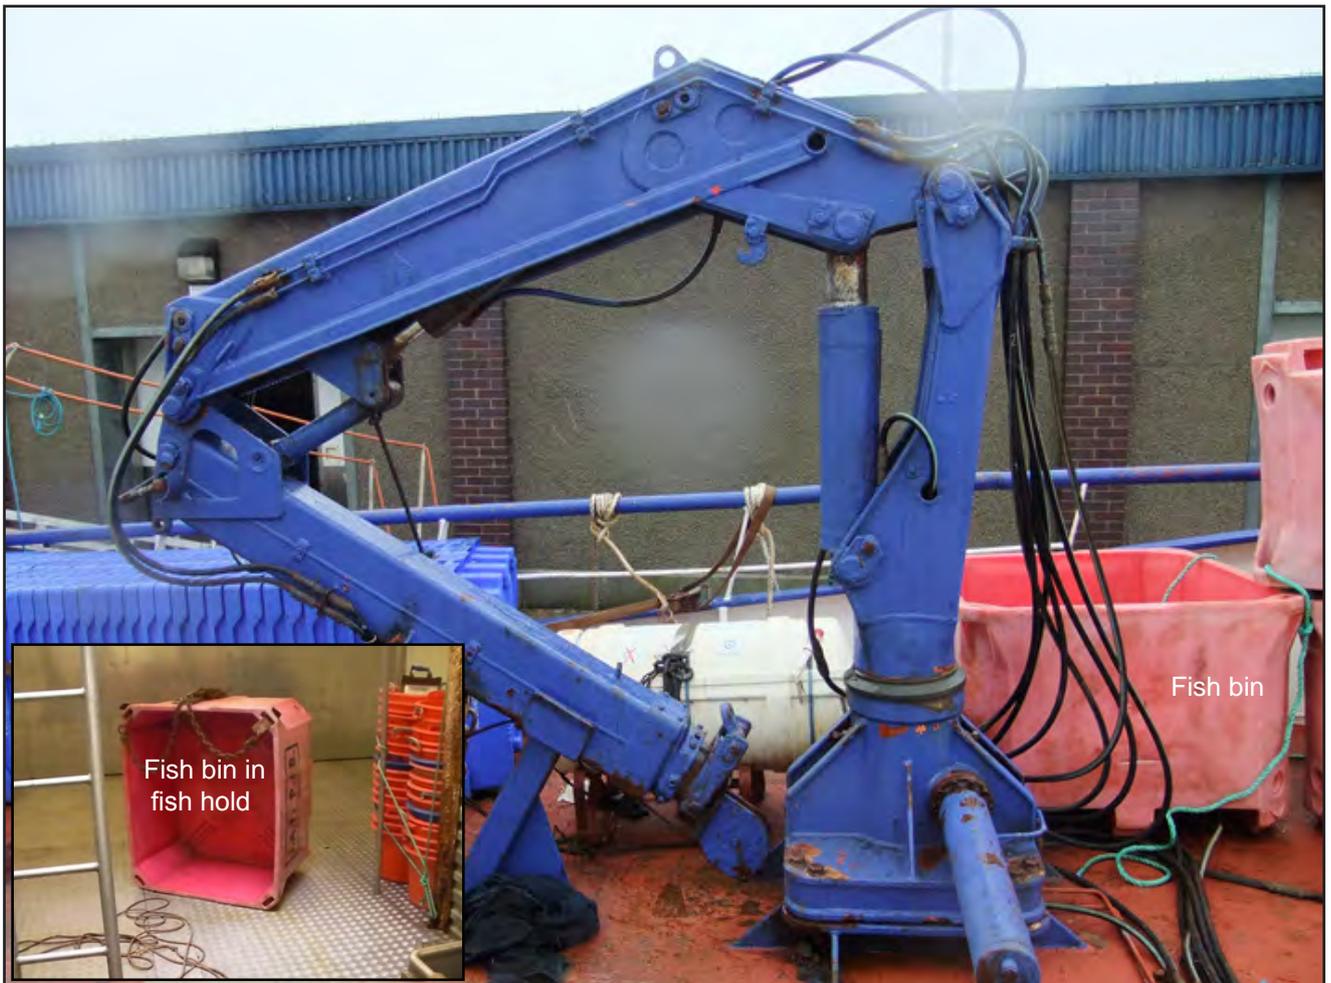
Figure 6: Landing crane and fish bin

The watchkeeper left the fish hold and went up to the processing deck; he then connected a fish bin to the hook of the unloading crane. When the bin was ready to lower into the fish hold, the watchkeeper shouted down to the crewman. After hearing no response, the watchkeeper looked down into the hold and saw that the crewman had also collapsed. The watchkeeper called to the skipper, who had arrived back on the processing deck, and told him about the crewman's collapse. The watchkeeper then climbed into the bin and the skipper lowered him into the fish hold (**Figure 6**).

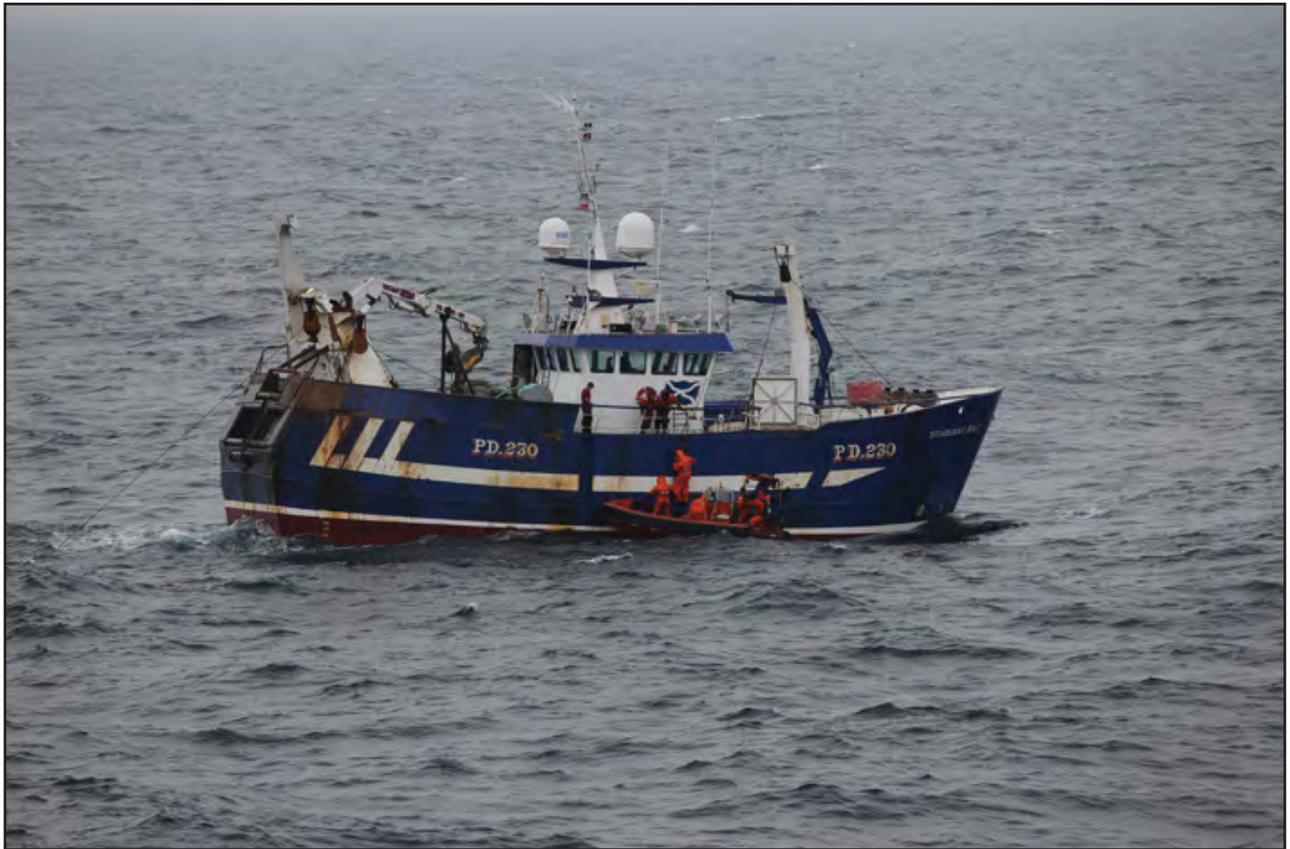
Figure 7: *Skandi Carla's* rescue team boarding *Starlight Rays*

One of the rescuers from *Skandi Carla* donned the BA set, entered *Starlight Rays's* fish hold and attempted to push the unconscious engineer into the fish bin. He was not successful as the engineer was too heavy to be moved by one person.

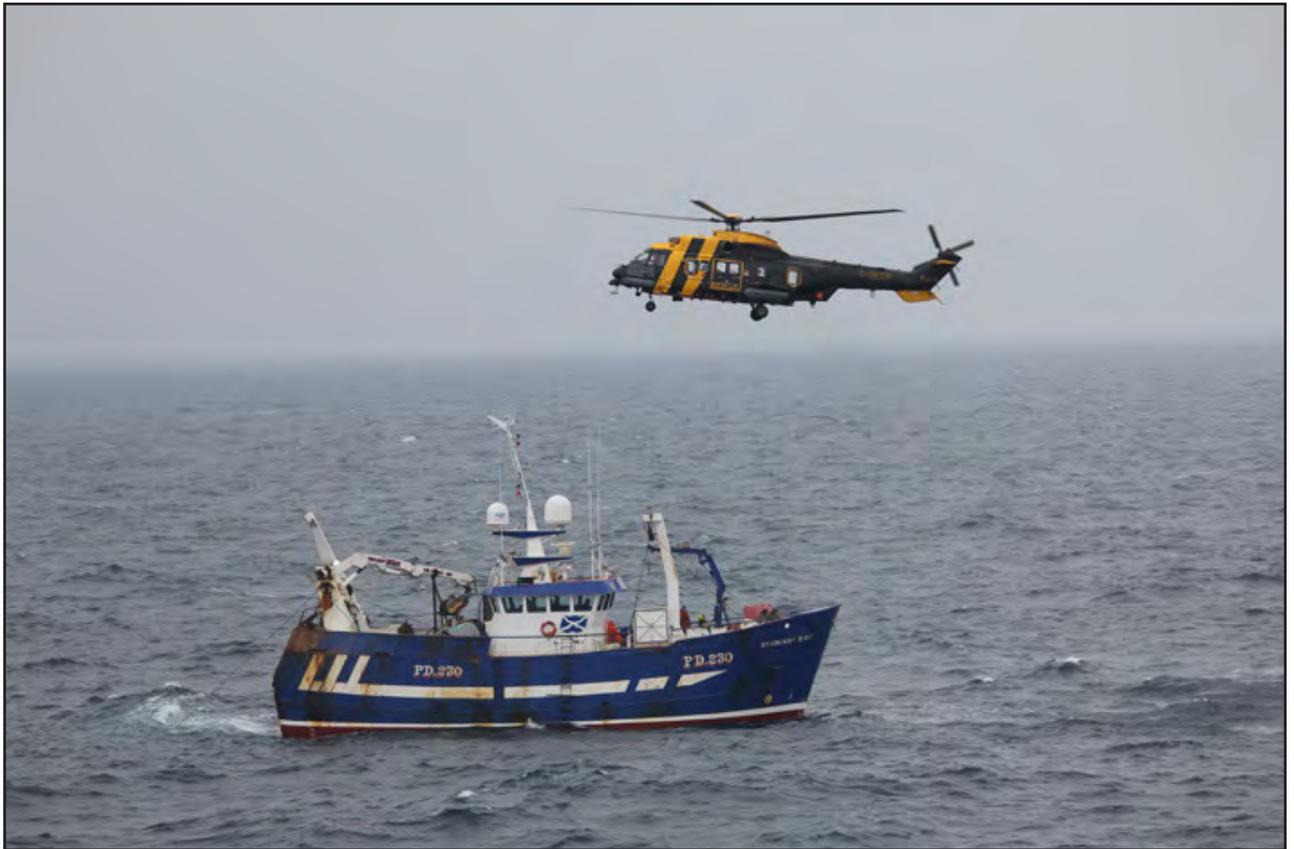
Figure 8: Bond rescue helicopter R11

At 1613 the unconscious engineer was hoisted from *Starlight Rays* into R11. By then, the crewman had regained consciousness, and he was hoisted on board R11 at 1618 (**Figure 8**). The two men were then transferred by R11 to Aberdeen Royal Infirmary. The skipper and the watchkeeper told the rescue party that they felt well, and the rescue party returned to *Skandi Carla* in their boat.

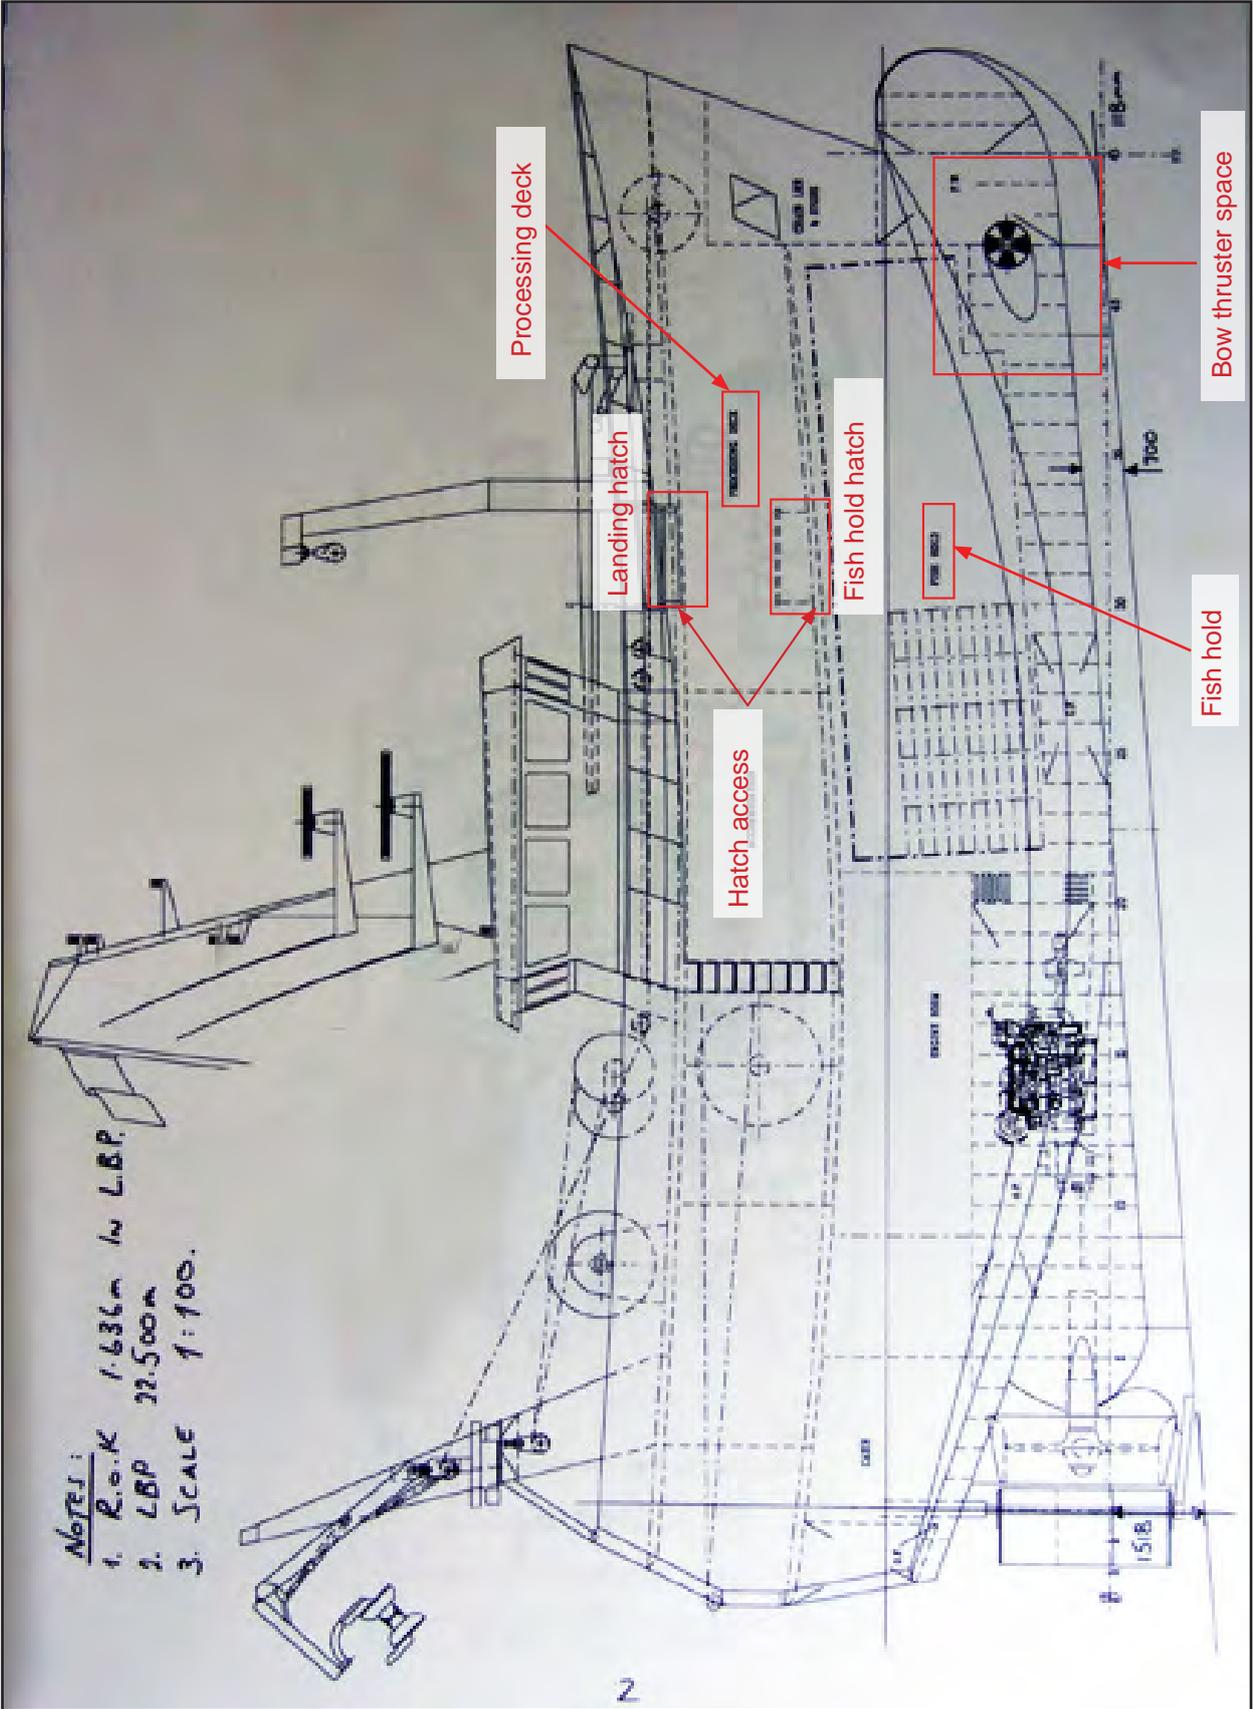
Figure 9: Starlight Rays' general arrangement drawing

Starlight Rays was a 26.4m length overall (LOA) fishing boat fitted out for pair trawling. The fish processing deck was enclosed by a weathertight shelter that was fitted with a deck head hatch through to the open air for landing fish, and a starboard side hatch for bringing the net's cod end inboard (**Figure 9**). The hatch in the shelter was positioned above the processing deck hatch which provided the only access to the fish hold (**Figure 2**).

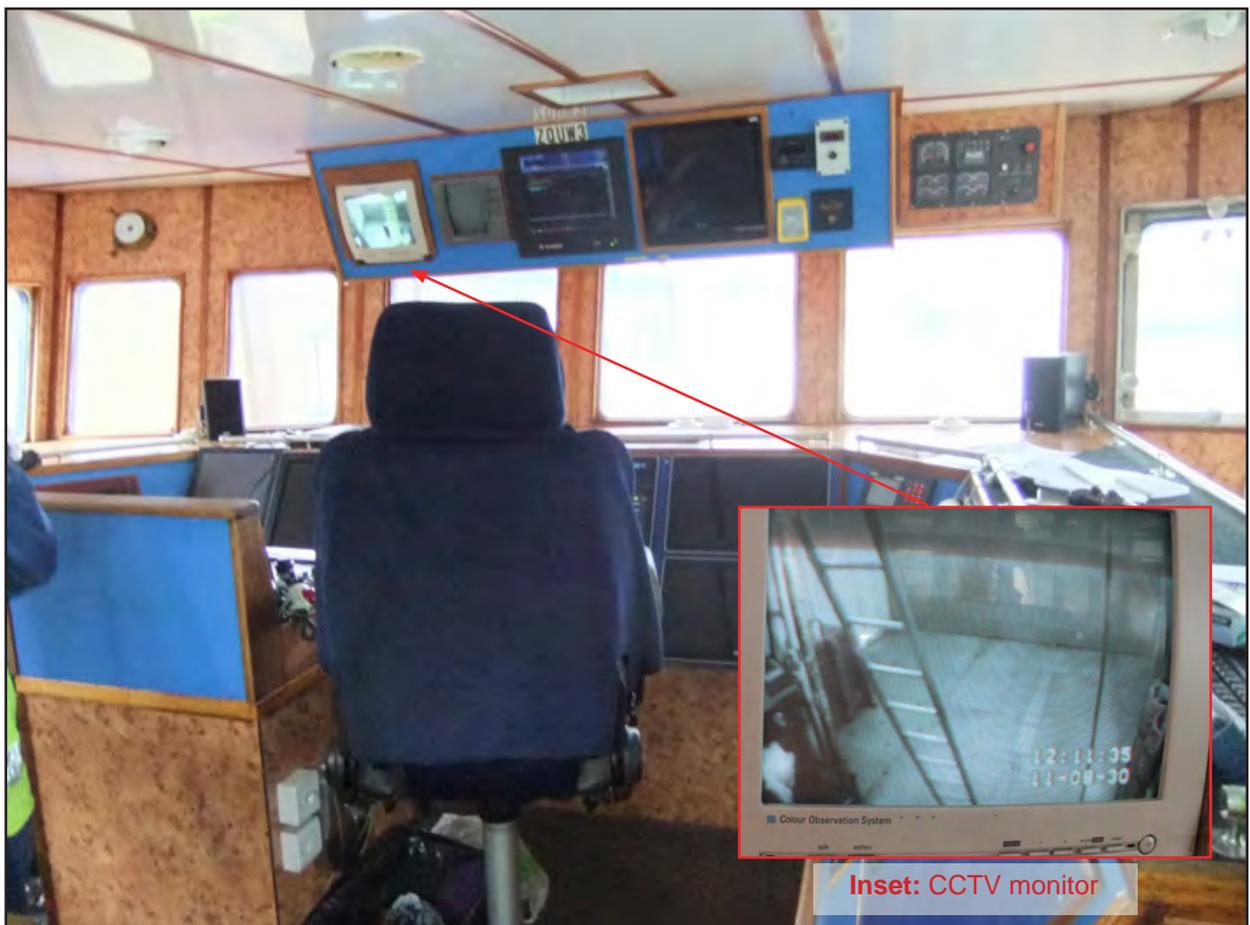
Figure 10: Wheelhouse watchkeeping chair, radar and inset, CCTV monitor display

When working as a guard vessel either the skipper or watchkeeper usually kept watch alone in the wheelhouse. Whoever was on watch generally sat in the starboard chair so that he could maintain a visual lookout and keep a radar watch using the screen mounted at the starboard side of the deck head displays (**Figure 10**). While *Starlight Rays* was at sea, the CCTV monitor, located on the port side of the same deck head display as the radar, showed alternately the fish gutting belt and the aft end of the fish hold and its access ladder (**Figure 10** inset).

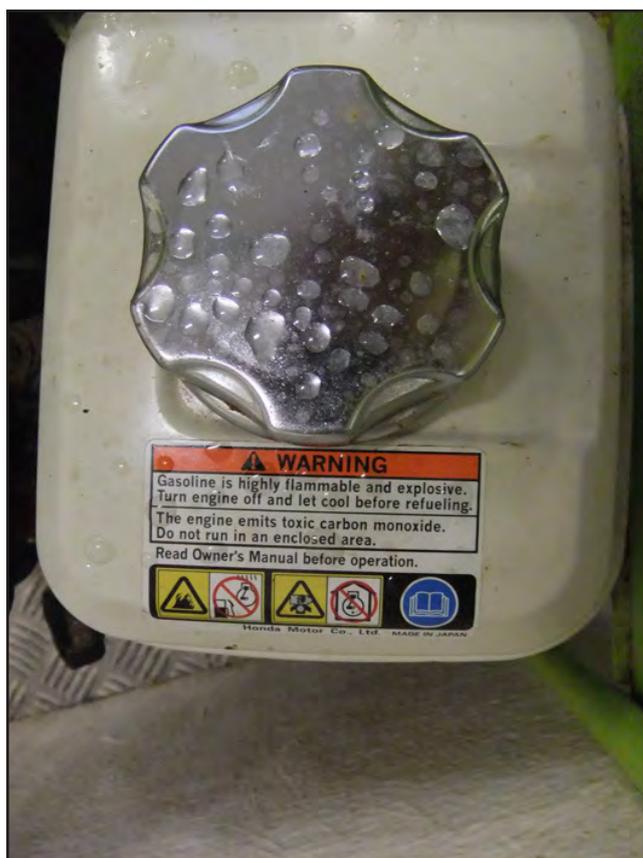
Figure 13b: Warning notice on the petrol tank

The pump had a warning notice placed on the petrol tank, immediately next to the filling cap (**Figure 13b**) stating:

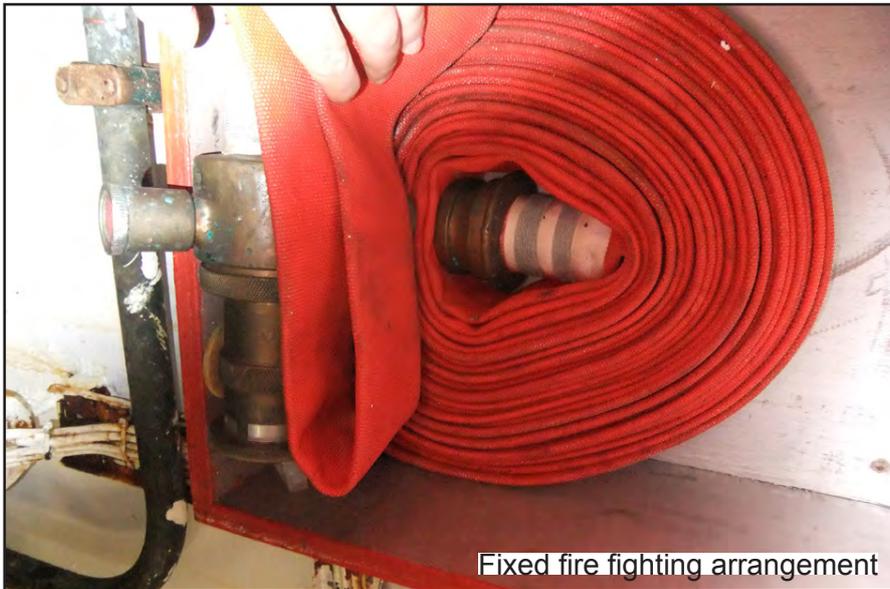
Figure 15: Portable pump hoses and the fixed fire system

Starlight Rays' pump discharge hose

Fixed fire fighting arrangement
