Report on the investigation of the accidental  
discharge of carbon dioxide on board

***SD Nimble***

resulting in serious injury to a  
shore-based service engineer  
at Her Majesty's Naval Base

23 August 2011

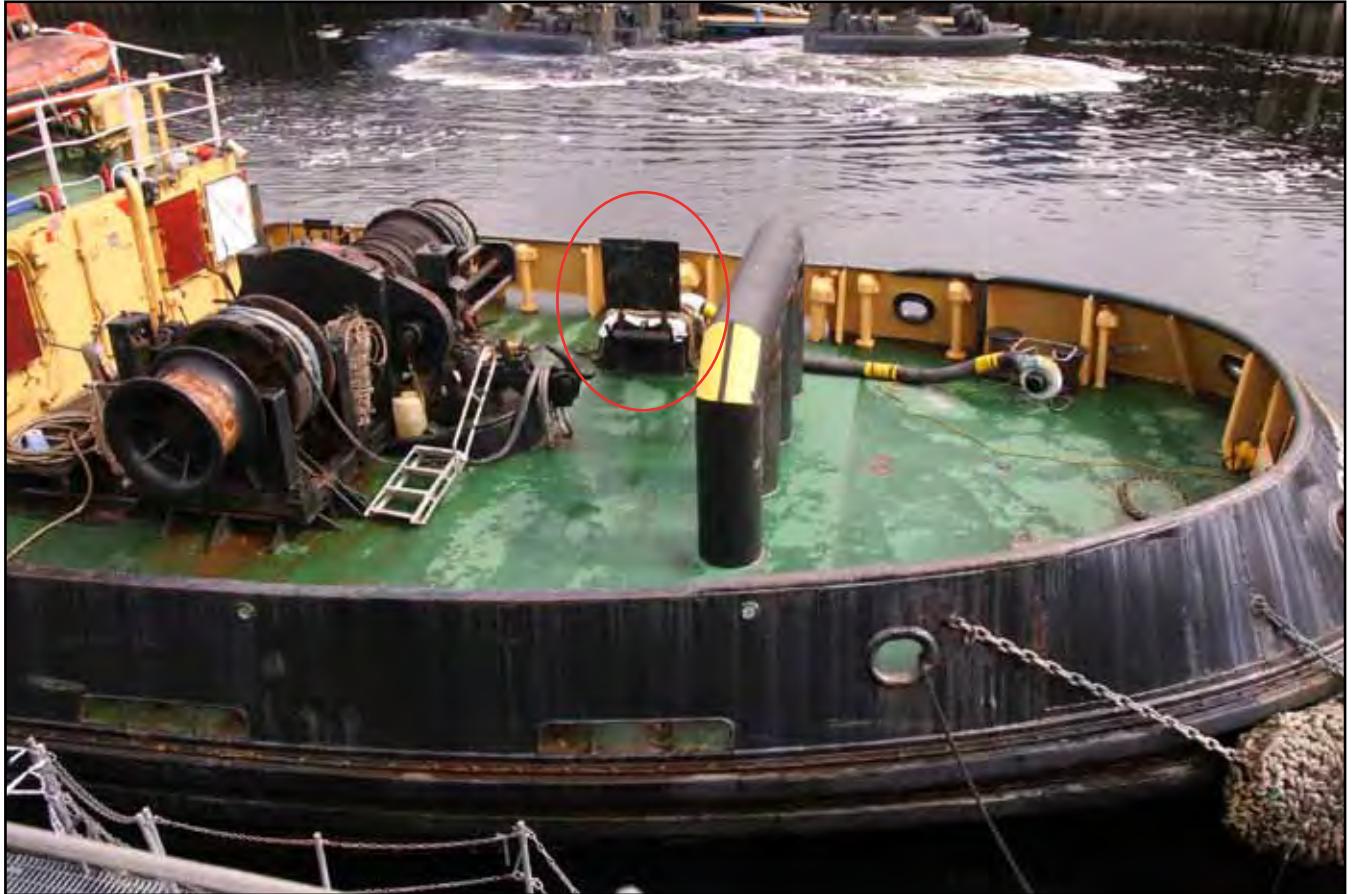
Figure 4: Aft hold hatch

The AB escorted the senior engineer to the deck hatch leading to the aft hold (**Figure 4**). The AB opened the hatch lid and explained where the CO<sub>2</sub> cylinder room was within the aft hold (**Figure 5**). The senior engineer then entered the hold. The ventilation exhaust fans in the hold were not operating.

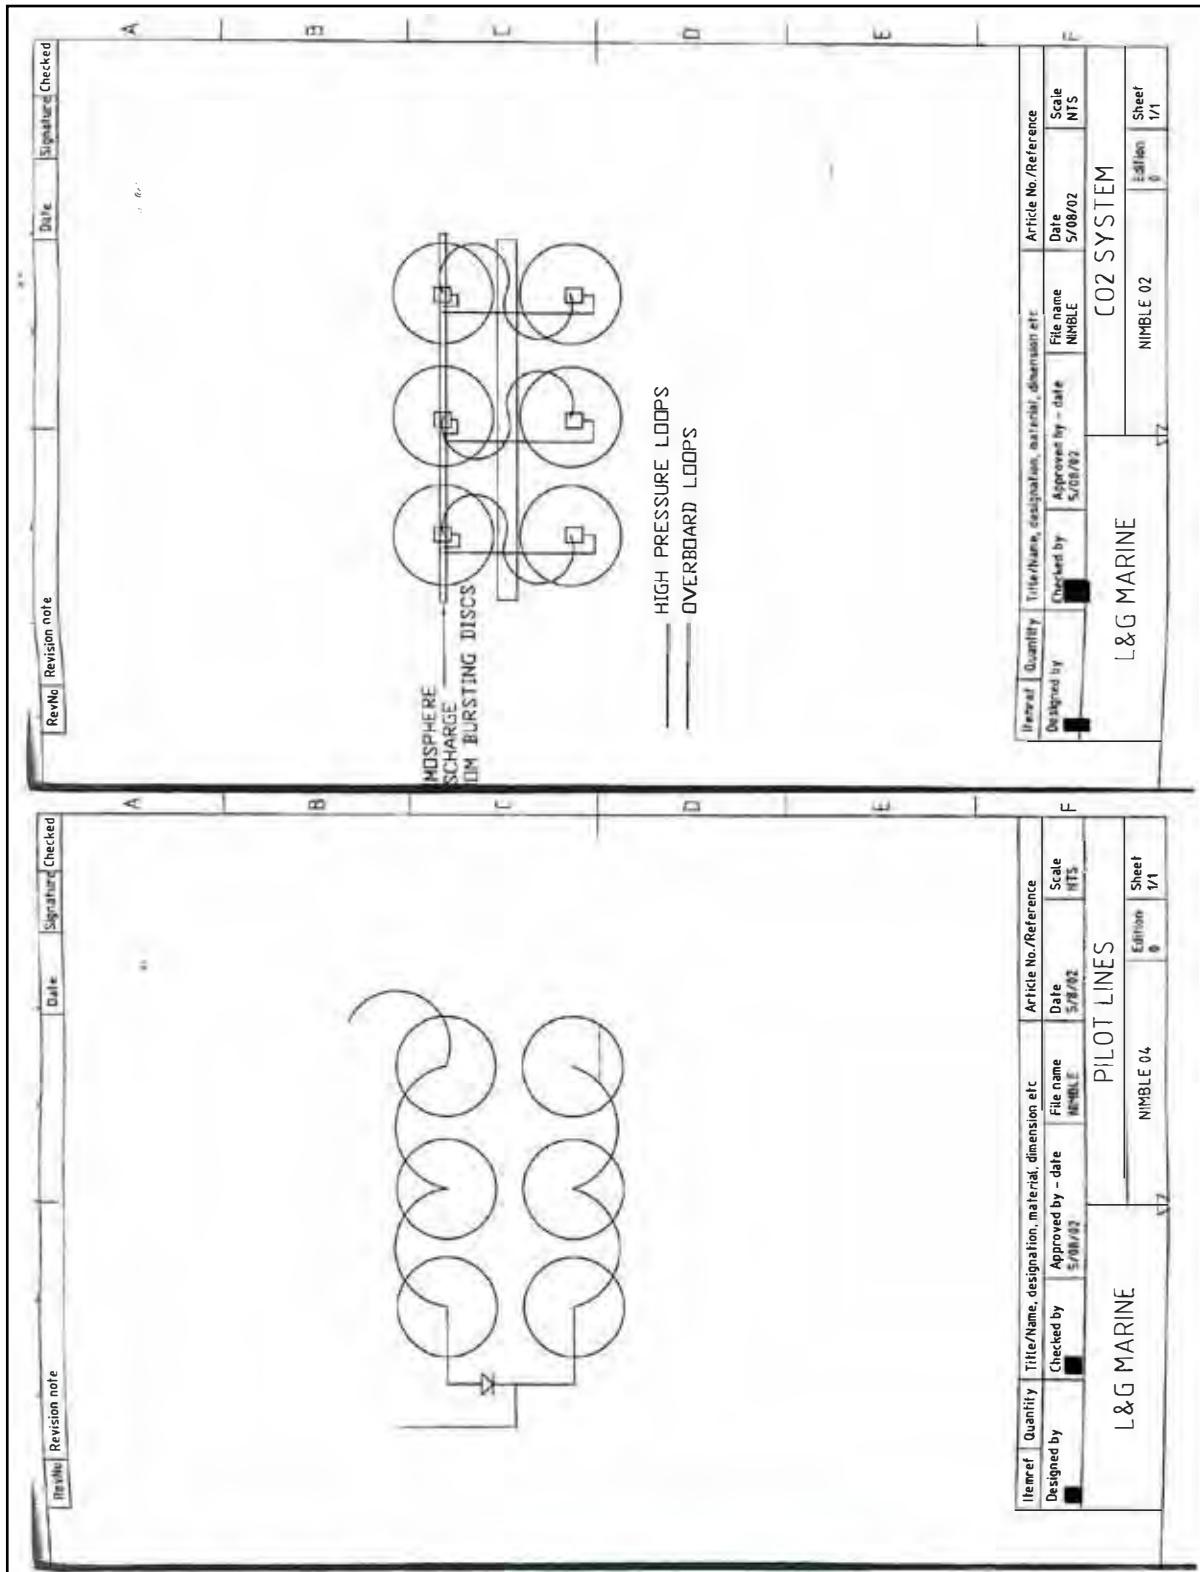
**Figure 7:** Drawings of the pilot and atmosphere lines

A '*Fire Fighting System Manual for RMAS Nimble*' was supplied by L&G and was held ashore by SLMS. The manual showed basic line diagrams of the CO<sub>2</sub> system, detailed drawings of a pressure actuator valve, and a simplified drawing of the pilot and atmosphere relief lines (**Figure 7**). The manual did not contain any maintenance instructions or procedures.

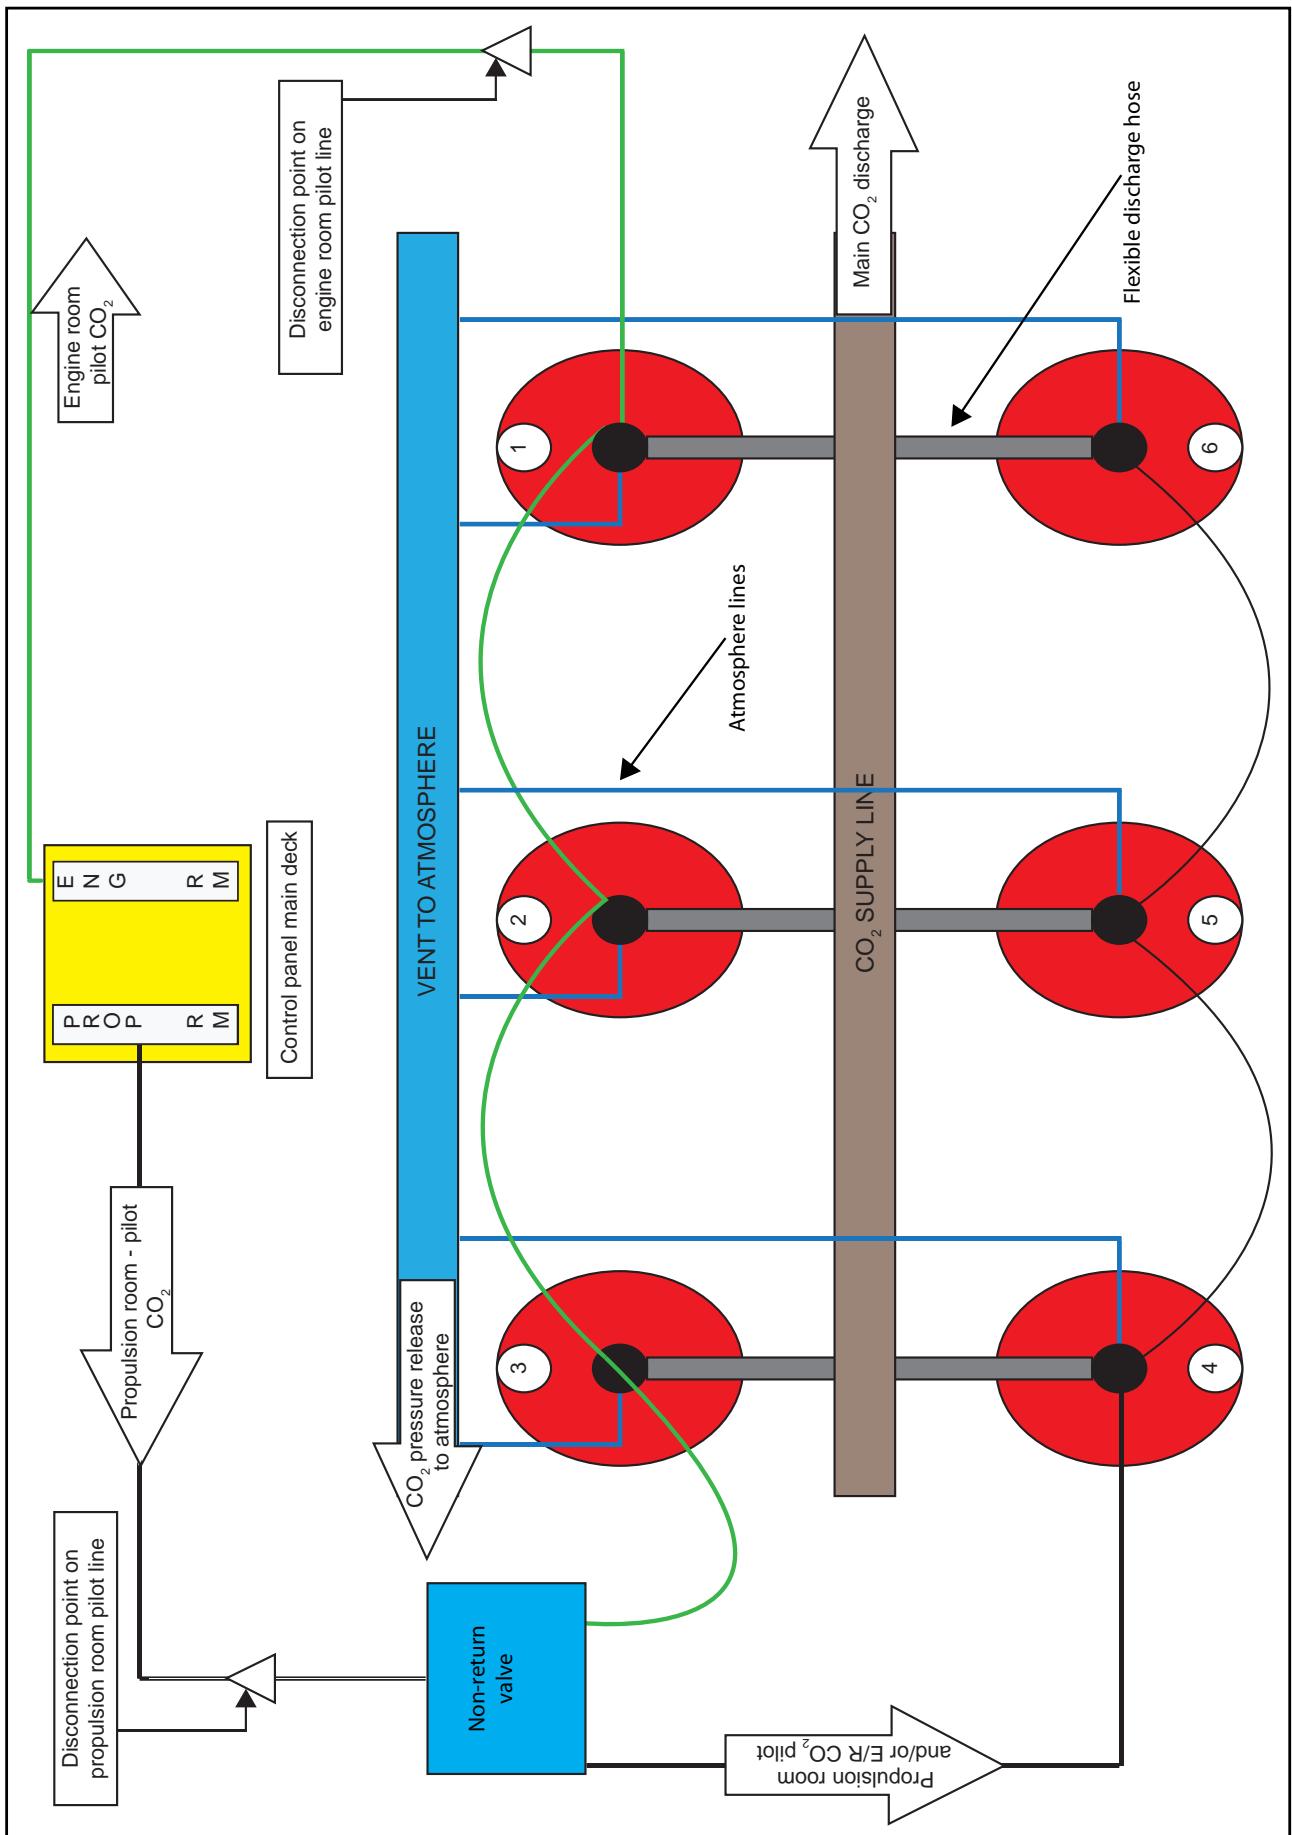
Figure 8: System diagram

The CO<sub>2</sub> cylinders were secured in two banks of three cylinders. For the purpose of this report, the cylinders are referred to by the numbers shown in **Figure 8**. The cylinders were remotely activated from the control station by the release of CO<sub>2</sub> from pilot cylinders (**Figure 3**) through small bore pilot lines which were black in colour and were connected to the main cylinders. A non-return valve was fitted into the pilot line between cylinders 3 and 4. This allowed cylinders 4 to 6 to be released into the propulsion room or all six cylinders to be released into the engine room. Each cylinder was fitted with a pneumatic operating valve which enabled the CO<sub>2</sub> to be released manually if required.

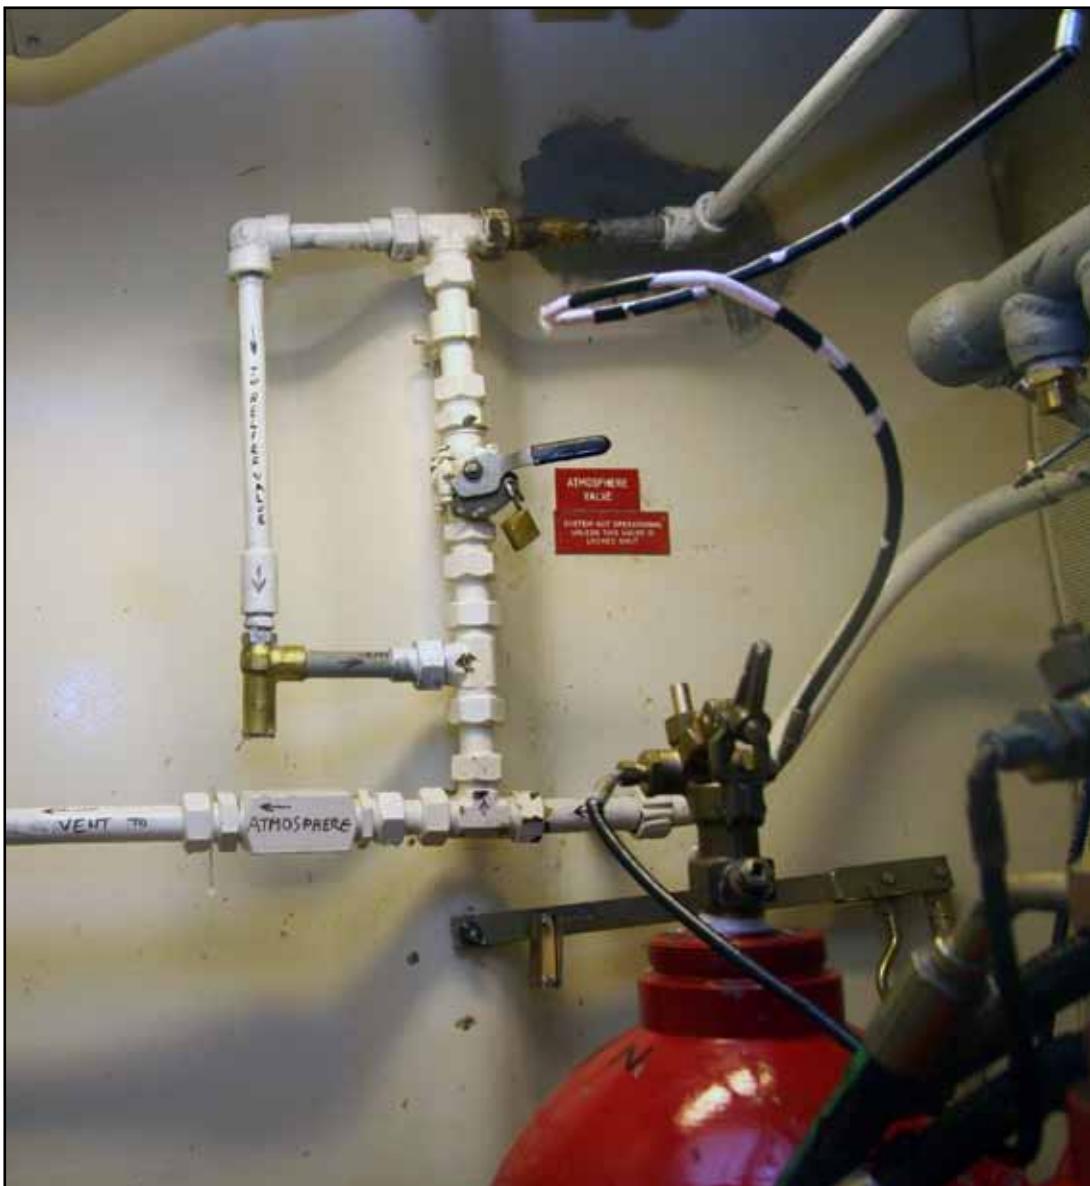
Figure 9: System labels

When the system was activated, the CO<sub>2</sub> in the cylinders was discharged into a common manifold via flexible hoses. The common manifold fed a distribution line fitted with a pressure gauge and a pressure relief valve set at 150 bar. To prevent the cylinders from over-pressurising, small bore lines, similar in appearance to the pilot lines, connected each cylinder to an atmosphere (overboard) line. The atmosphere line was fitted with a manually-operated ball valve which was intended to be locked shut in normal operation. Apart from a tally adjacent to the atmosphere valve, all other instructions and labels on the system had been annotated using a marker pen (**Figure 9**).
