Report on the investigation of the
fatal accident of a crew member
on the Woolwich ferry

Ernest Bevin

on the River Thames, London

3 August 2011

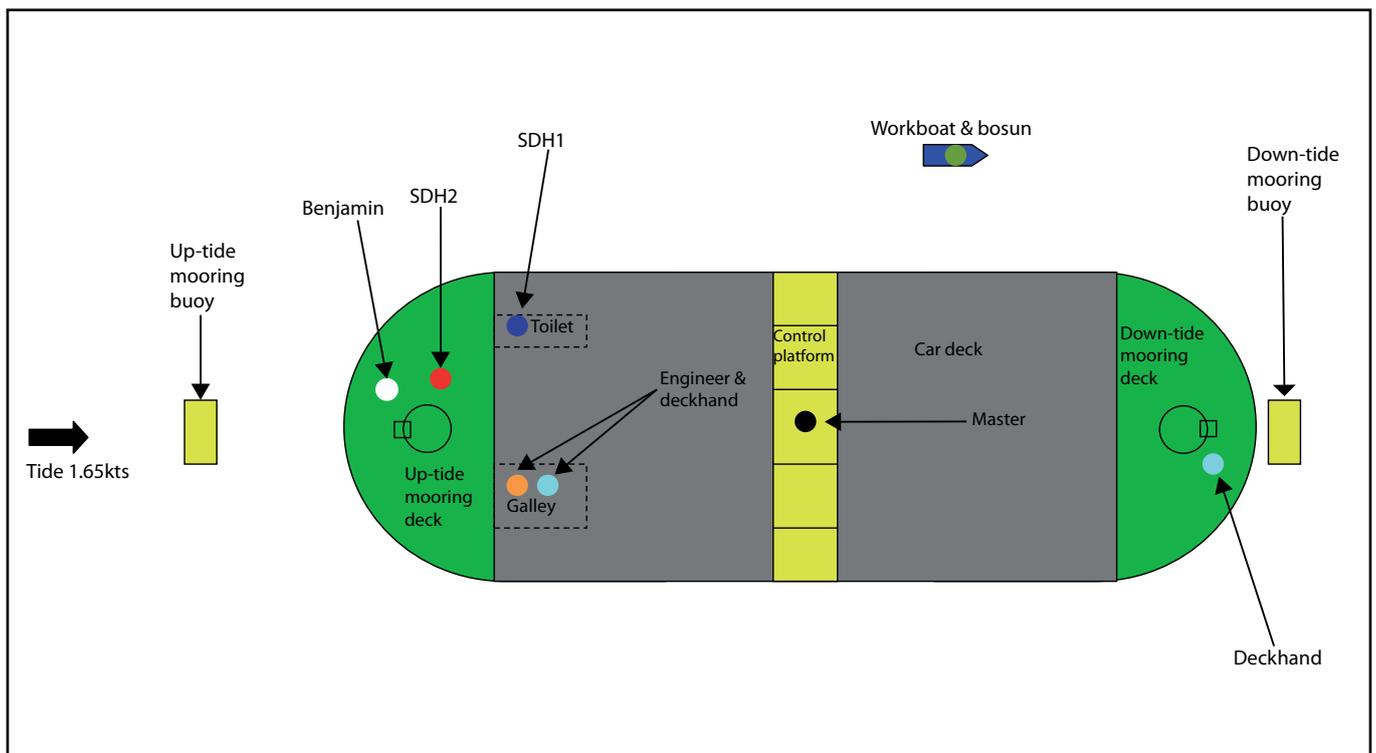
Figure 5: Diagram showing position of crew shortly before the accident

The positions of all crewmen at this time are indicated on **Figure 5**.

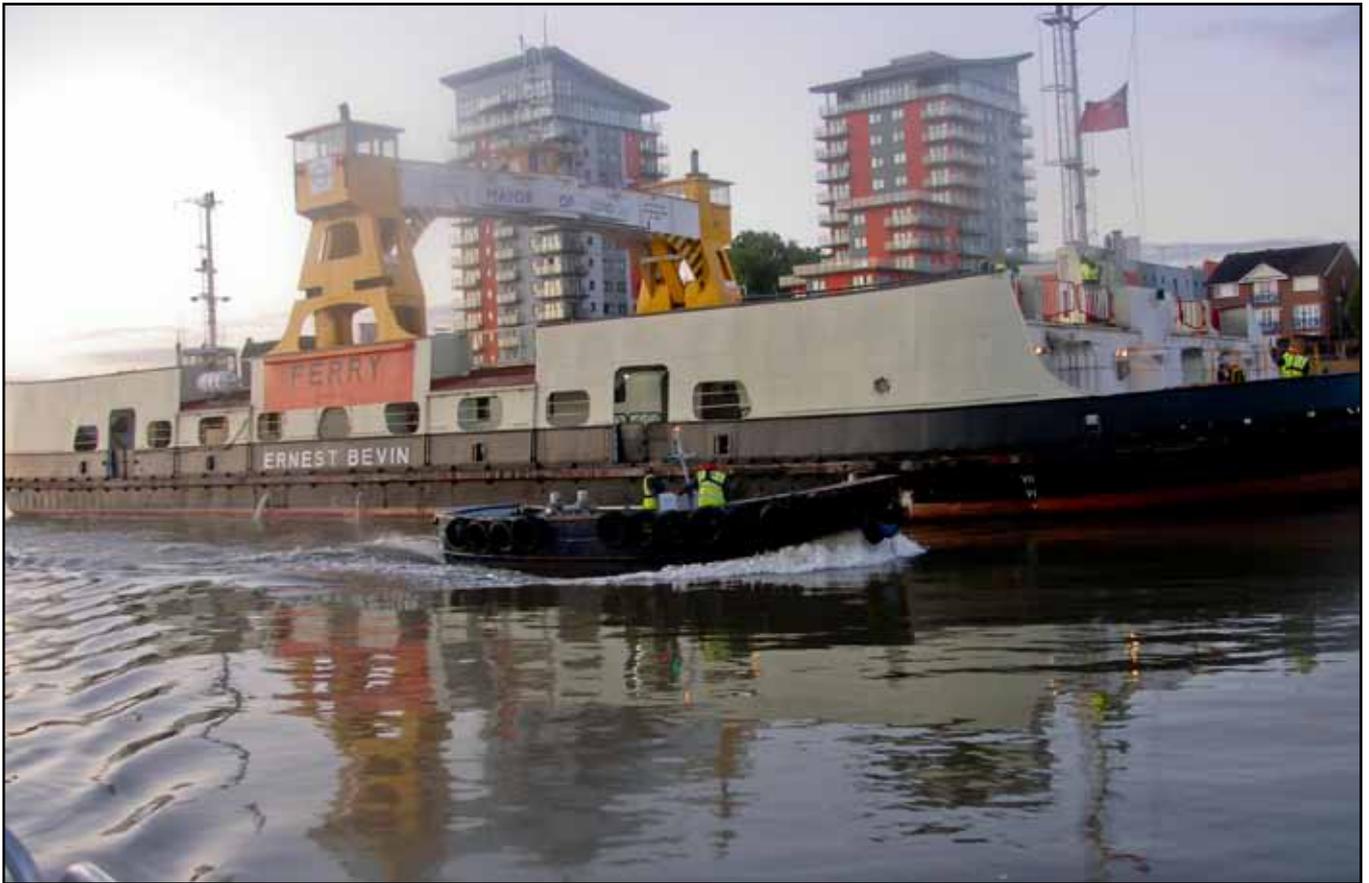
Figure 6a: Workboat and *Ernest Bevin*

The workboat's freeboard was just under 1m and inside from the deck to top rail was almost the same height (**Figure 6a** and **b**). This height, while good for keeping people inside the boat, made recovery of a person from the water extremely difficult. Once alongside the unconscious Benjamin, the only equipment available for his recovery was a life-ring and boat hook. The boat hook was used to initially get hold of Benjamin; thereafter he was held in place with great difficulty by SDH2 until the crewman from *Kew* assisted. This was an exhausting task, and SDH2 was concerned that if the lifejacket rose further, it would slip off Benjamin and he would be lost.

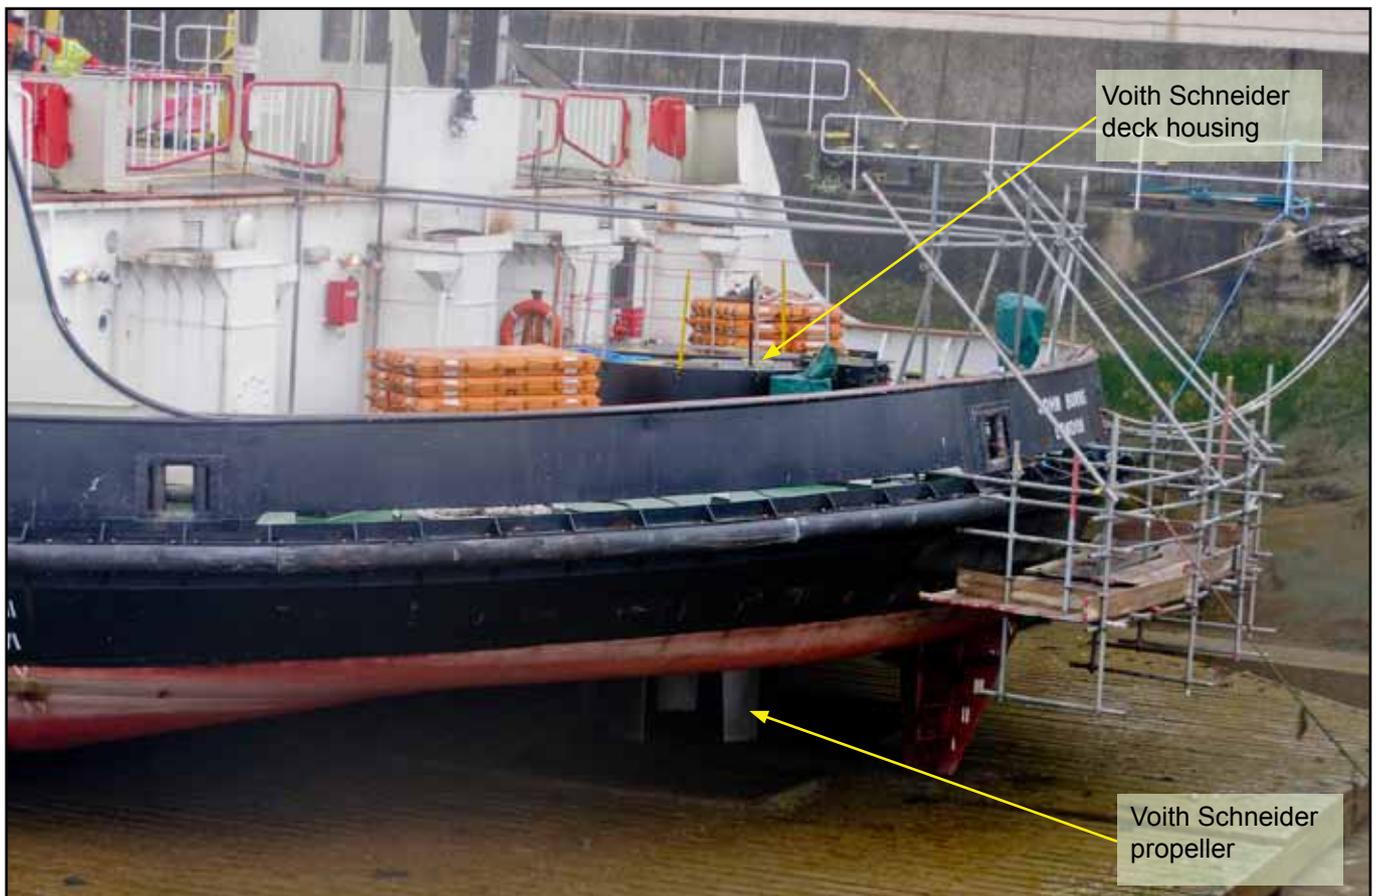
Figure 8: Sister ship *John Burns* showing Voith Schneider propeller below the counter

The ferries were powered by twin 368kW, 600 revolutions per minute (rpm) Mirrlees National engines driving fore and aft Voith Schneider cycloidal propulsion units. Voith Schneider propulsion is favoured by ferries and harbour tugs because it offers good manoeuvrability, efficiency and longevity. These units had deck housings immediately above the propellers (**Figure 7**) which covered the gearbox, leading down to a propeller well and out through the hull to five controllable pitch blades protruding vertically from the vessel's counter (**Figure 8**).

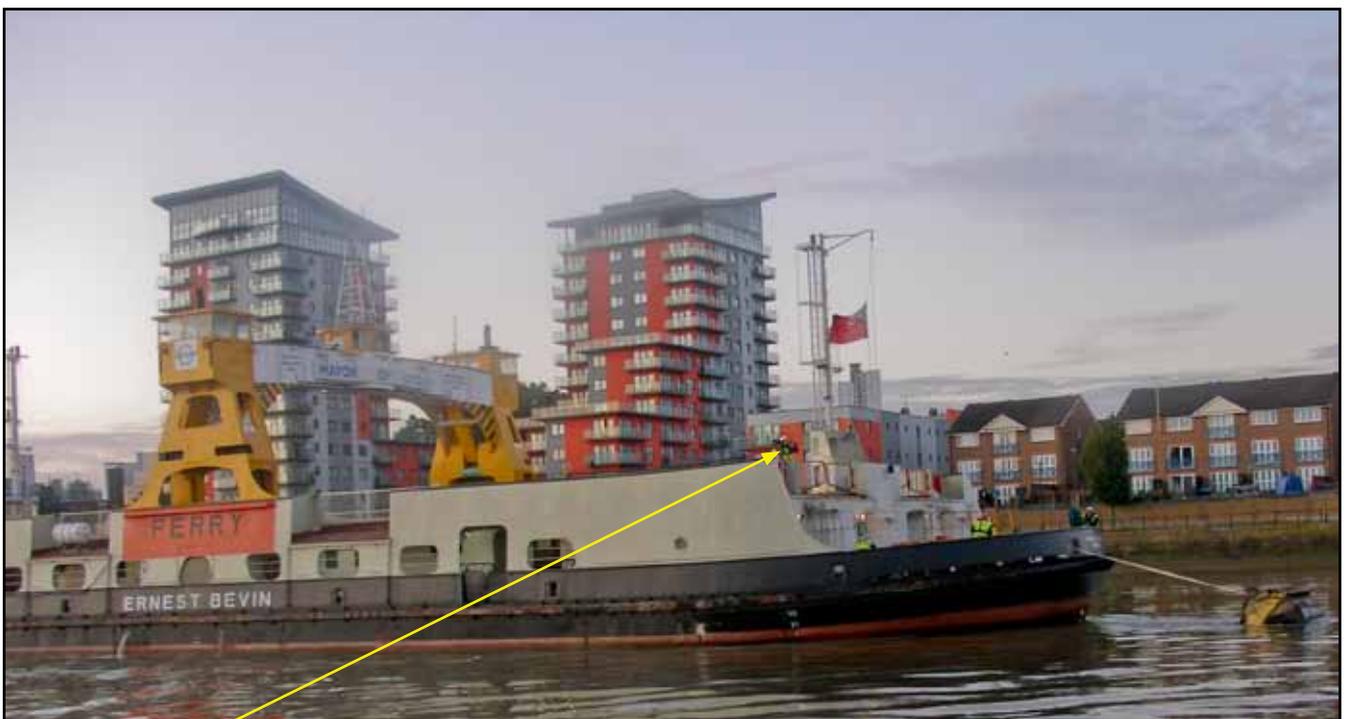
Figure 10: Mate positioned by edge of car deck to facilitate monitoring of deckhands and direct communication with master

The master controlled the vessel from a central wheel-box sitting atop of the raised athwartships platform with subsidiary wheel-boxes positioned on the outboard port and starboard wings of the platform. While this afforded him a good view of the main car deck, his view of the mooring decks was restricted by the car deck's traffic control huts (**Figure 9**). By walking between the wheel-boxes, the master could improve his view of the mooring decks to a limited extent. Due to this restricted view, when mooring and unmooring, the master was reliant on the mate and deck crew passing him information on the distances and directions between the ship and the mooring buoys. To provide the master with this guidance, the mate either positioned himself on the mooring deck with the deckhands, or at the edge of the car deck, in clear view of the master and with an unobstructed view of the mooring deck below him (**Figure 10**).

The master's view and line of sight towards the mooring deck and buoy were impaired by the traffic control huts and car decks (**Figure 9**). Generally, mates would either supervise the unmooring from the edge of the car deck, which gave a good view of the buoys, the deck crew and the master, or, they joined the deckhands on the mooring deck and moved into the master's line of sight as necessary for signalling.
