Serious injury on board the yacht *LIQUID VORTEX* 28 May 2011

SUMMARY

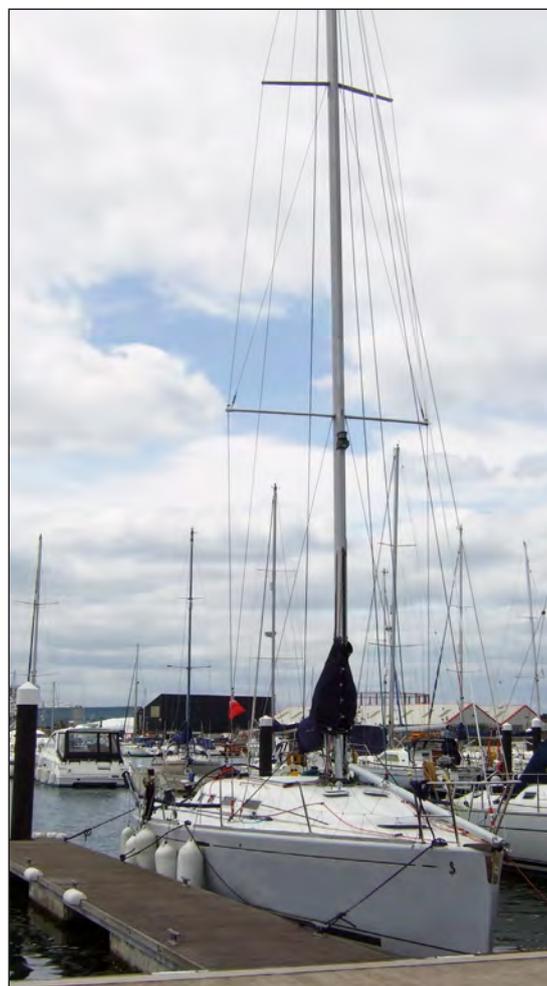
Figure 1

On 28 May 2011, a 23 year old crew member on board the commercially operated sailing yacht *Liquid Vortex* (Figure 1) was seriously injured when the vessel gybed. The gybe occurred when the yacht was running downwind in the Myth of Malham offshore race in the English Channel.

Liquid Vortex
