Report on the investigation of the
contact between the ro-ro cargo ferry

Clipper Point

at the Port of Heysham's South Quay,
and two berthed ships

on 24 May 2011

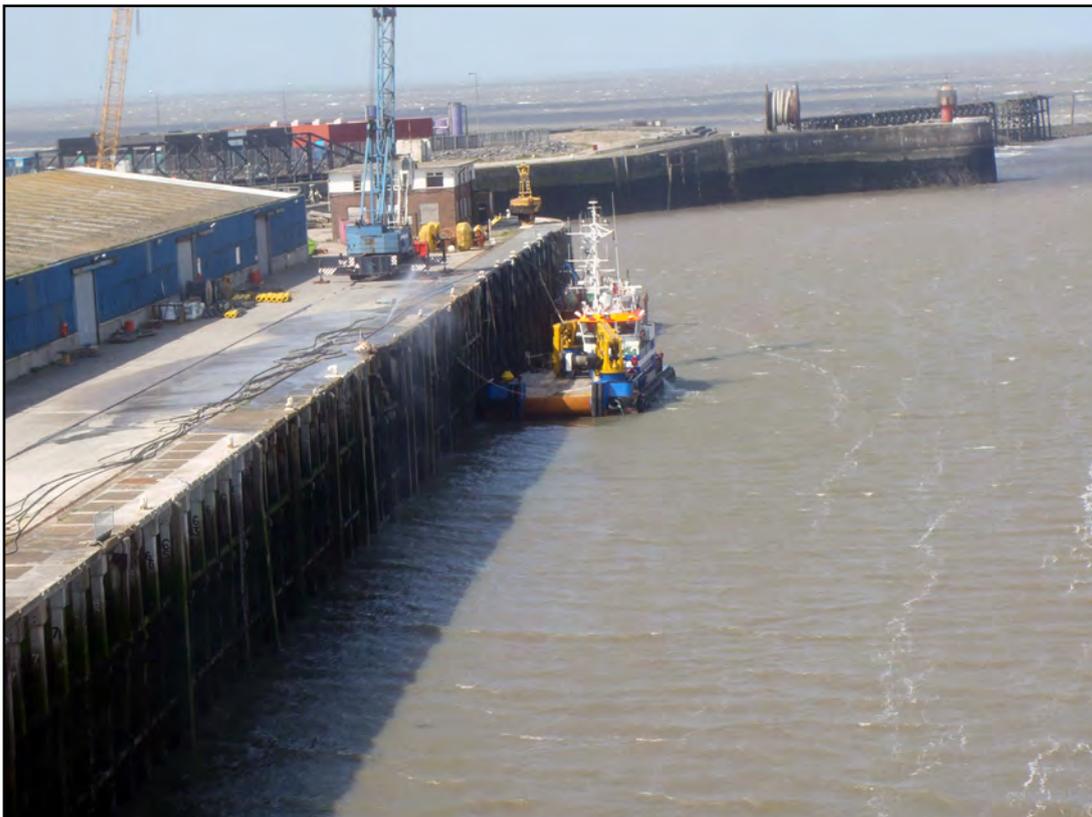
Figure 4: Position of the two vessels alongside South Quay

At 0507, as *Clipper Point* approached the harbour entrance, the master saw the two vessels that were alongside South Quay (**Figure 4**) and then identified the vessel that was close to No.1 jetty as *Sea Trojan*. The master remained at the centre console; the chief officer, standing on the port bridge wing, monitored the ship's position in relation to the North Roundhead². The third officer, at the aft mooring station, monitored the distance of the stern from the South Roundhead. *Clipper Point* approached the Roundheads and, at 0512, the master used the rudders to turn the ship to port and reduced pitch on the propellers to slow the vessel.

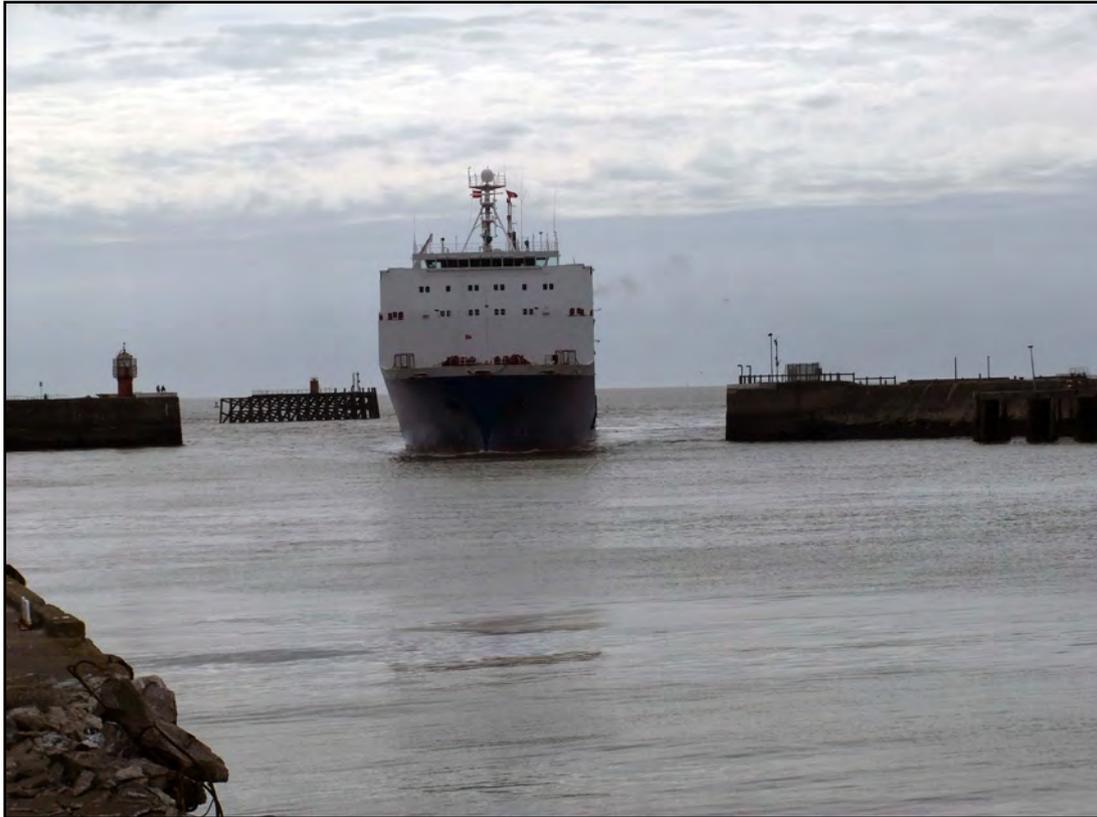
Figure 5: Ferry passing through the Port of Heysham's Roundheads

At 0513 *Clipper Point* passed between the Roundheads (**Figure 5**) at a speed of around 8 knots. Once the stern was clear of the Roundheads the master placed the rudders hard to starboard. He also used the one functional bow thruster to push the bow to starboard in order to stop the turn to port and steady the ship's heading.

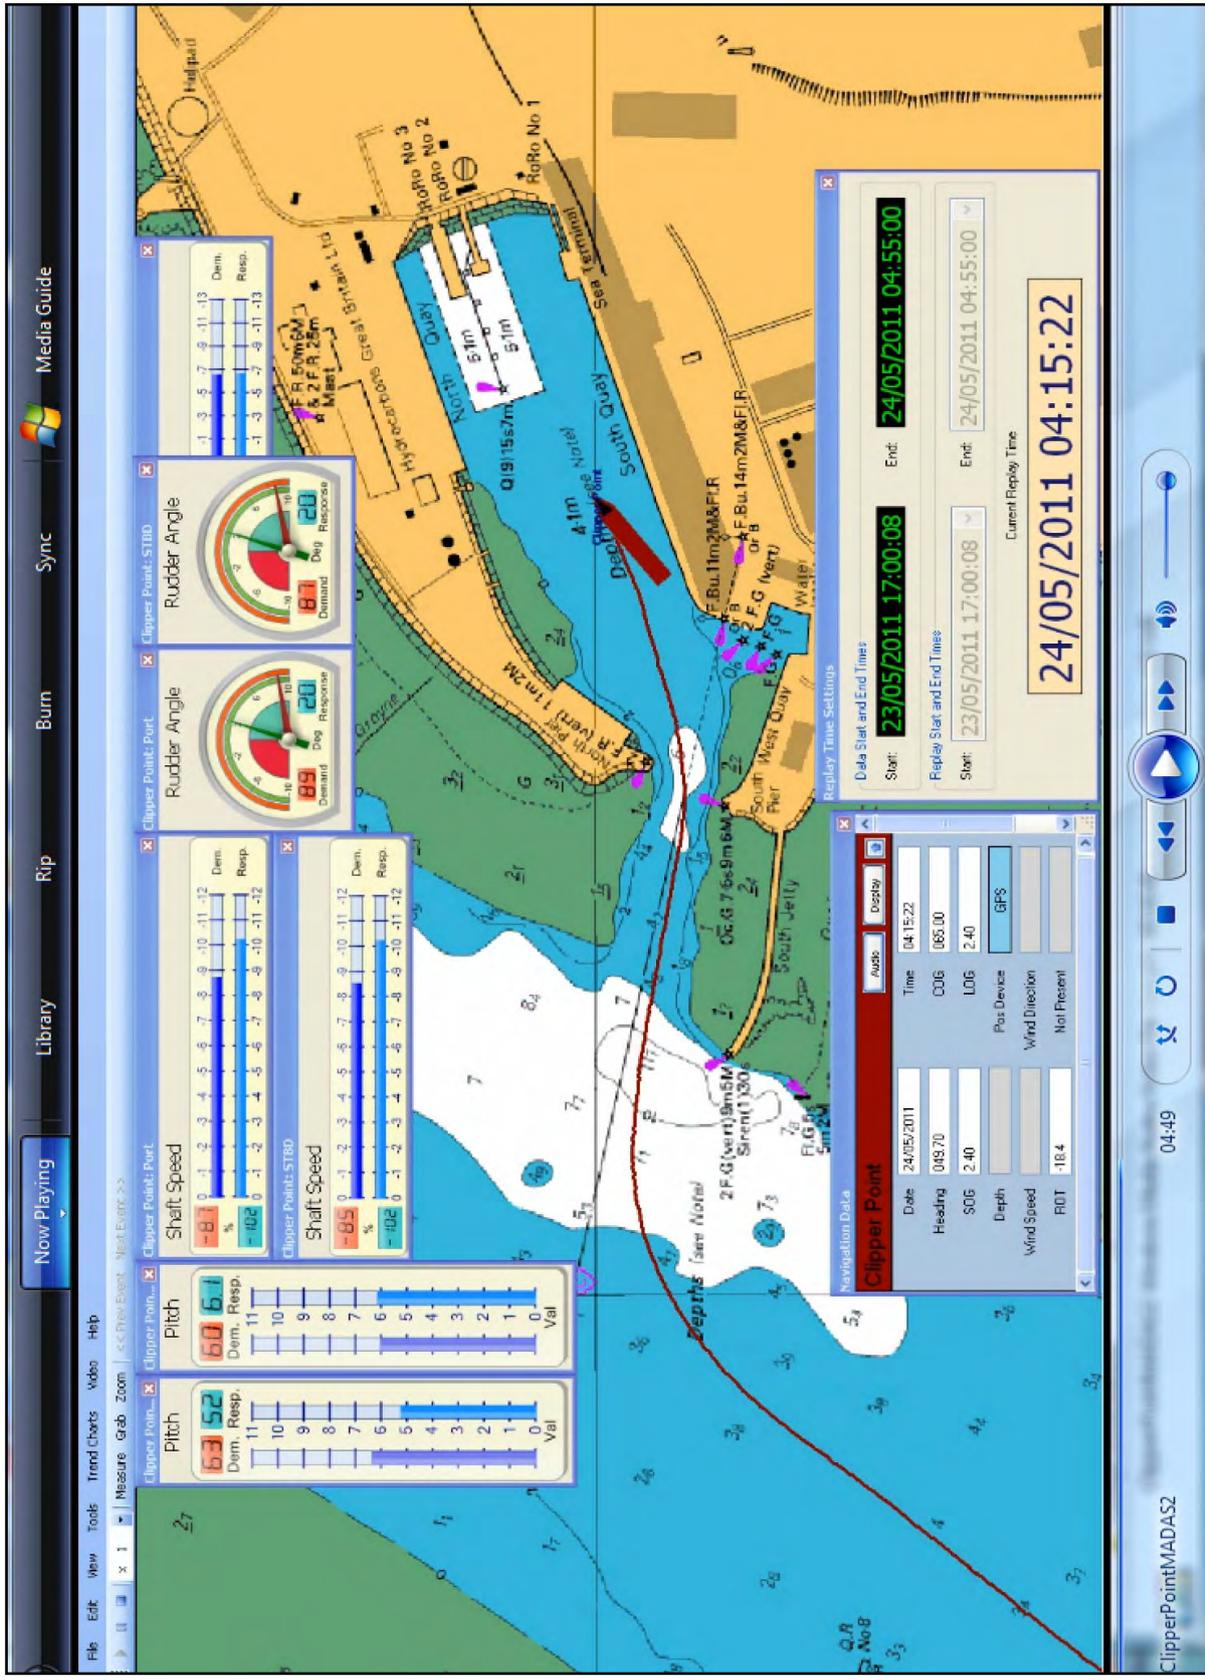
Figure 6: Clipper Point's position and propulsion status prior to contact

At 0515:20 *Clipper Point* was heading 050° (**Figure 6**), but with a course over the ground of around 070° (parallel to South Quay). The third officer reported the distance to the vessels that were alongside at South Quay; the first, a fishing boat at the western end of South Quay and then, next to it, the 11m beam work boat *MPR2* as *Clipper Point* came further into the harbour.

At 0516 the third officer reported that *Clipper Point's* stern had cleared *MPR2* by a distance of about 0.5m, 8 seconds later he reported that the stern was 4m away from South Quay. The master used the single bow thruster to push the bow to port, and put both rudders full to port. He put the port propeller pitch astern and increased ahead pitch on the starboard propeller with the intention of starting a short turn round to port. Although the master was aware that his vessel was now closer to South Quay than was usually the case, he had always manoeuvred in the harbour by turning to port and had not considered an alternative method, or how a turn could be aborted safely.

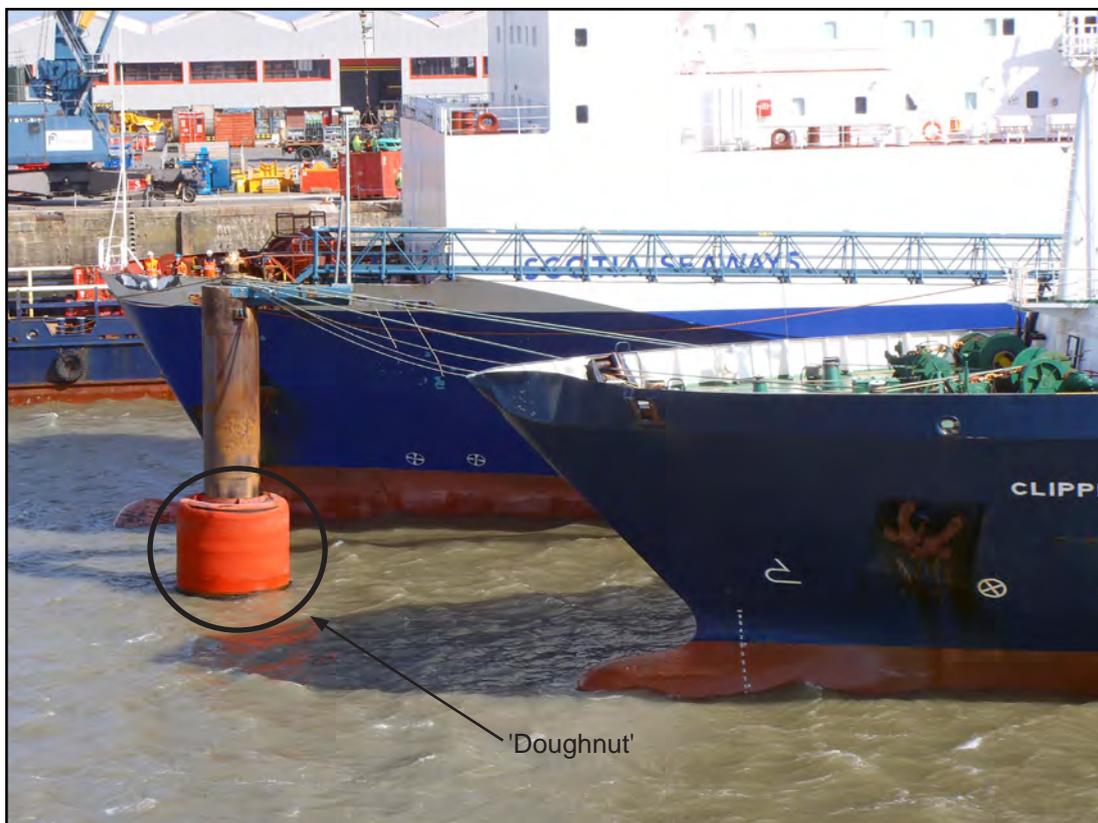
Figure 7: *Clipper Ranger* (No.2 berth) and *Scotia Seaways* (No.3 berth)

The master made further demands for the chief officer to instruct the tug to push against the bow. The tug's skipper had seen *Clipper Point's* contact with South Quay and knew that she was out of position and might need to abort the turn. The tug's skipper decided not to push against *Clipper Point's* bow as requested because he was concerned about damaging his vessel, but he did not communicate this to *Clipper Point's* chief officer because he thought it would be obvious to see. The master made more requests for the chief officer to tell the tug skipper to assist while the ship continued towards the ferries *Clipper Ranger*, alongside at No.2 berth, and *Scotia Seaways*, alongside at No.3 berth (**Figure 7**).

Clipper Point's bow made contact with *Scotia Seaways'* port bow at around 0520 before striking the jetty's circular fender, known locally as the 'doughnut' (**Figure 7**). *Clipper Point's* stern swung to starboard and, at 0523, the starboard shoulder made contact with the bow of *Clipper Ranger*. The effect of the wind reduced and the

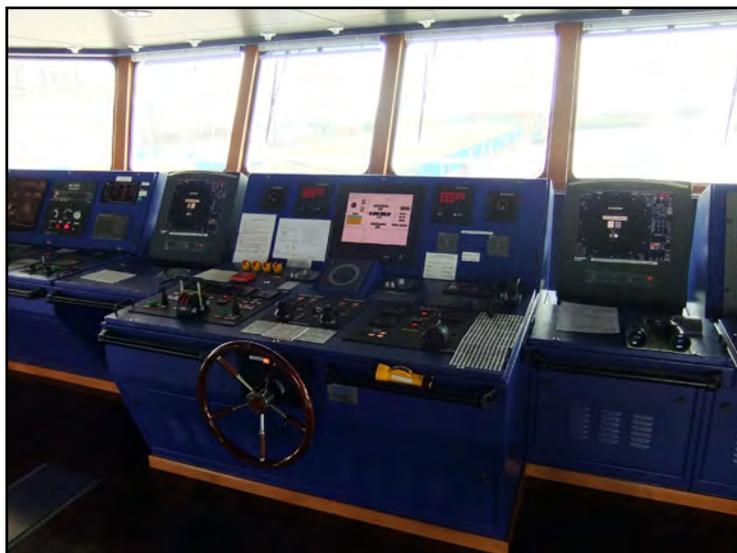
Figure 12: *Clipper Point* - Bridge centre console

The electronic chart system (ECS) display, ship's heading, rate of turn, wind speed and direction, as well as log speed and ground speed information, were displayed on the centre console (**Figure 12**). The consoles at the bridge wings only provided wind speed and direction, shown on a square, 100mm sided display (**Figure 13**).

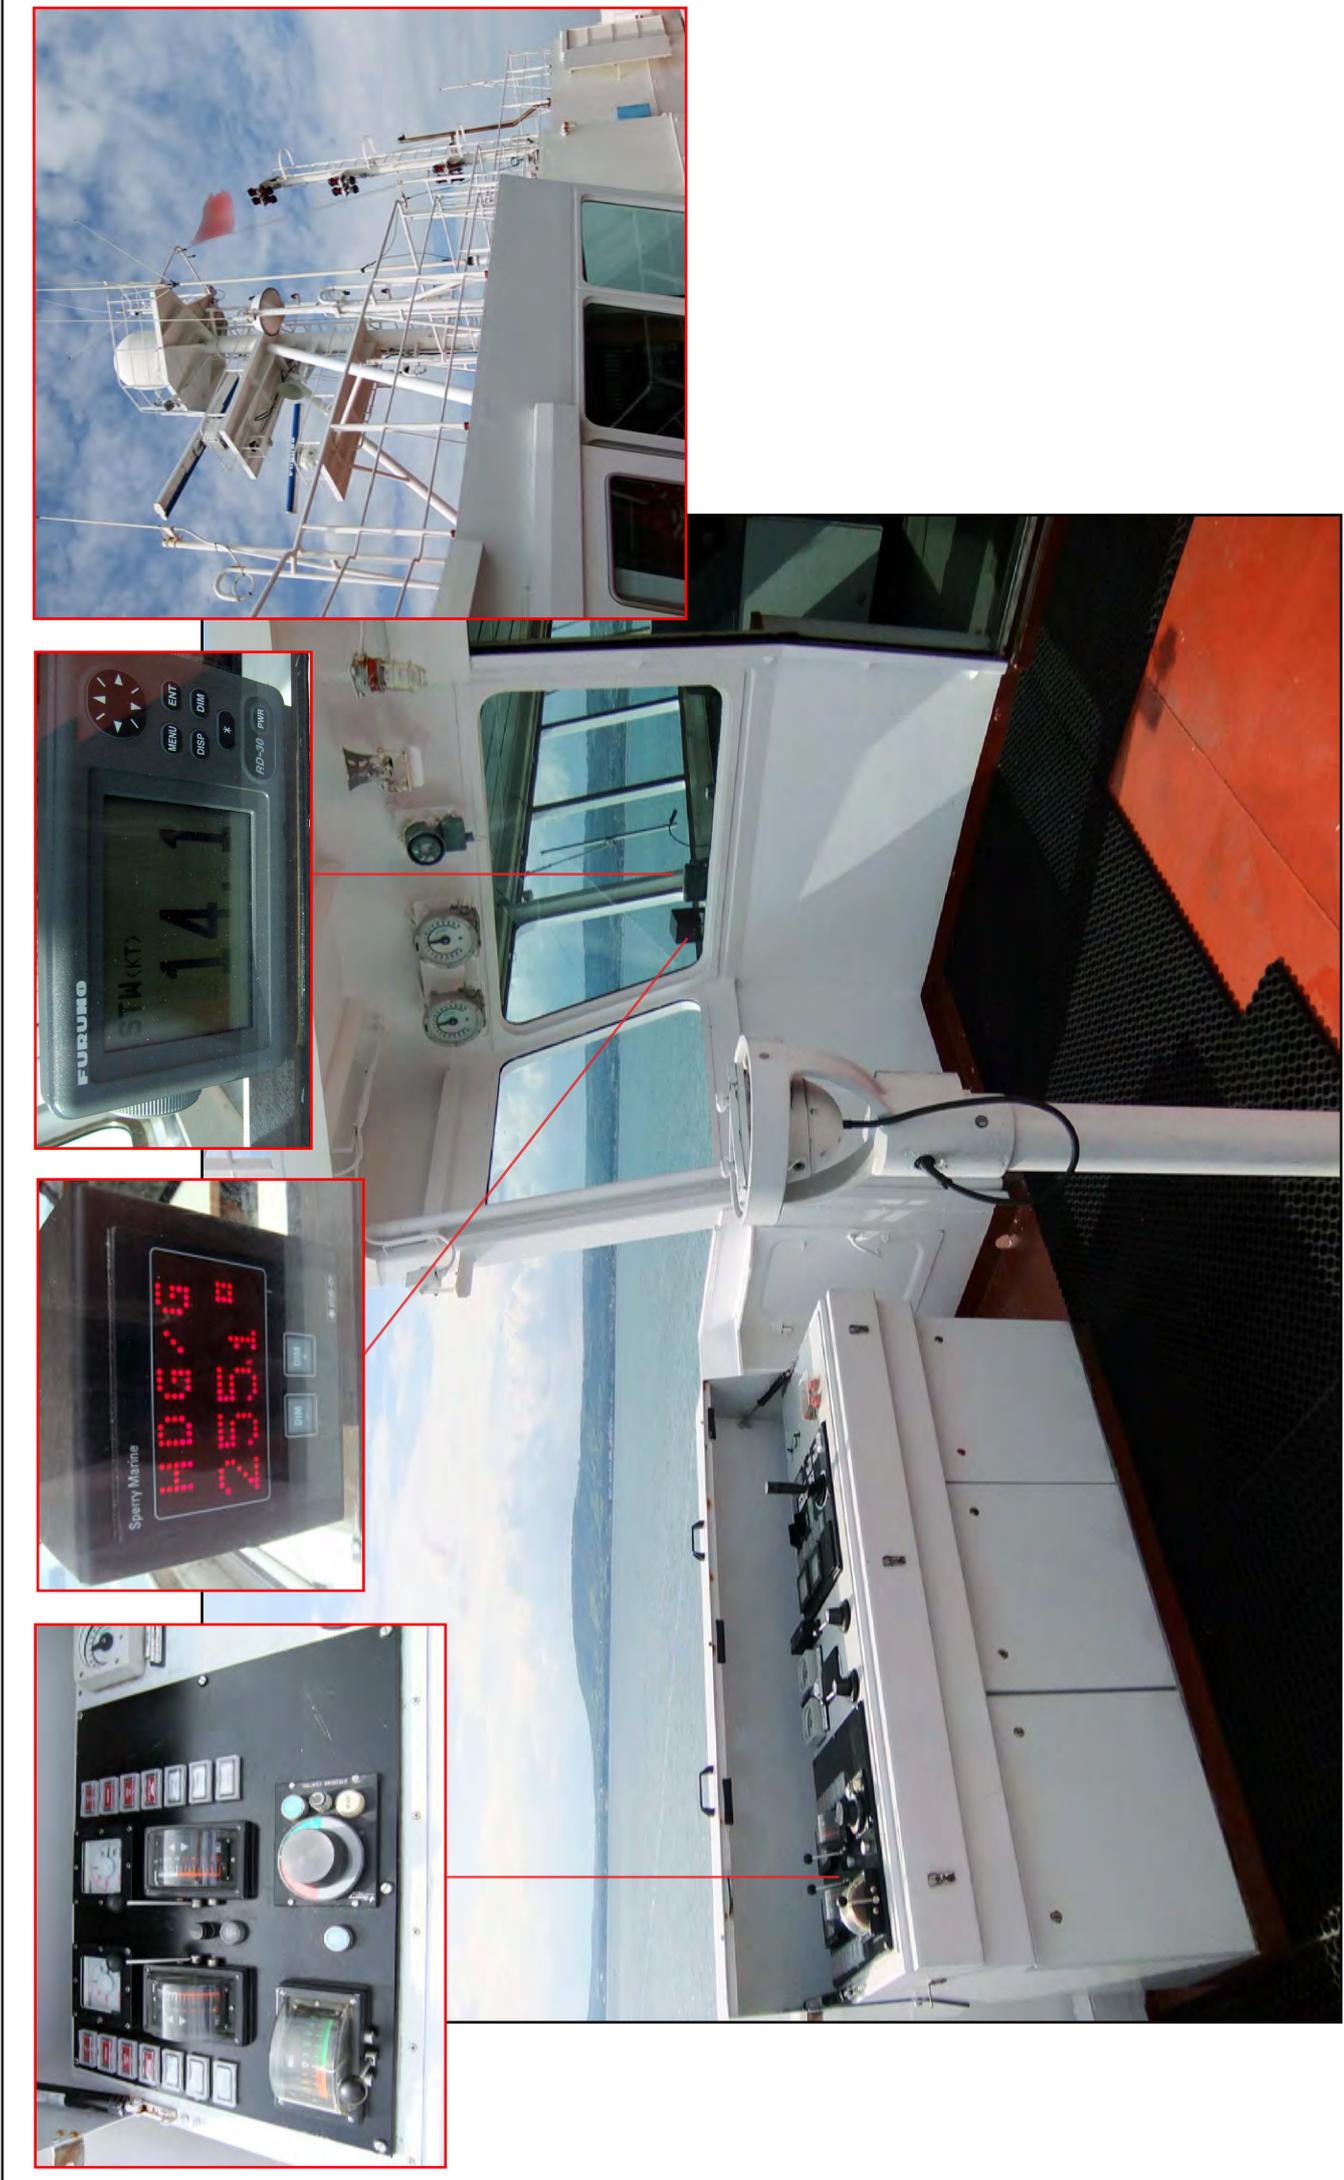
Figure 14: Bridge wing arrangement of a ship similar to *Clipper Point* operating from the Port of Heysham

Other similarly sized ferries that called at the Port of Heysham were fitted with synchronised propeller and bow thruster controls at each of the control stations. These were kept aligned automatically, simplifying the process of transferring control. Instruments provided at the bridge wings provided heading and speed information, as well as large easy to read indications of rudder angle. The open bridge wings of these vessels also provided the bridge team with an immediate appreciation of the actual wind speed and direction (**Figure 14**).

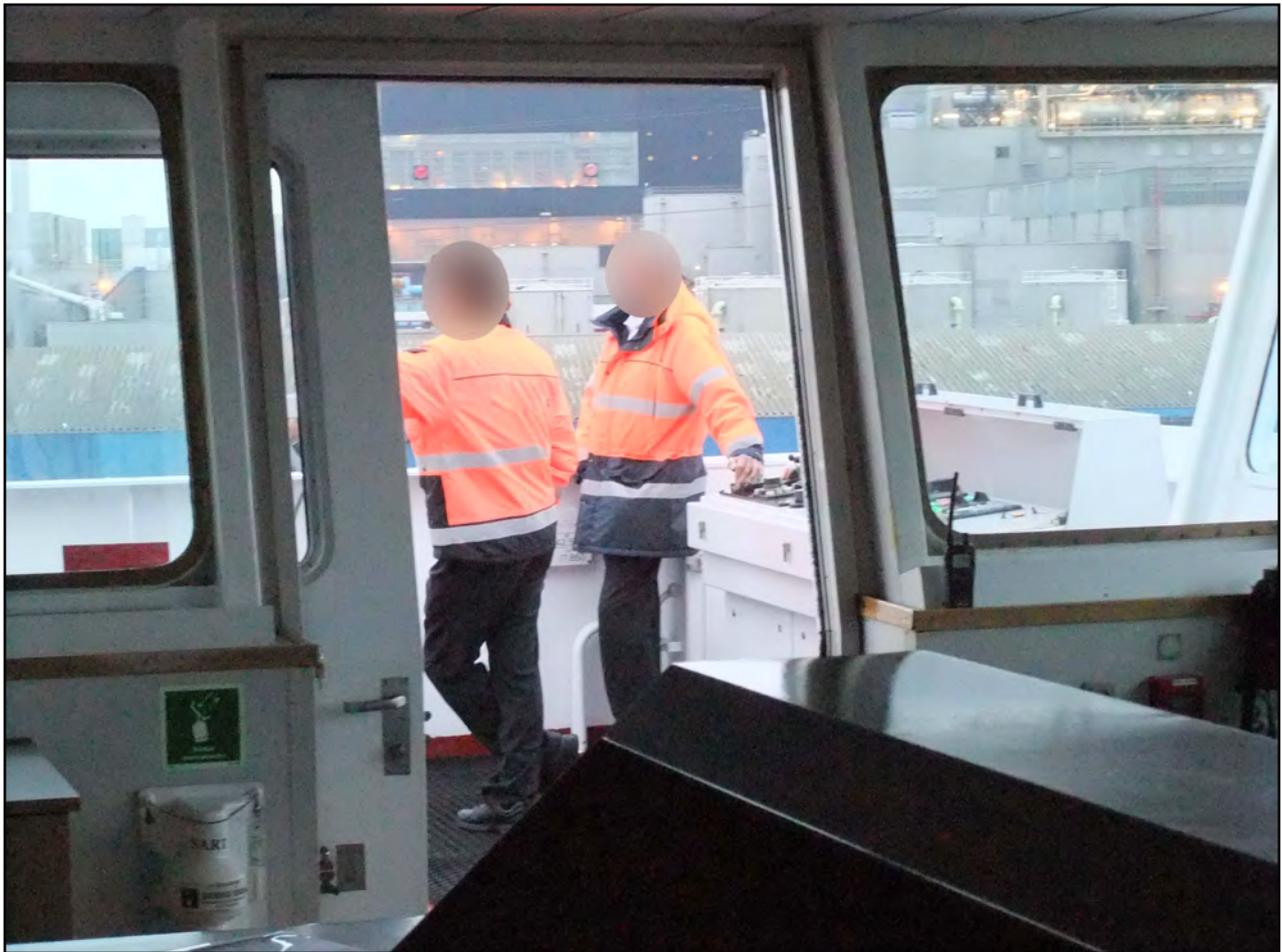
Figure 15: Bridge team on board a ship similar to *Clipper Point* operating from the Port of Heysham

Other bridge teams on vessels calling into the Port of Heysham operated differently. On one vessel both the master and the PEC-holding chief officer alternated the ship-handling role daily; this allowed each to observe the other's actions, provided support to one another and quickly identified any omissions or errors in judgment. Transfer of control between consoles was verified before the supporting officer joined the officer who was in charge of manoeuvring the ship (**Figure 15**). The master and chief officer transferred control from the centre console to the starboard bridge wing once the stern was inside the port's Roundheads; this allowed both officers to monitor the stern's position during the swing compared with South Quay, and any berthed vessels. The two officers then transferred to the port bridge wing once the stern was well clear of South Quay to enable them to watch the ship's port side as the vessel approached the berth.
