## SUMMARY

## MV CMA CGM PLATON

### Contact with Bevans Wharf River Thames 15 May 2011

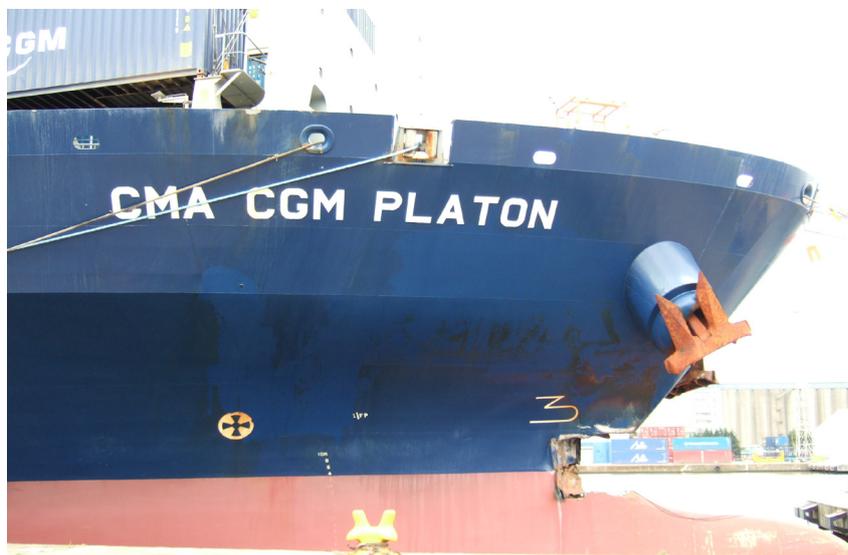
At 1004 (UTC+1) on 15 May 2011, the UK registered container vessel *CMA CGM Platon* made heavy contact with a quay on the south bank of the River Thames. The quay sustained superficial damage but the vessel suffered significant damage to her bow, and her forepeak tank was punctured. Fortunately there was no pollution and no one was hurt.

The MAIB investigation found that the pilot had applied port helm too late to prevent the vessel's bow from swinging to starboard once it entered the tidal stream.

A recommendation has been made to the Port of London Authority on the use of tugs which, in concert with action already taken by the Authority, is designed to prevent similar accidents in the future.
