Report on the investigation into  
the collision between the fishing vessels  
***Sapphire II and Silver Chord***  
resulting in the foundering of *Sapphire II*  
off Stornoway, Scotland  
12 January 2011

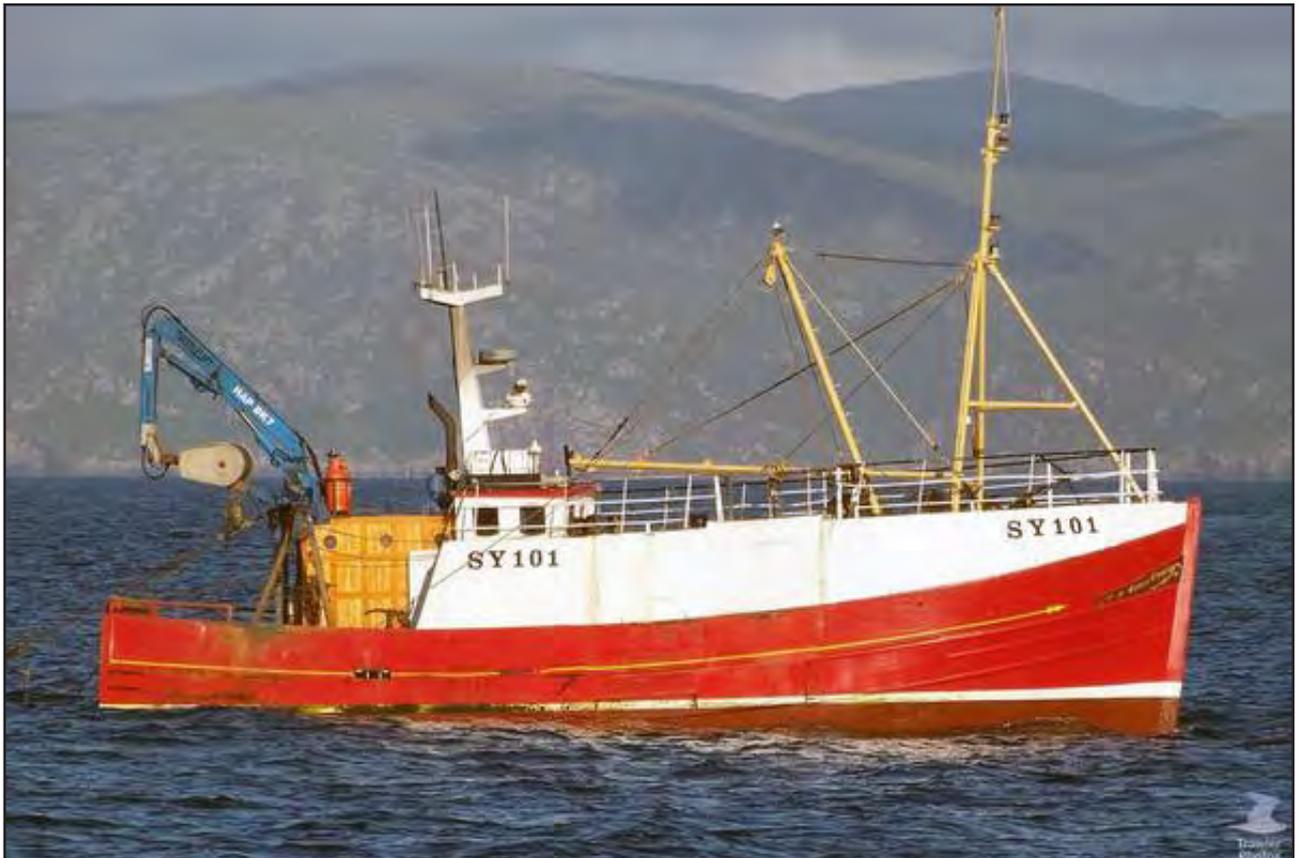
At 1840 on 12 January 2011, the 16.84m prawn trawler *Silver Chord* (**Figure 1**) collided with the 14.99m prawn trawler *Sapphire II* (**Figure 2**). At the time of the collision, *Sapphire II* was stopped in the water while her skipper, who was operating single-handed, recovered the vessel's fishing gear. *Silver Chord* was making 5.5 knots (kts) as she proceeded towards Stornoway after a day's fishing.

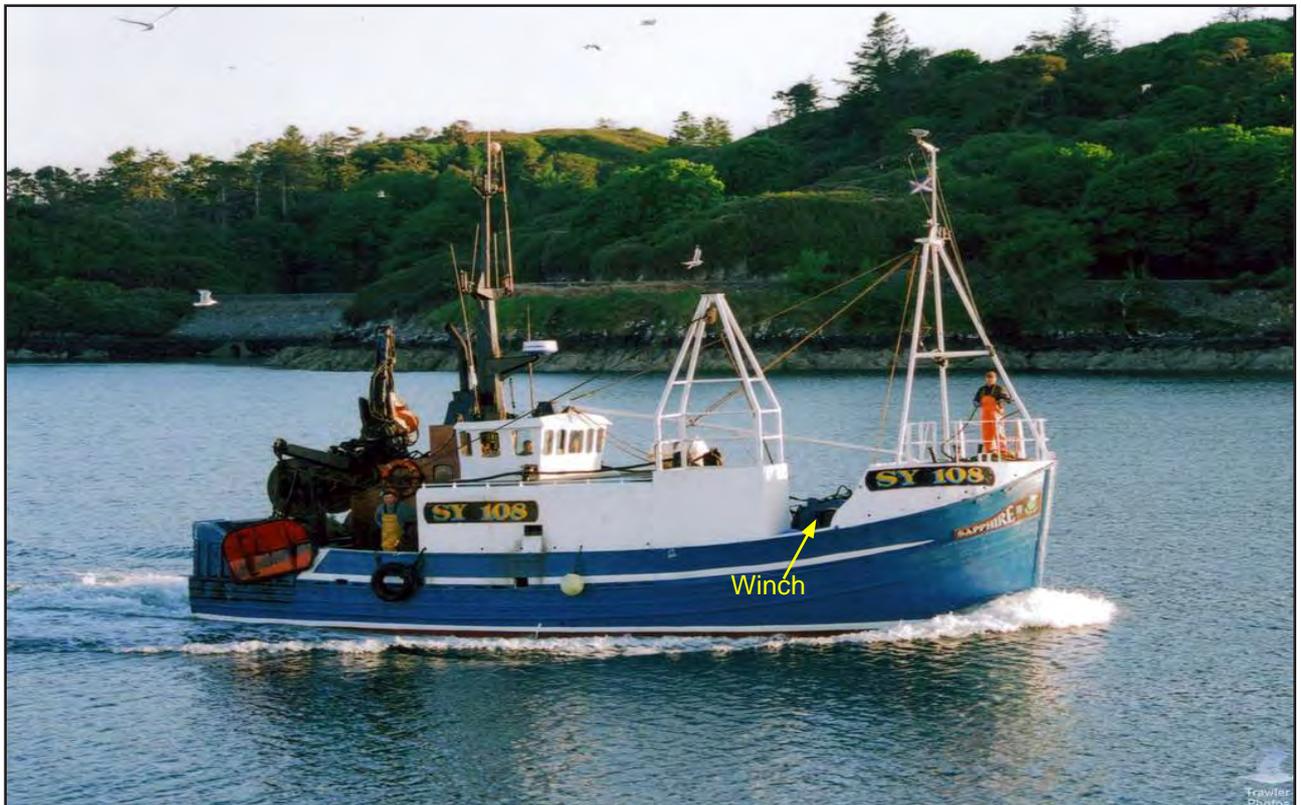
*Sapphire II*'s hull was penetrated and the fish hold quickly started to flood. Her skipper reported the accident to the coastguard, and transferred to *Silver Chord* before *Sapphire II* sank at about 1850. *Silver Chord* was also damaged, but was able to return to Stornoway under her own power. There were no injuries.
