Report on the investigations into
the loss of the skipper from fv
Discovery
during single-handed fishing operations
3 miles east of Fraserburgh
9 October 2010
and
the loss of the skipper from fv
Breadwinner
while fishing single-handedly
5.5 miles east of Score Head, Bressay
20 January 2011

DISCOVERY INVESTIGATION

BREADWINNER INVESTIGATION

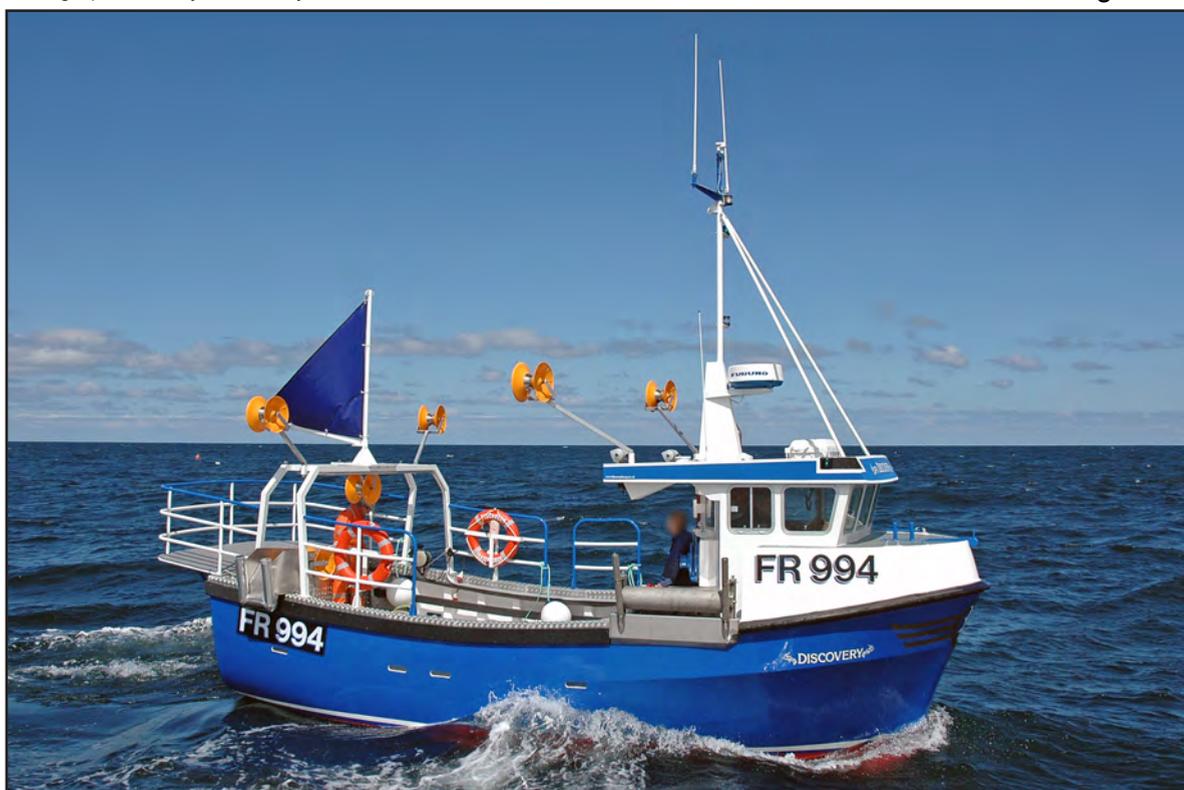
Figure 10

Discovery was fitted out for creel fishing with the ability to fish for mackerel simultaneously (**Figure 10**). Additional railings were fitted along the vessel's port side to facilitate the stowage of multiple leaders of creels. The stern was also fitted with an additional stowage area above the transom. The starboard side was fitted with railings from the stern to about a third of the way along the deck. There were no guardrails on the starboard side in the area of the baiting table. The bulwark height in this area was estimated to be about 750mm (**Figure 8**).

Discovery's fit out at build

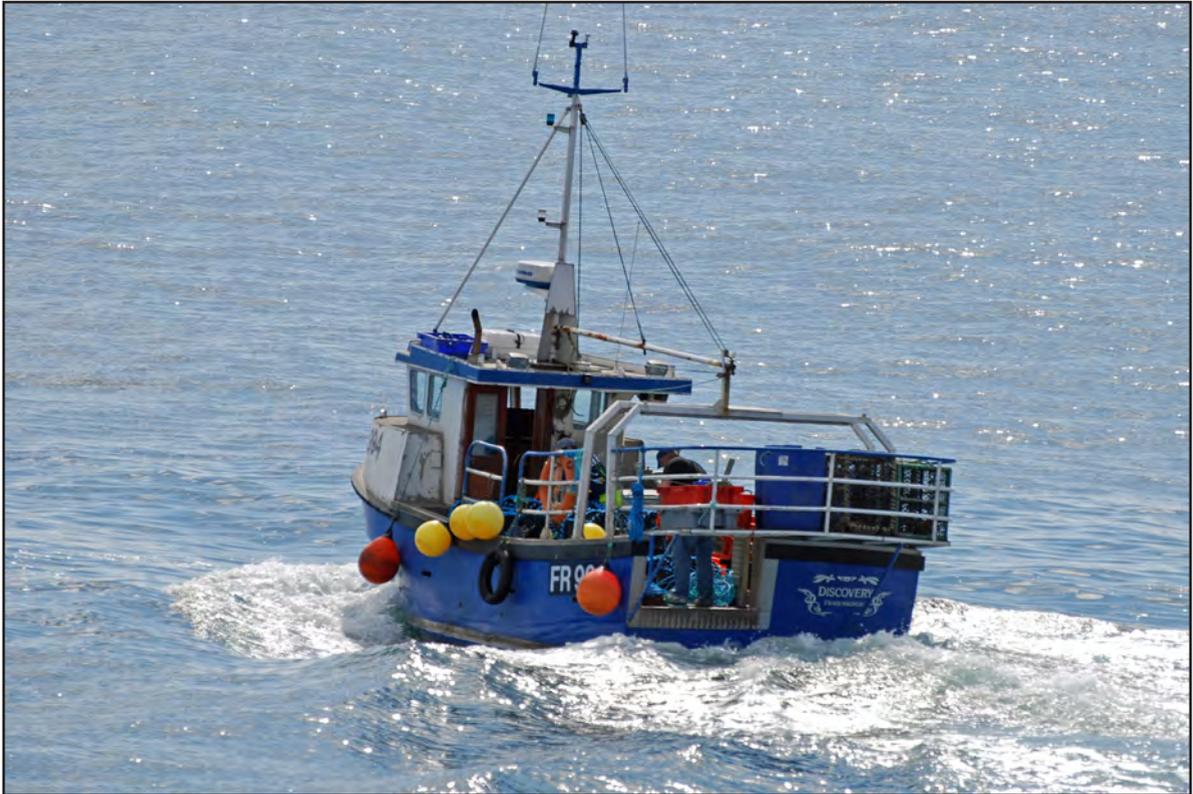
Discovery showing closable stern door arrangement

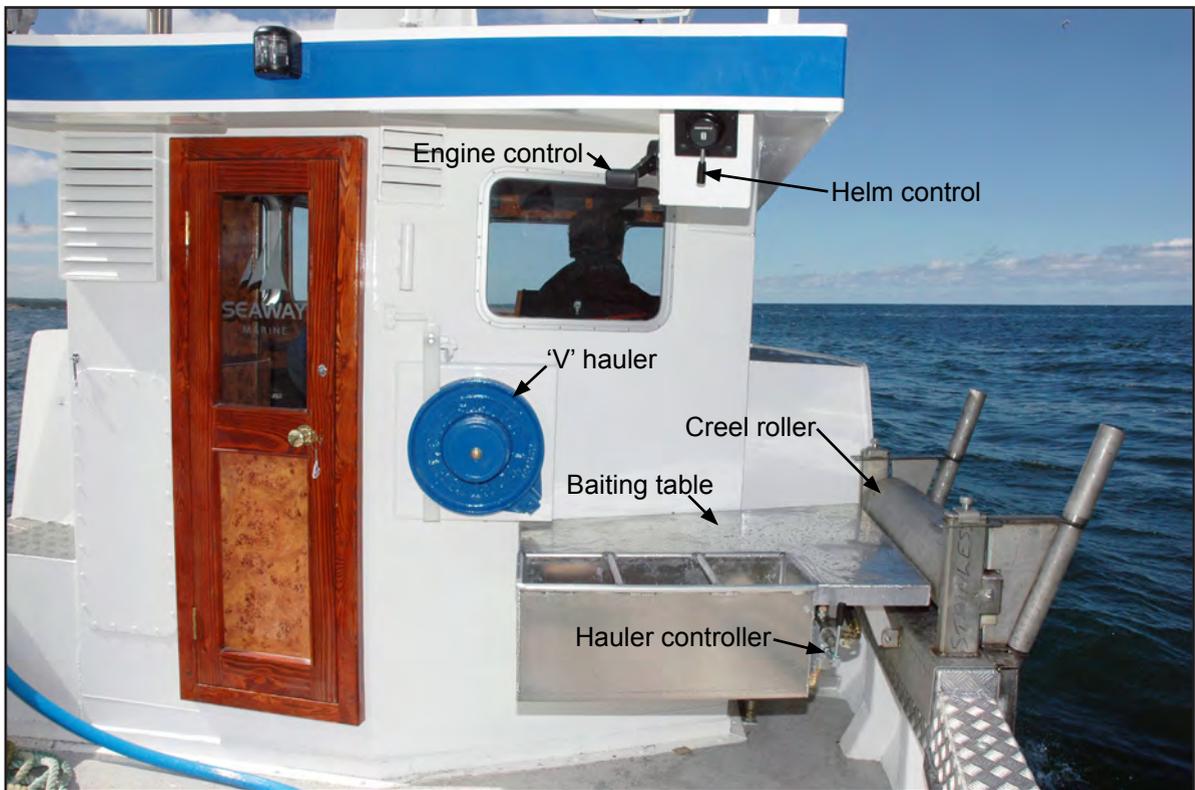
The investigation found that back ropes are liable to ride out of a 'V' wheel hauler if they do not lead correctly on to the potting roller. The investigation has also highlighted the hazards faced by fishermen working single-handedly, and their vulnerability to emergency situations.

'V' wheel hauler, roller and control arrangement

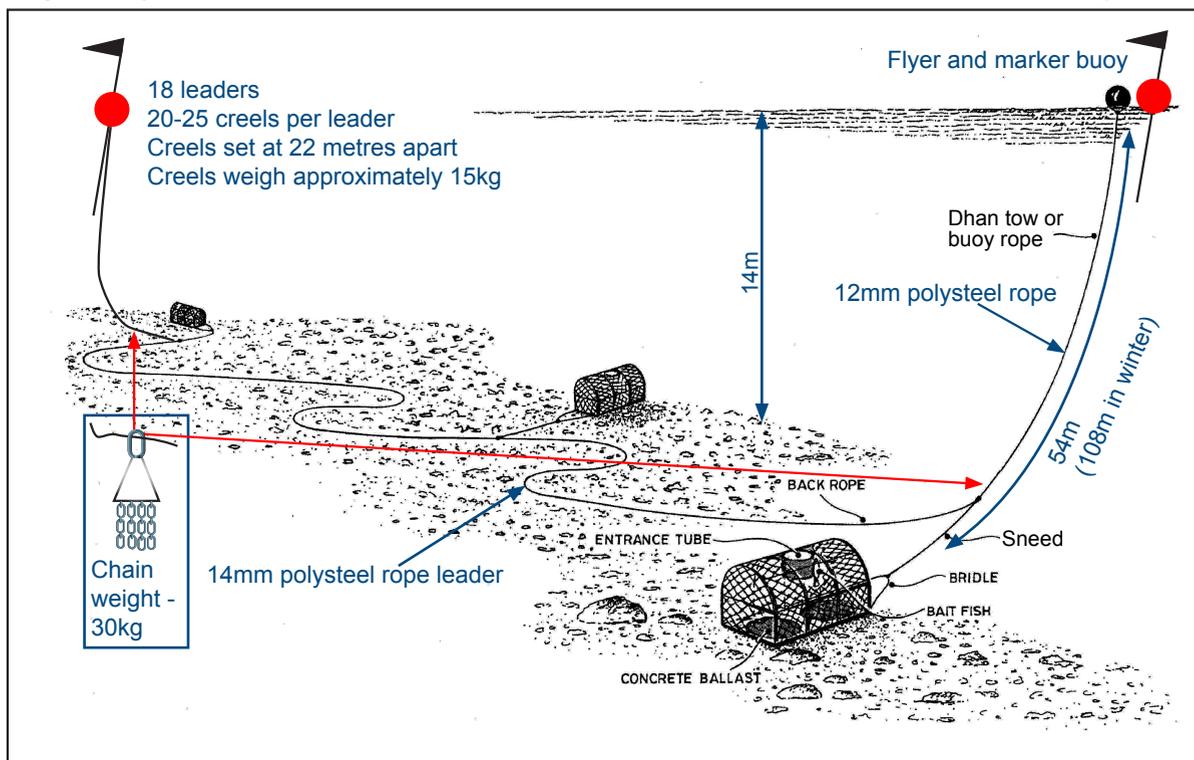
Figure 13

Diagrammatic creel leader arrangement

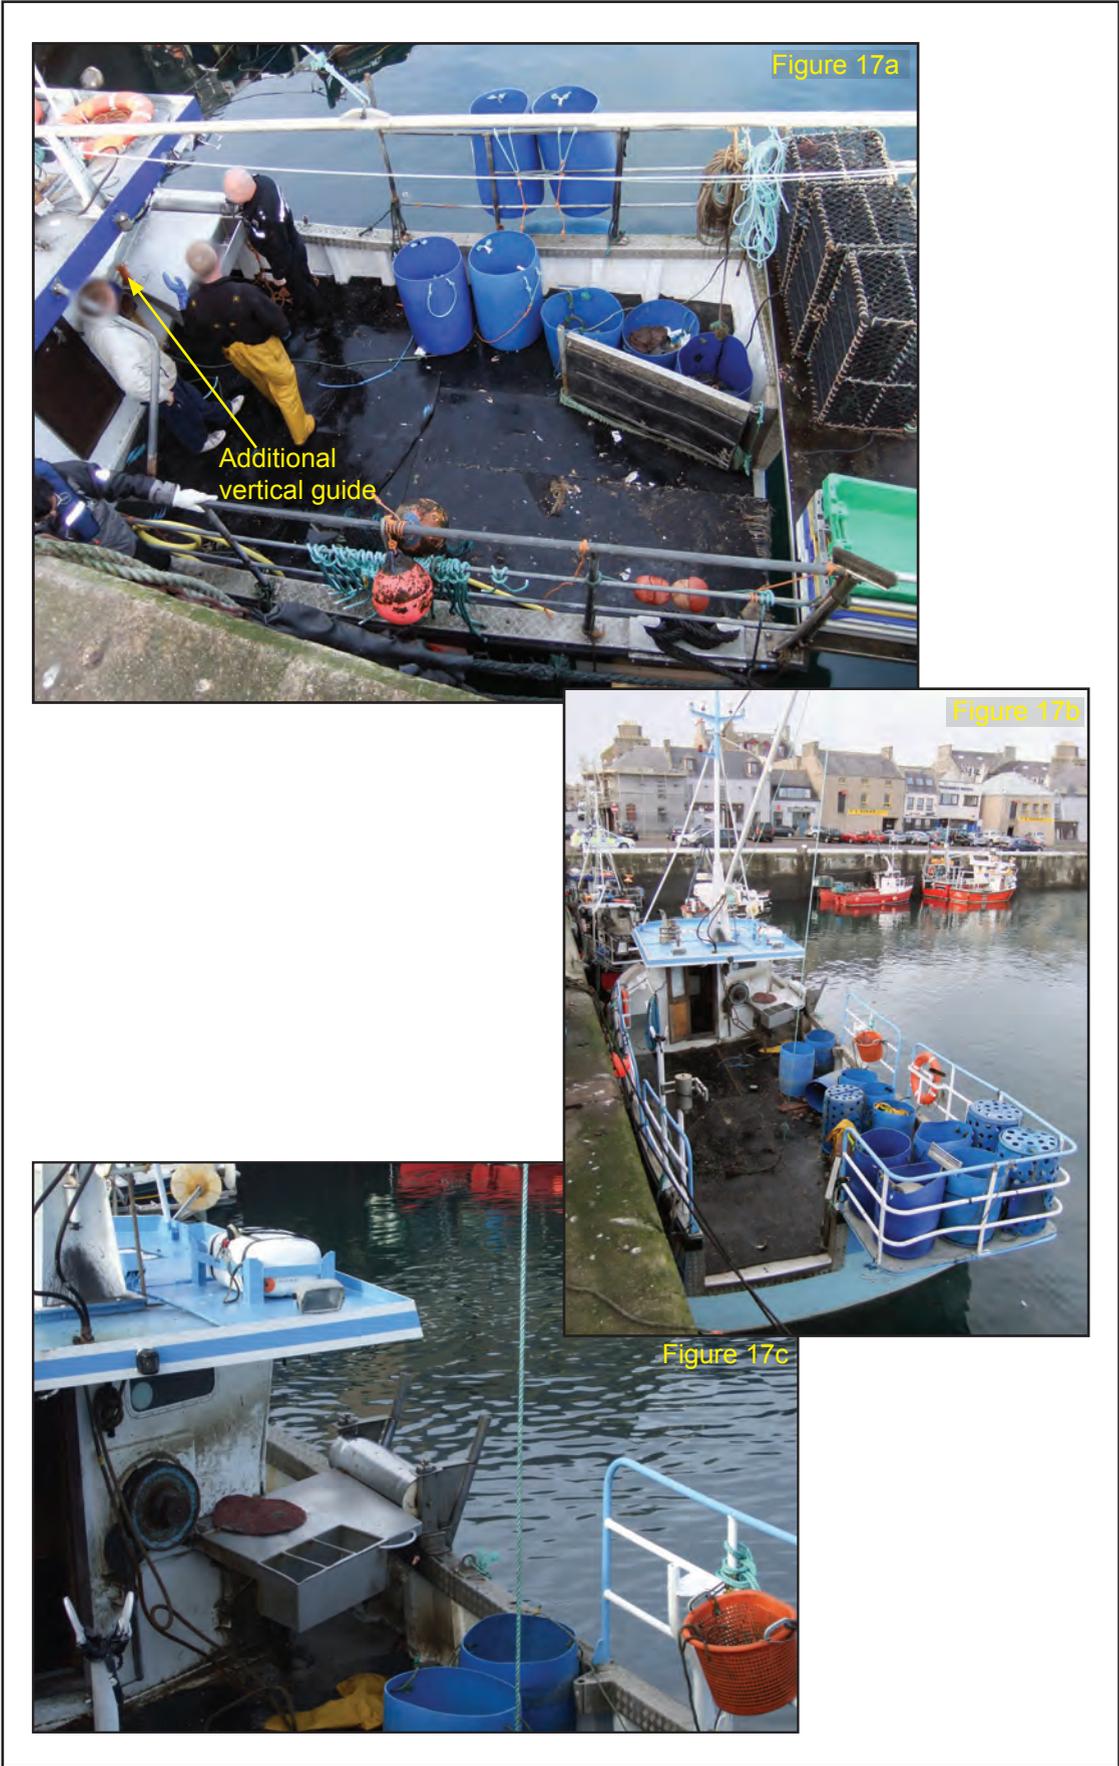
Figure 17

Hauler and rollers on potters similar to *Discovery*

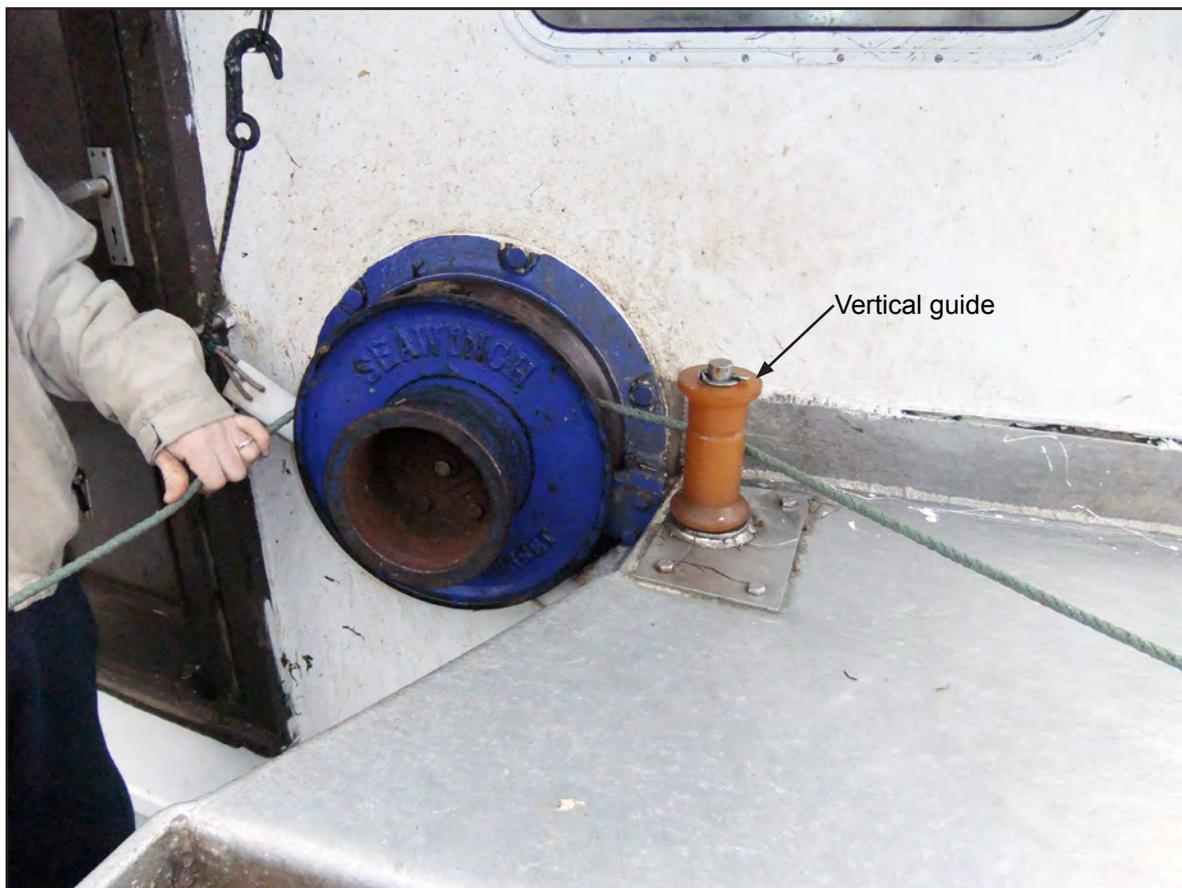
Figure 18

Vertical guide fitted to a potter similar to *Discovery*

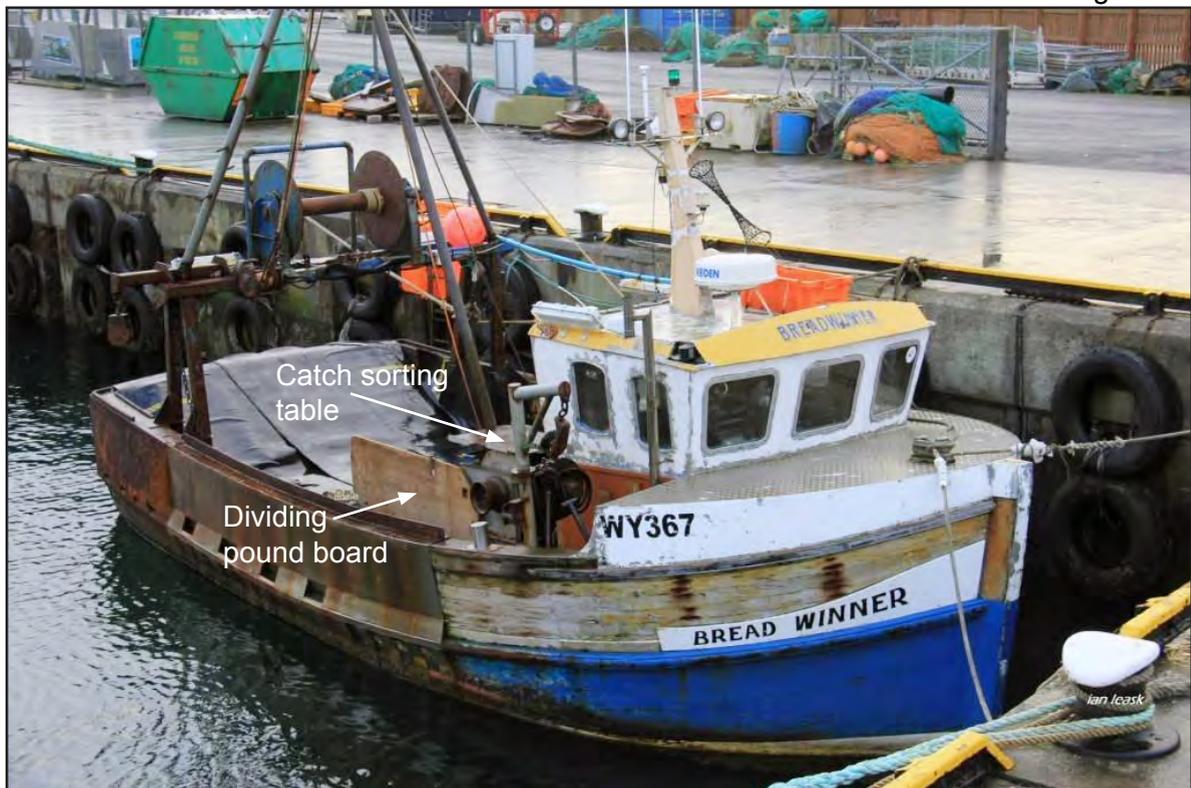
Figure 22

Breadwinner

Neil Smith modified *Breadwinner* for one-man operation of creels by installing a full width plywood shooting ramp forward of the transom bulwark. To give protection to the ramp and deck, the entire area was covered in heavy duty laminated rubber matting. Of note was the installation of a dividing pound board fastened to, and abaft of, the winch on the starboard side (**Figure 22**). This board kept creels stacked on deck separated from the back rope.

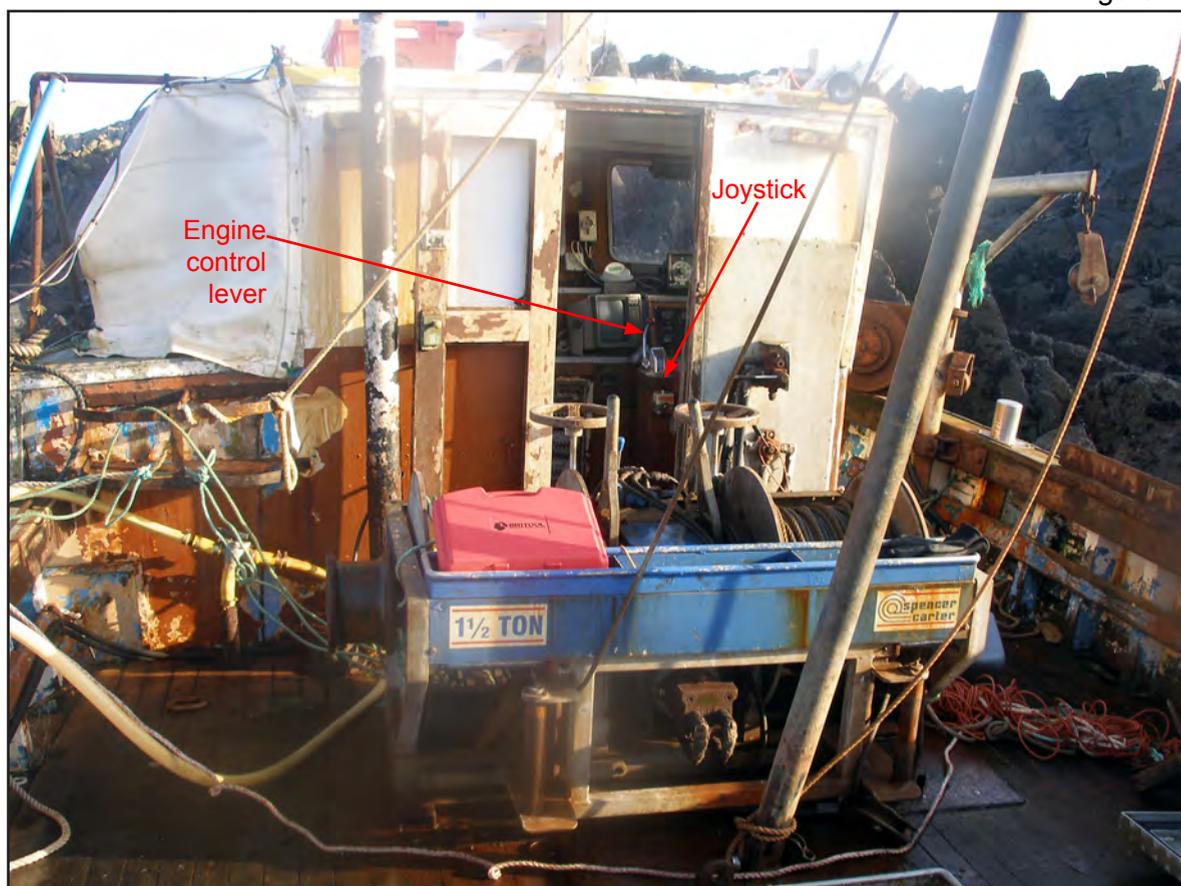
Engine control and joystick relative to wheelhouse access

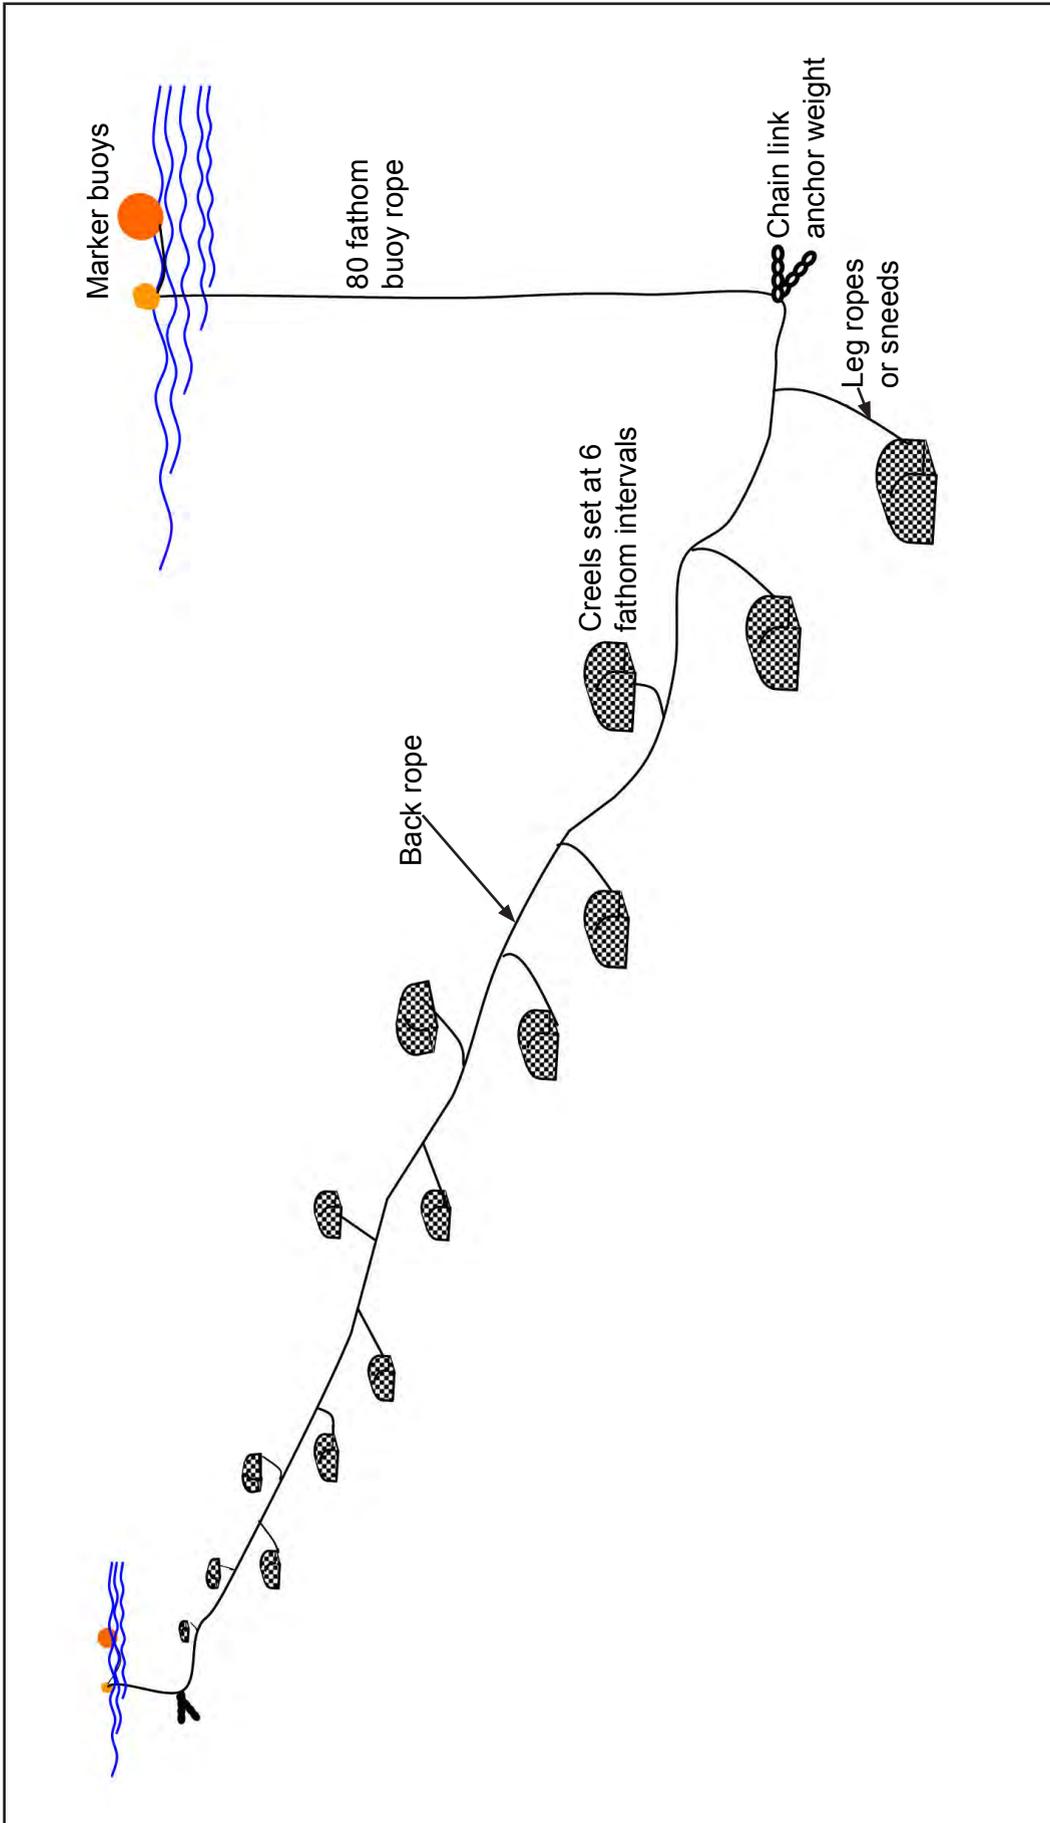
Figure 28

Diagrammatic representation of *Breadwinner's* creels leaders

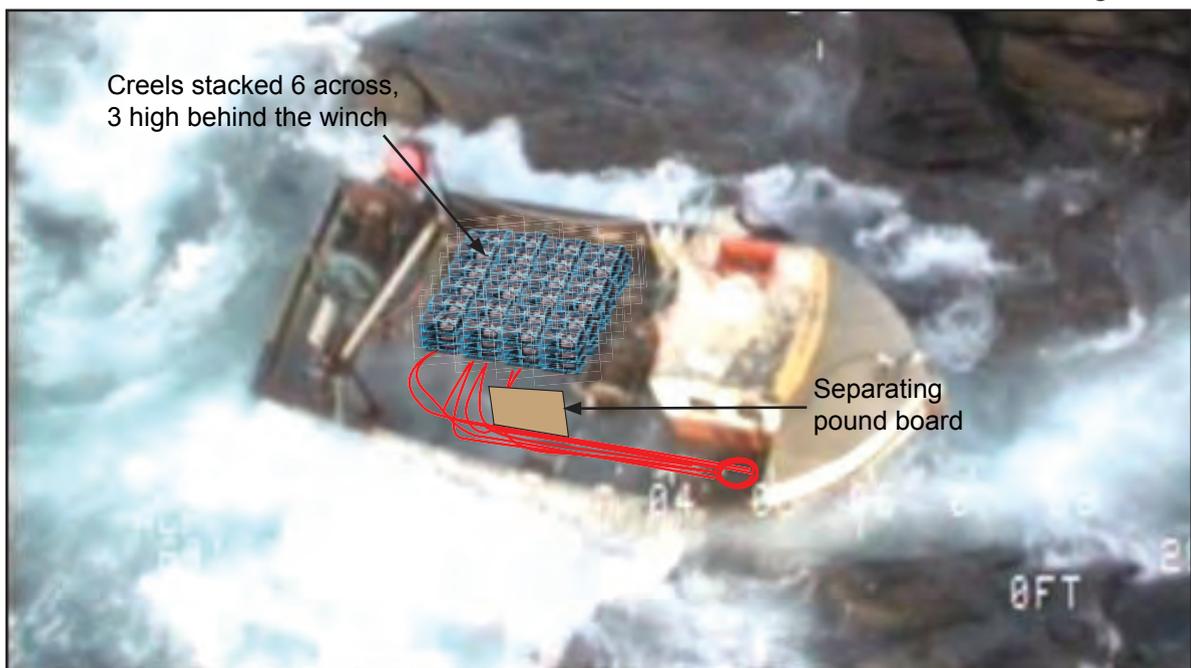
Figure 29

Breadwinner's system of shooting was known as a self-shooting arrangement. Prior to shooting, a leader of 70 creels was stacked in rows of three high and six athwartships behind the trawl winch for four rows towards the stern (**Figure 29**). To shoot a leader of creels, the skipper would set a boat speed of about 3kts and engage the autopilot on a suitable heading. He would then leave the wheelhouse to deploy the first marker buoy, buoy rope and chain weight. The tension on the back rope created by the chain weight would then pull the creels over the stern in succession as the boat steamed ahead. The skipper would normally remain in the wheelhouse during shooting, but would go on to the deck to cast away the second set of marker buoys, which were usually stowed between the winch and the wheelhouse, within easy reach of the wheelhouse door.

Diagrammatic representation of creels stowed on deck

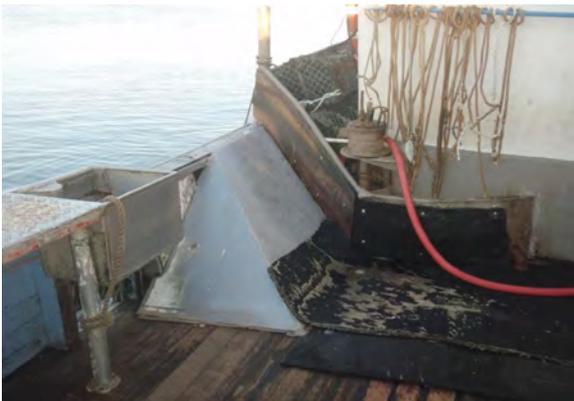
Figure 11: Self shooting ramp mid-ships onboard the Bridlington based vessel *Nordstjerne*

Figure 11 above shows a system using a ramp to allow an adaptation of self shooting from mid-ships. During shooting operations a crew member rolls or places each pot in position at the foot of the ramp to ensure it is shot away without incident. Although this method requires some human intervention the effort required is minimal.

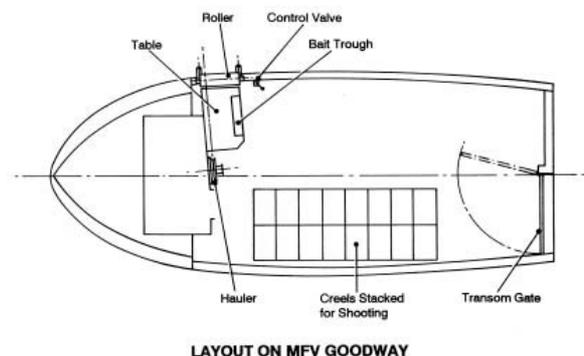
Figure 12: Roller layout on MFV Goodway

The general layout on the vessel is shown below. Ideally, to enable the vessel to be easily controlled the roller needs to be mounted well forward on the vessel's rail and in a reasonably horizontal position.

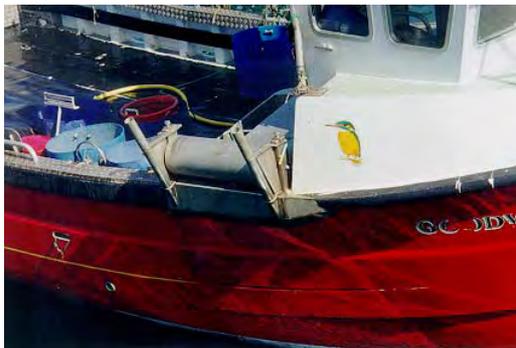
Figure 13: Seafish roller design

Most pots/creels can be hauled over this size of roller, including 'inkwell' type pots, the critical factor being that there is clearance between the side rollers for the maximum dimension of the pot. Figure 13 shows the Seafish roller design with removable side rollers to avoid damage when mooring the vessel.

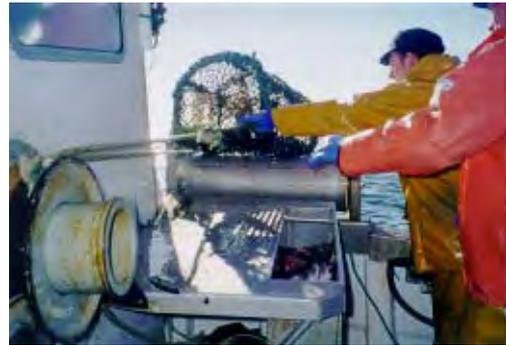
Figure 14: Hauling pots with roller

The pots/creels can be hauled over the roller at a modest speed, but it is essential that the hauler is slowed from high speed as each pot arrives at the roller. To achieve rapid smooth control a quarter turn rotary control valve is recommended. This should be mounted adjacent to the roller, readily accessible to the person standing at the roller but with the

handle protected such that it cannot be accidentally caught by a rope or clothing.

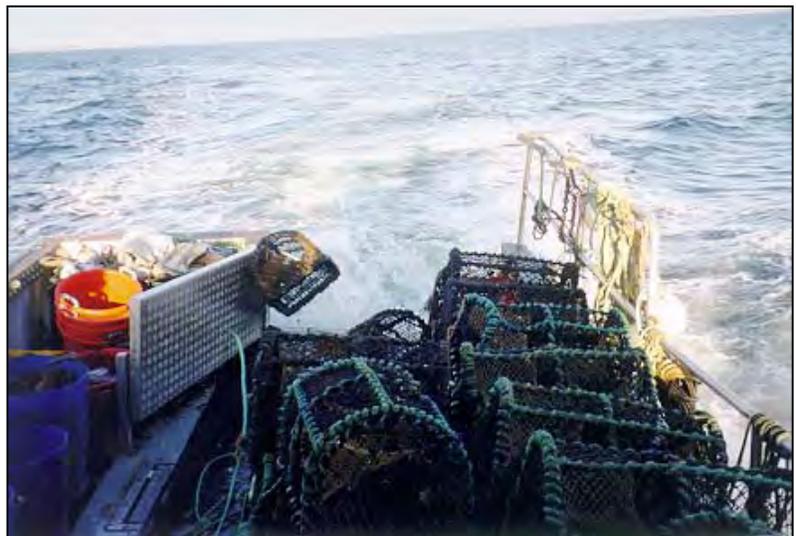
Safety on the 'GOODWAY' is very much assured by the shooting arrangements on the vessel. As can be seen in the photograph, the vessel has a gate in the transom bulwark that is opened to allow the creels to be shot directly off the deck. A lanyard operated quick release clip is used to let go the end anchor with all the crew clear of the deck throughout the shooting operation.
