Report on the investigation of
the collision between the fishing vessel
Homeland
and
the ro-ro passenger vessel
Scottish Viking
4.2 miles off St Abb's Head
5 August 2010
resulting in one fatality

Report No 4/2011
March 2011

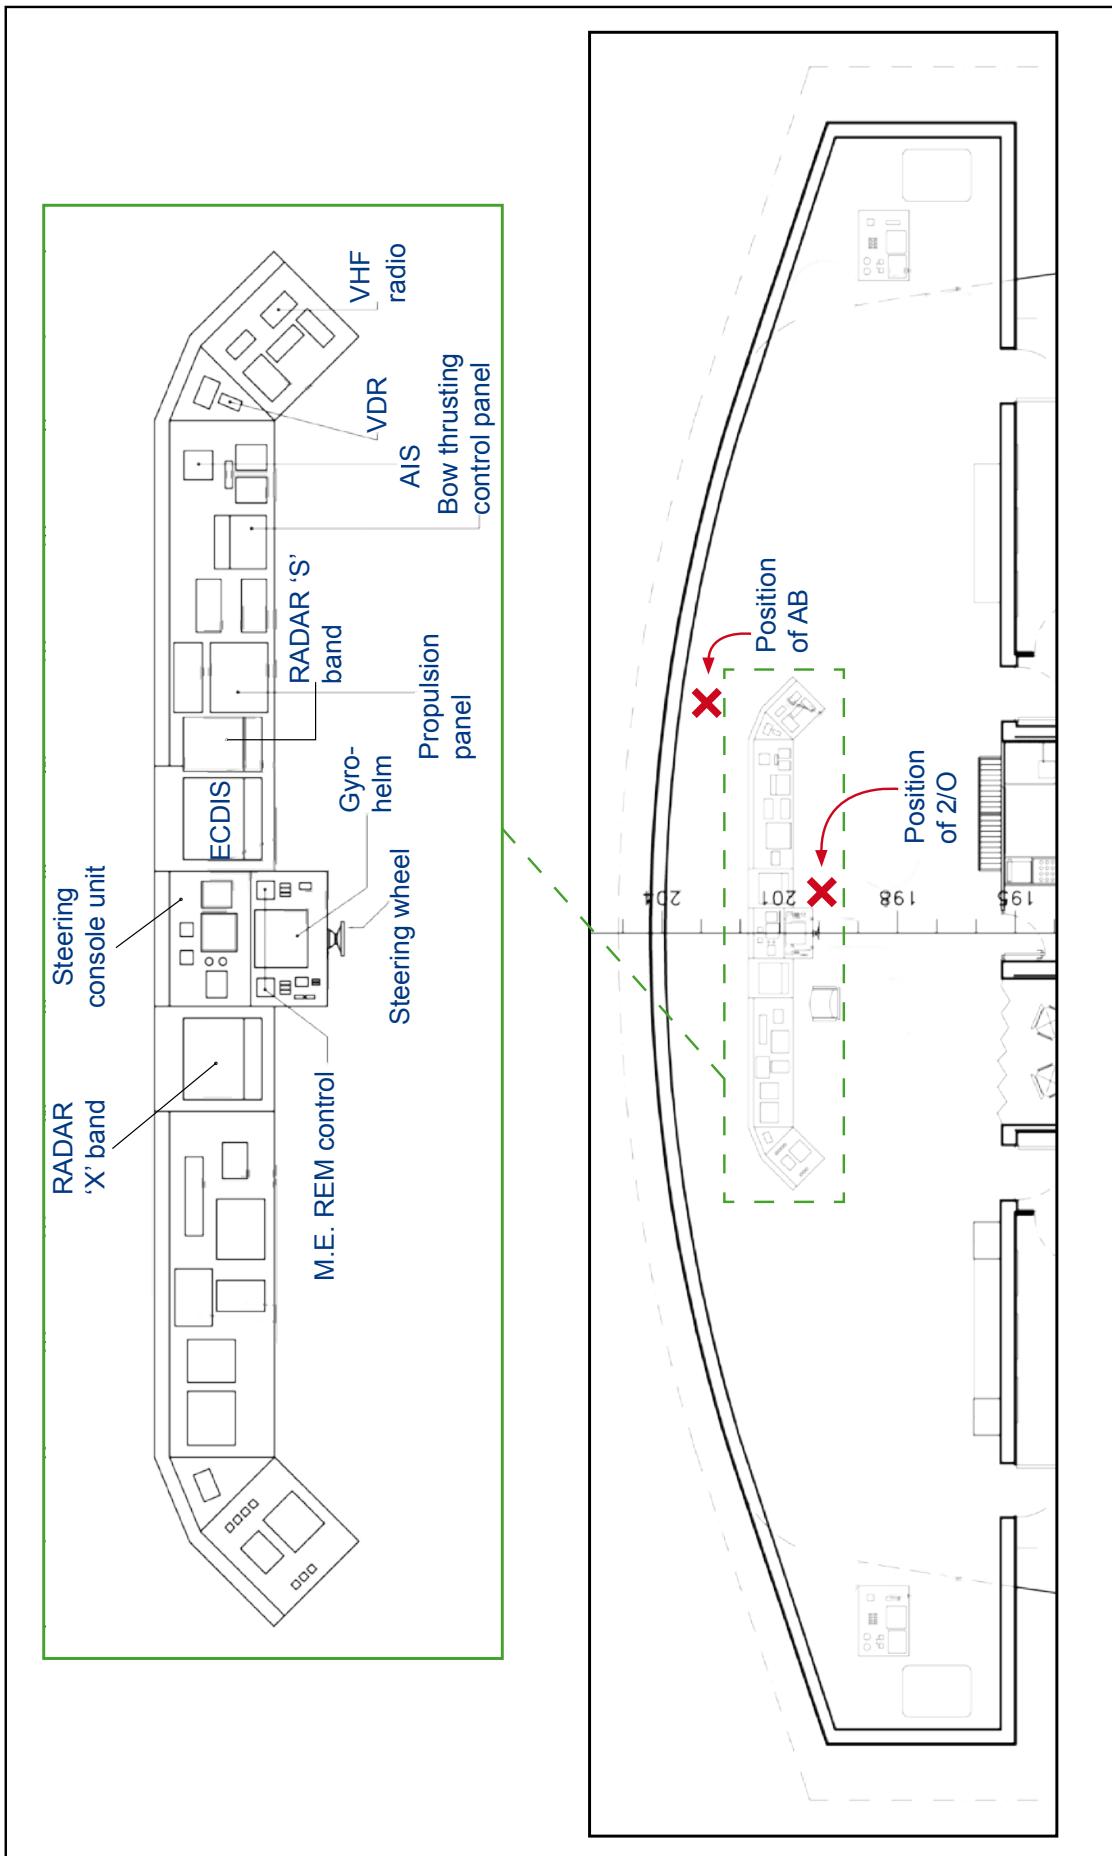
Figure 5

While standing between the steering console stand and the starboard radar (**Figure 5**), the second officer sighted three fishing vessels at about one point on the starboard bow. The AB, who was conducting a visual lookout and was positioned by the starboard clear view screen (**Figure 5**), also noted these vessels. No visual bearings were taken of these vessels, and their radar targets were not plotted, nor were their bearings otherwise monitored. Both the second officer and AB continued to observe visually the three fishing vessels. At 1944 (**Figure 6**), when the nearest fishing vessel (*Homeland*) was at 1 mile range, the AB expressed concern that the vessels were crossing, and that there was a possibility of a close-quarters situation. The second officer acknowledged this.

Scottish Viking - Bridge layout

Scottish Viking was equipped with an integrated bridge system (**Figure 5**) fitted with predominantly Japan Radio Company navigational equipment. This included two radars with automatic radar plotting aid (ARPA) facilities, and an electronic chart system (ECS) unit, all capable of overlaying AIS data on their respective screens. Both radars were capable of interrogating AIS targets to provide information for use on collision avoidance. A gyro repeater and azimuth ring for the taking of visual bearings was provided at each bridge wing.
