Report on the investigation of  
a lifting equipment failure  
on board the floating sheerleg

***Cormorant***

102 berth, Southampton

**Report No 15/2010  
November 2010**

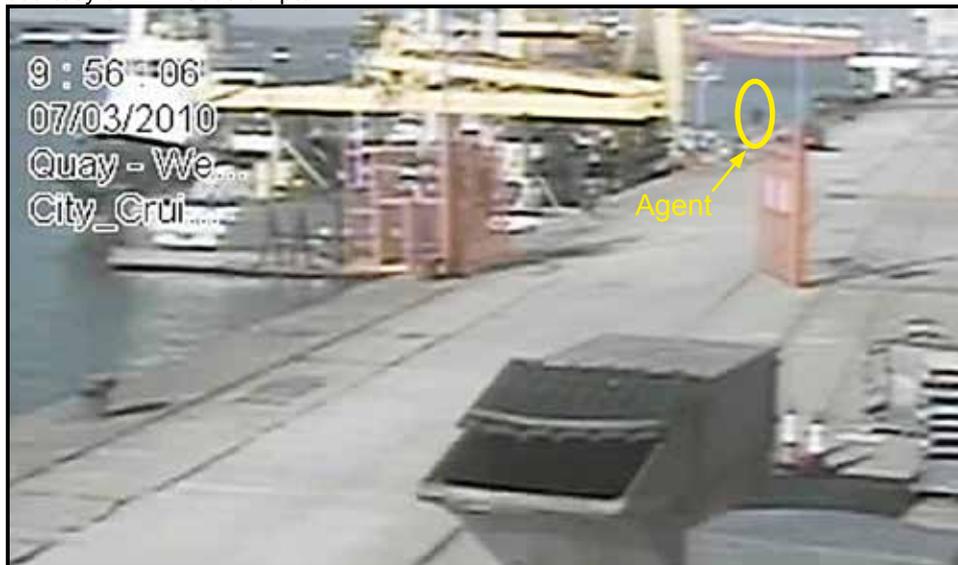
Figure 2

At 0956, the commercial agent boarded the vessel (**Figure 2**). The master directed him to enter the wheelhouse using the port aft door, where he was met by the able bodied seaman (AB) who had come up from the accommodation to assist.

Agent boarding the vessel

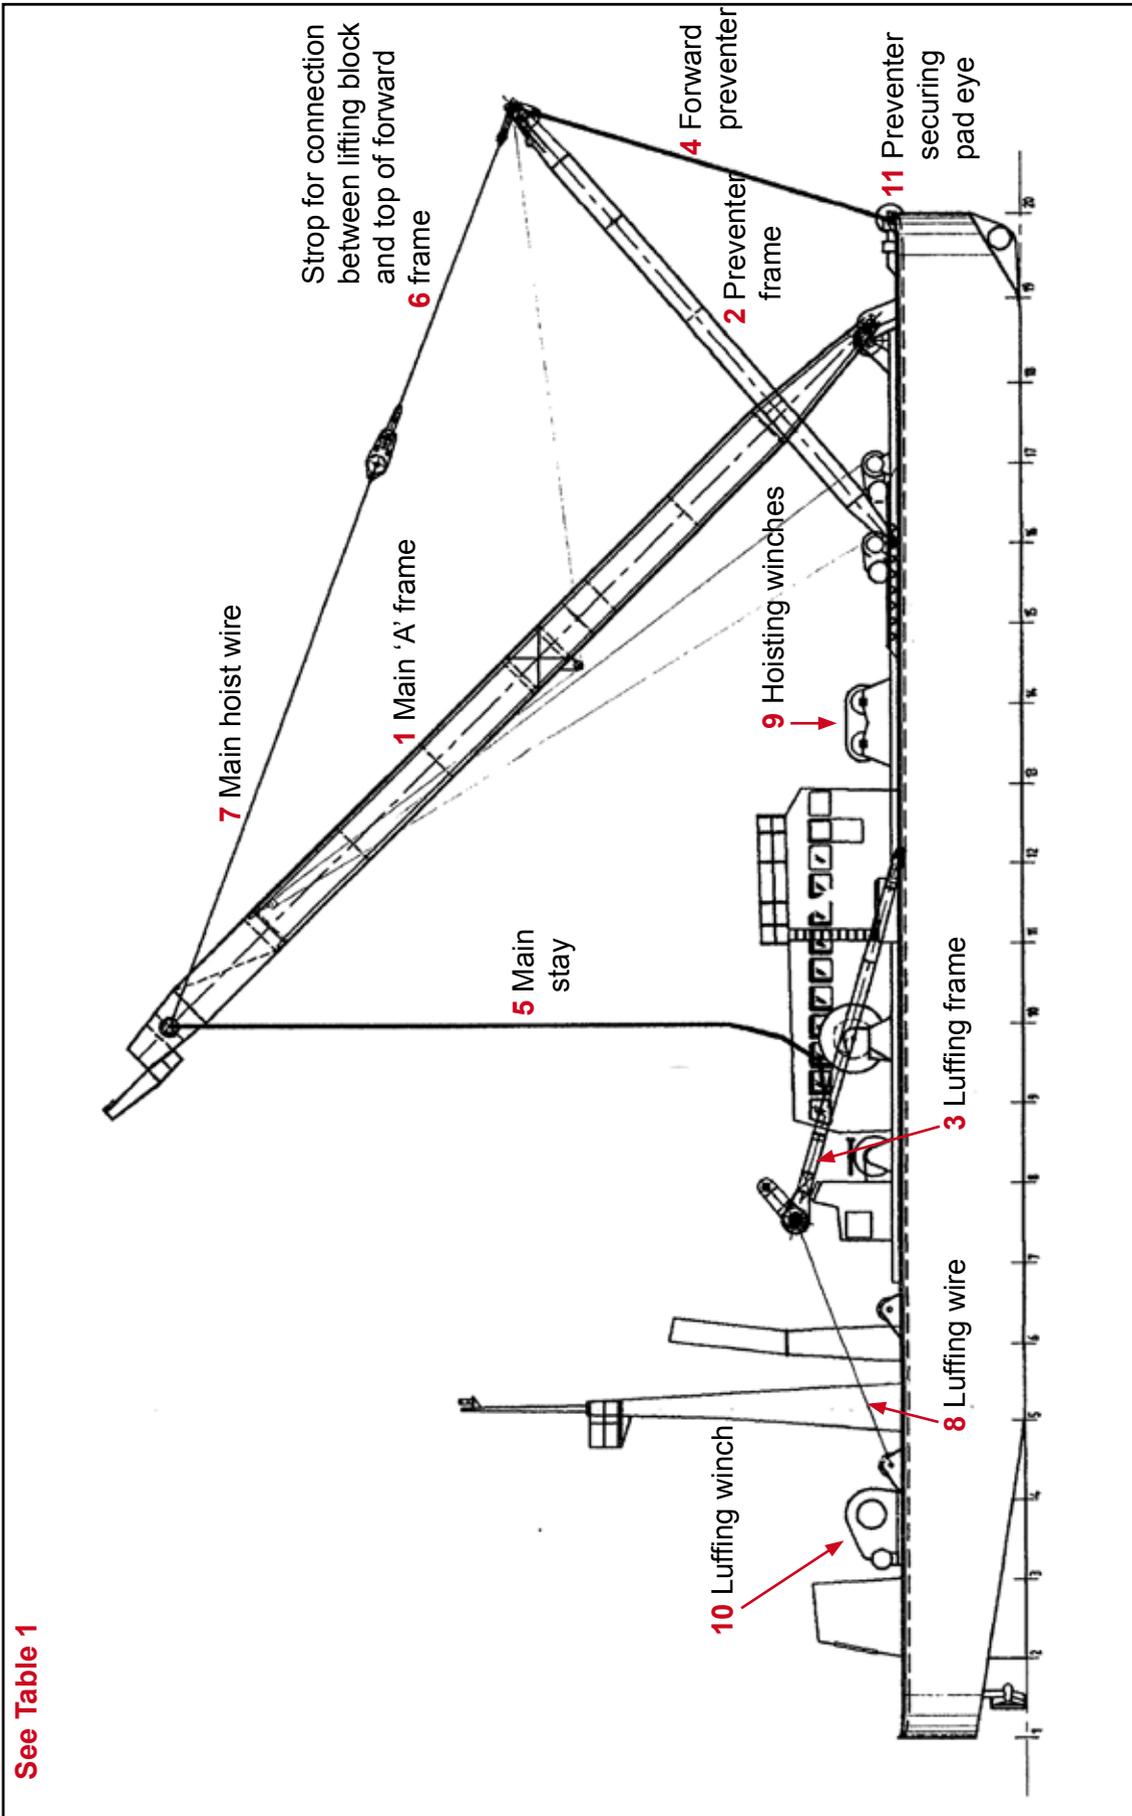
Figure 7

A side elevation of the crane showing its key components is shown at **Figure 7**. The specification of each component is detailed in **Table 1**.

Lifting equipment arrangement
