Report on the investigation of the contact by

Isle of Arran

with the linkspan at Kennacraig

Report No 13/2010
October 2010

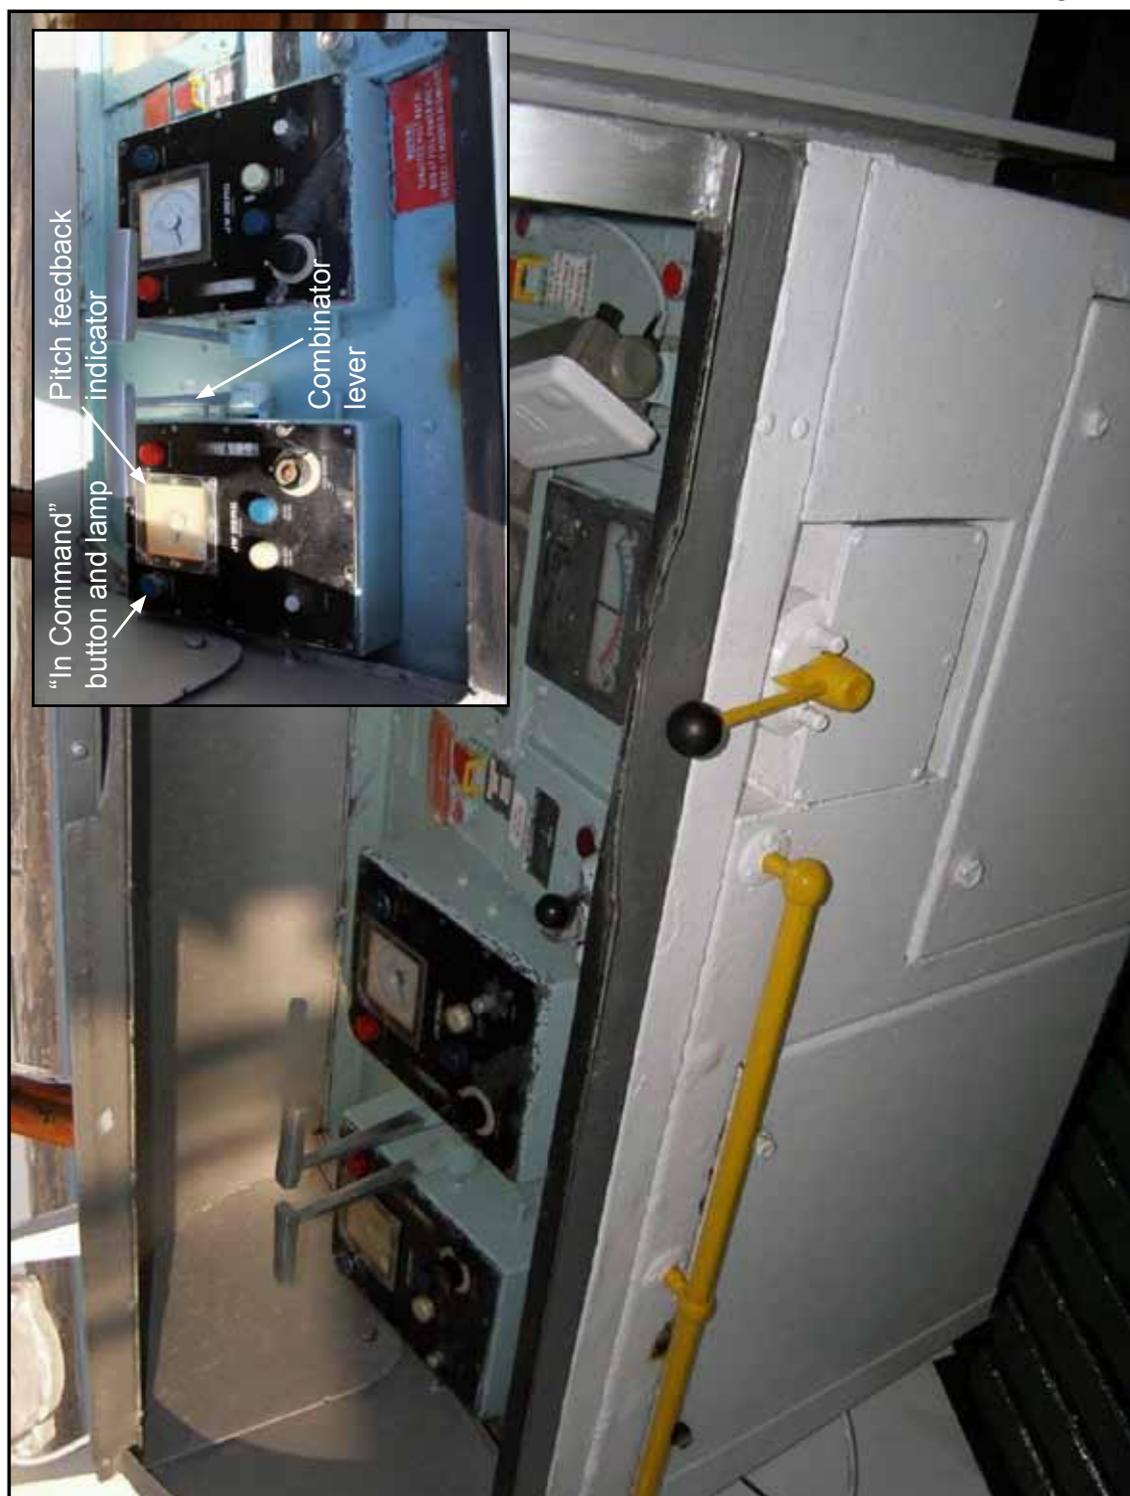
Figure 3

On the wing, the master opened the control box lid and set the combinator levers to '3' ahead to match the levers on the bridge console (**Figure 3**). He then pressed the "in command" button; the blue "in command" light on the wing console illuminated. The chief officer, who was still inside the bridge, confirmed that the "in command" lights on the bridge centre consoles had extinguished. The master interpreted noises from the pitch control pneumatic system within the port wing control box as further confirmation that control had been transferred.

Port bridge wing control console and insert

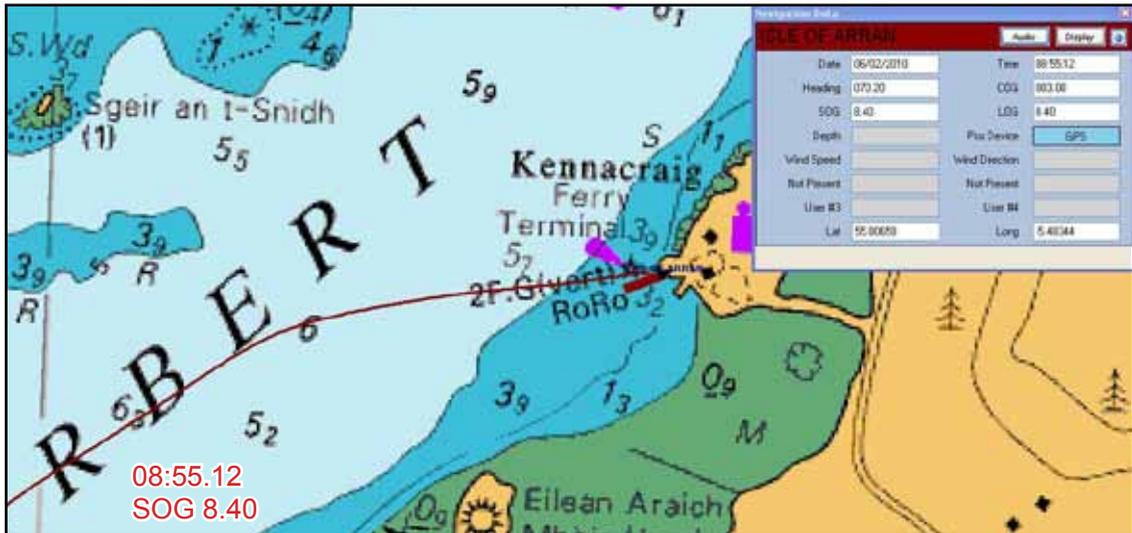
Figure 6

After impact, *Isle of Arran's* stern swung to starboard until she was about 30° to the pier (**Figure 6**). The port engine was stopped and shore lines put out fore and aft. Inspection of the starboard oil distribution (OD) box revealed a control linkage failure (**Figure 7**). A spare linkage was fitted by the second engineer and was adjusted to allow operation of the starboard CPP.

Contact with Kennacraig ro-ro terminal: AIS data extract

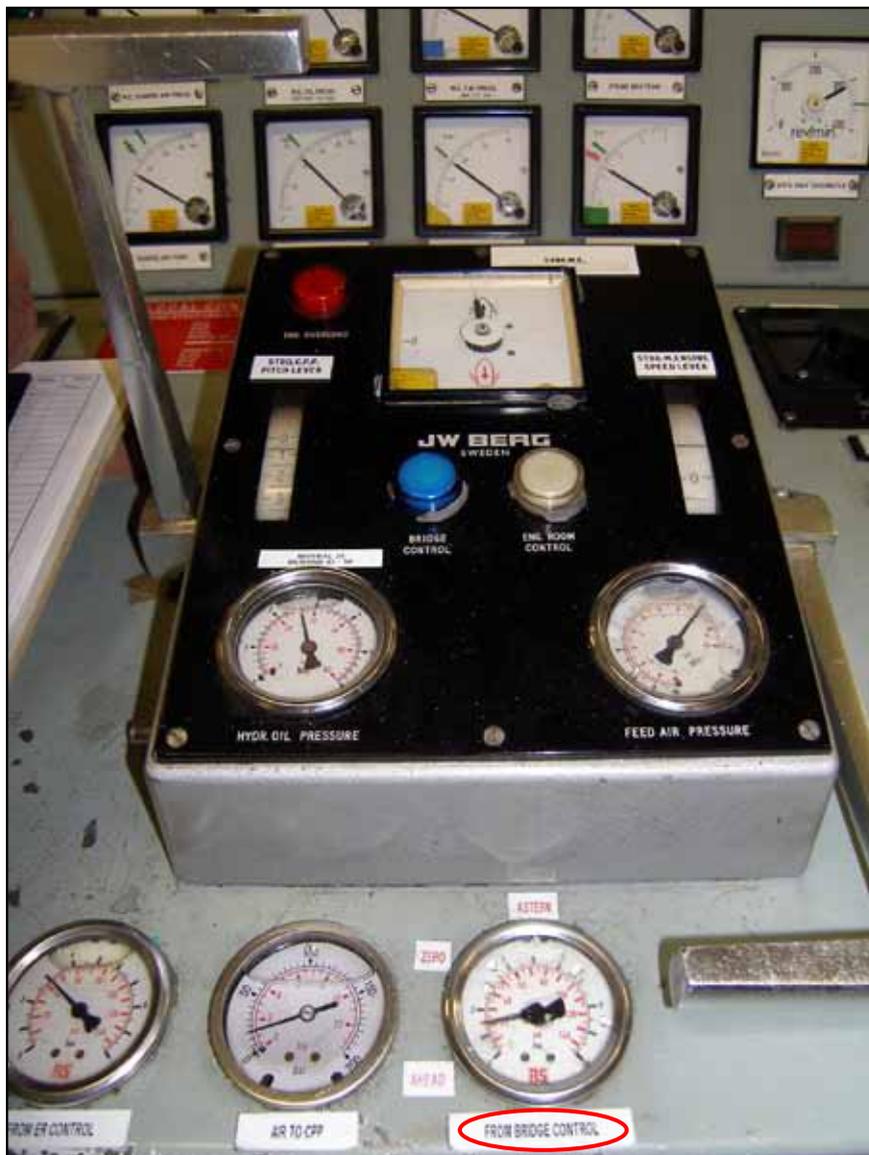
Figure 13

The ECR control consoles for the port and starboard engine and CPP systems included: a pitch lever; a main engine speed lever; a main control air pressure gauge; a CPP control air gauge (labelled “From Bridge Control”); a pitch feedback gauge; a hydraulic oil pressure gauge; a feed air pressure gauge; lamps to indicate whether the bridge or ECR had control; and an engine overload lamp (**Figure 13**).

ECR starboard engine/ CPP control console

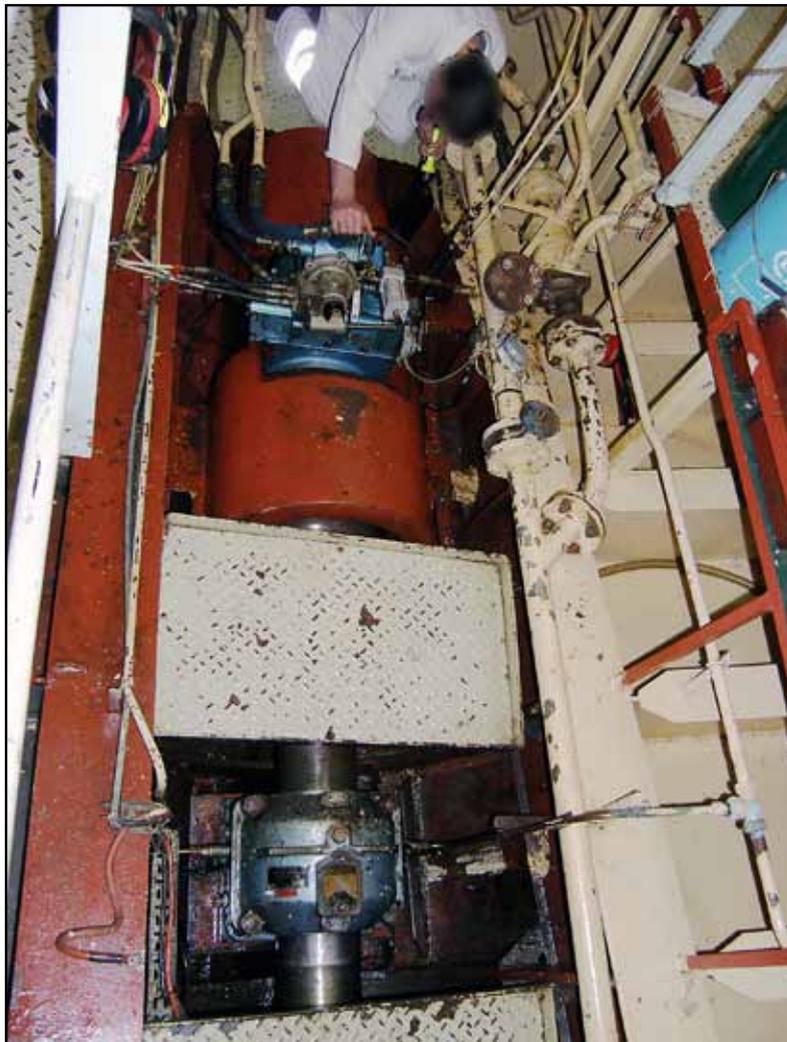
Figure 14

Isle of Arran was powered by two Mirrlees Blackstone medium-speed diesel engines each developing 2310bhp (1756kW), driving through controllable pitch propellers via a clutched flexible coupling and single reduction gearing. The pitch control or oil distribution boxes mounted on each shaft (**Figure 14**) were located in the gland space, aft of the engine room, and separate from the main engines and gearboxes. *Isle of Arran* was the only vessel in the CFL fleet fitted with these boxes, which were manufactured in Sweden by Berg, and were no longer in production.

Starboard CPP OD box and propeller shaft

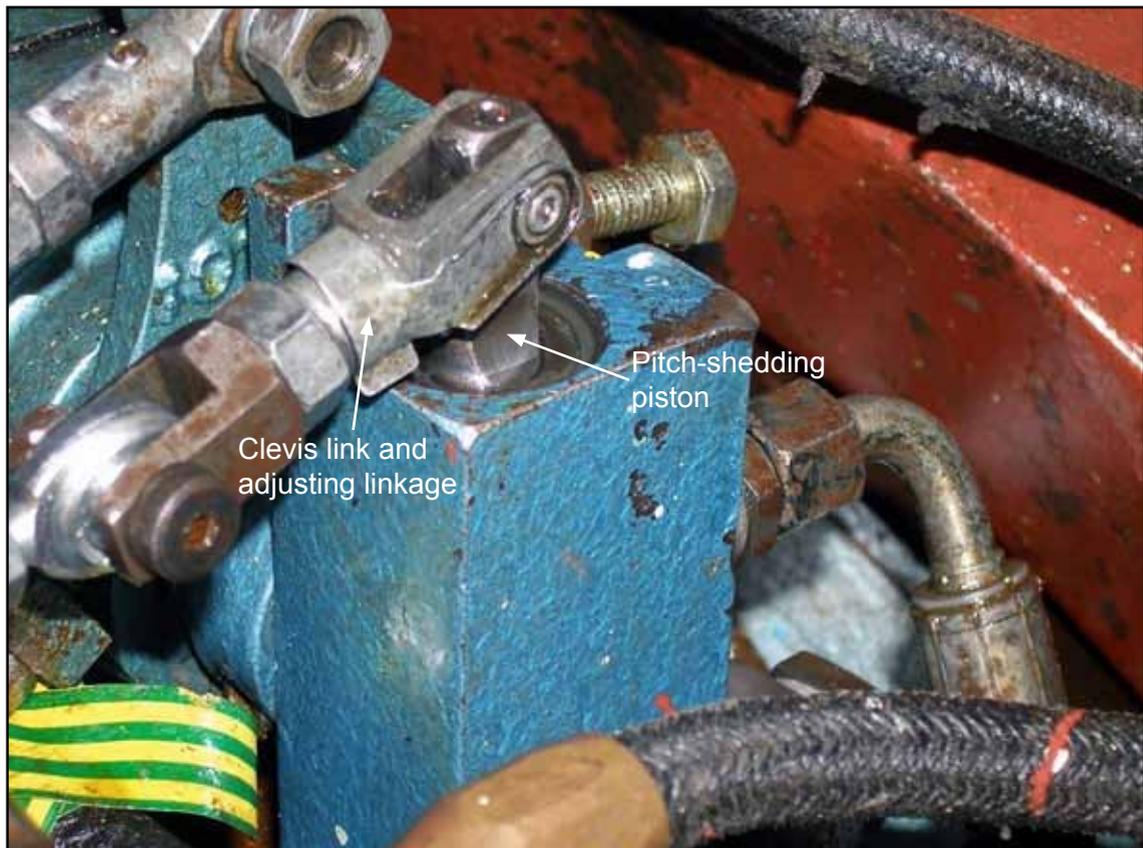
Figure 16

When an engine was overloaded, possibly due to operating in heavy weather, the pitch-shedding cylinder was operated by an electrical signal from a switch on the engine fuel rack via a hydraulic solenoid. The piston of the pitch-shedding cylinder rose a maximum of about 34mm and pushed back the servo cylinder rod (**Figure 16**). This movement forced oil to the opposite side of the two-way servomotor cylinder pilot piston and reduced the servomotor piston stroke. This decreased the angular position of the telemotor, which reduced the propeller pitch and the load on the engine.

Starboard OD box pitch-shedding cylinder

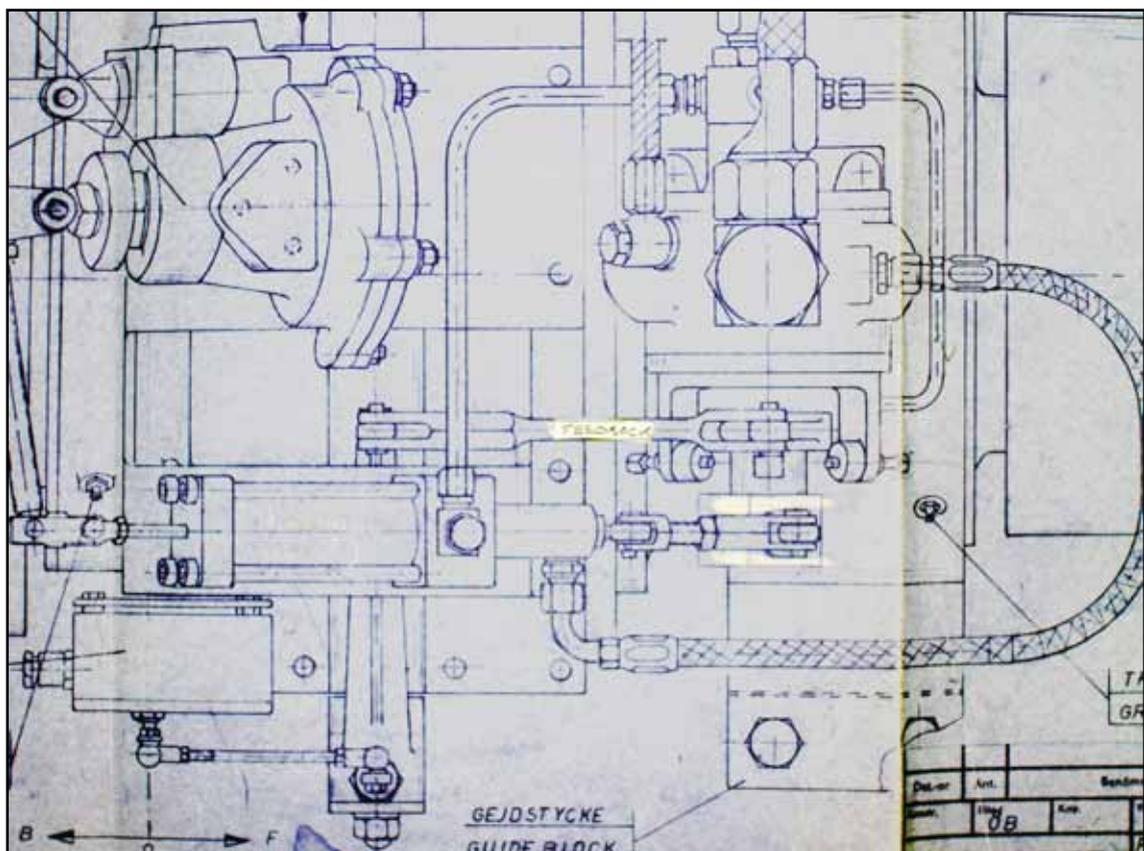
Figure 17

The CPP system manual held on board *Isle of Arran* was provided by Berg. It included an overview of the operation of the system and general drawings (Figure 17). However, because this information lacked sufficient detail, the ship's engineers had developed their own drawings of the system and its operation (Figure 18).

Berg manual drawing

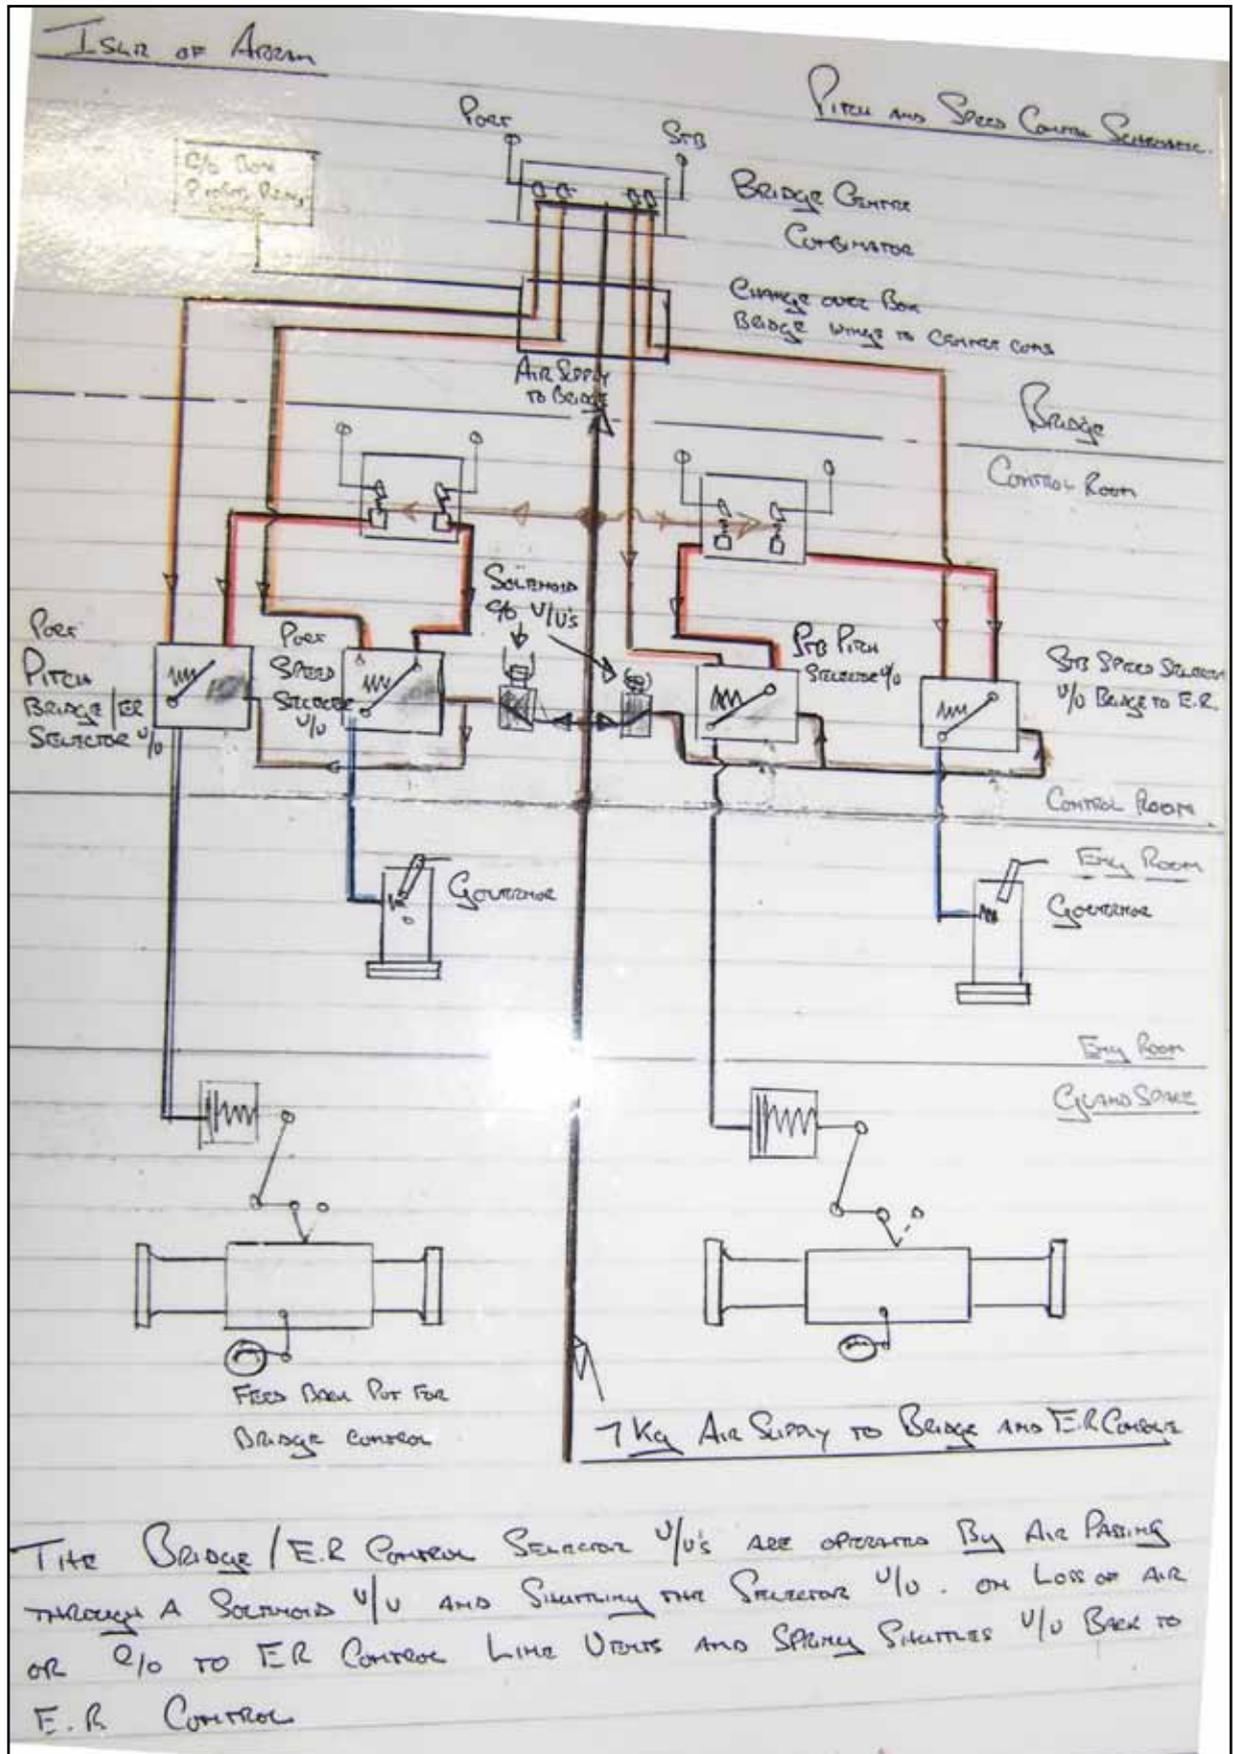
Vessel engineer's CPP system drawing
