Report on the investigation into  
the failure of the stores crane on the dredger

***Sand Falcon***

at West Thurrock, River Thames

**Report No 16/2010**  
**November 2010**

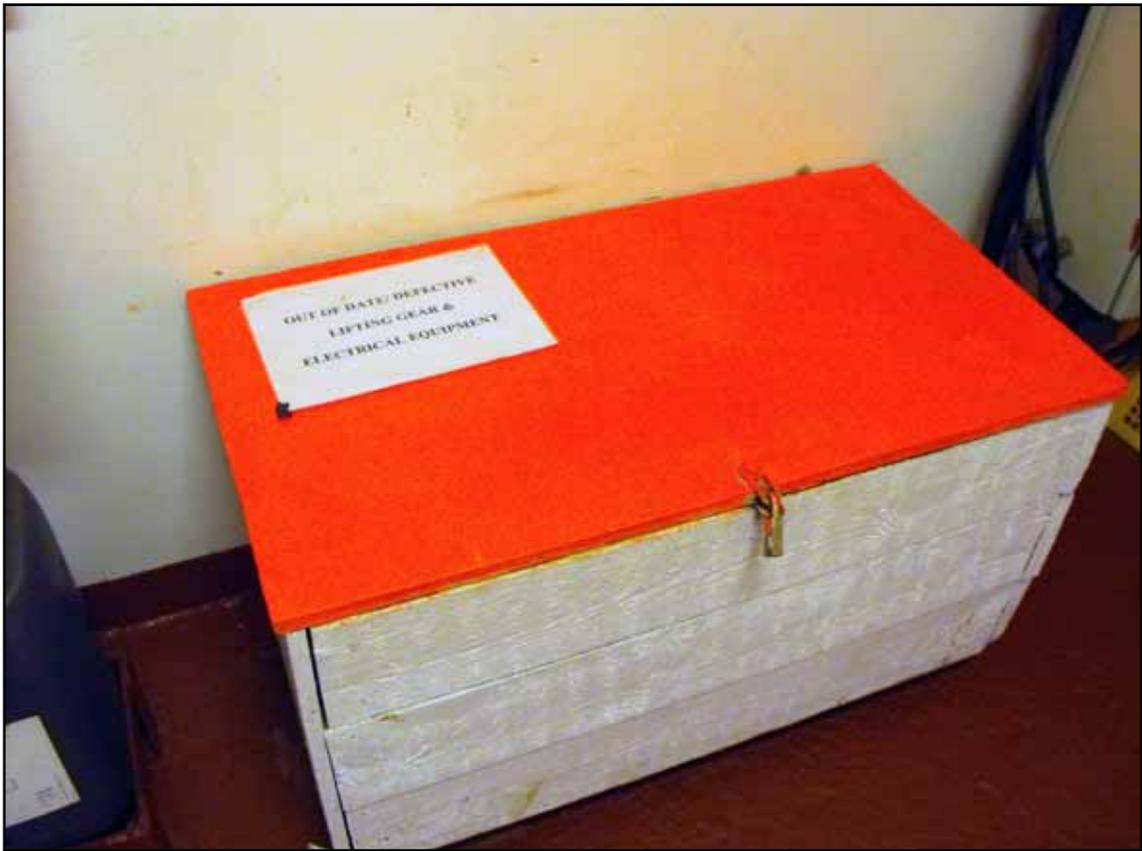
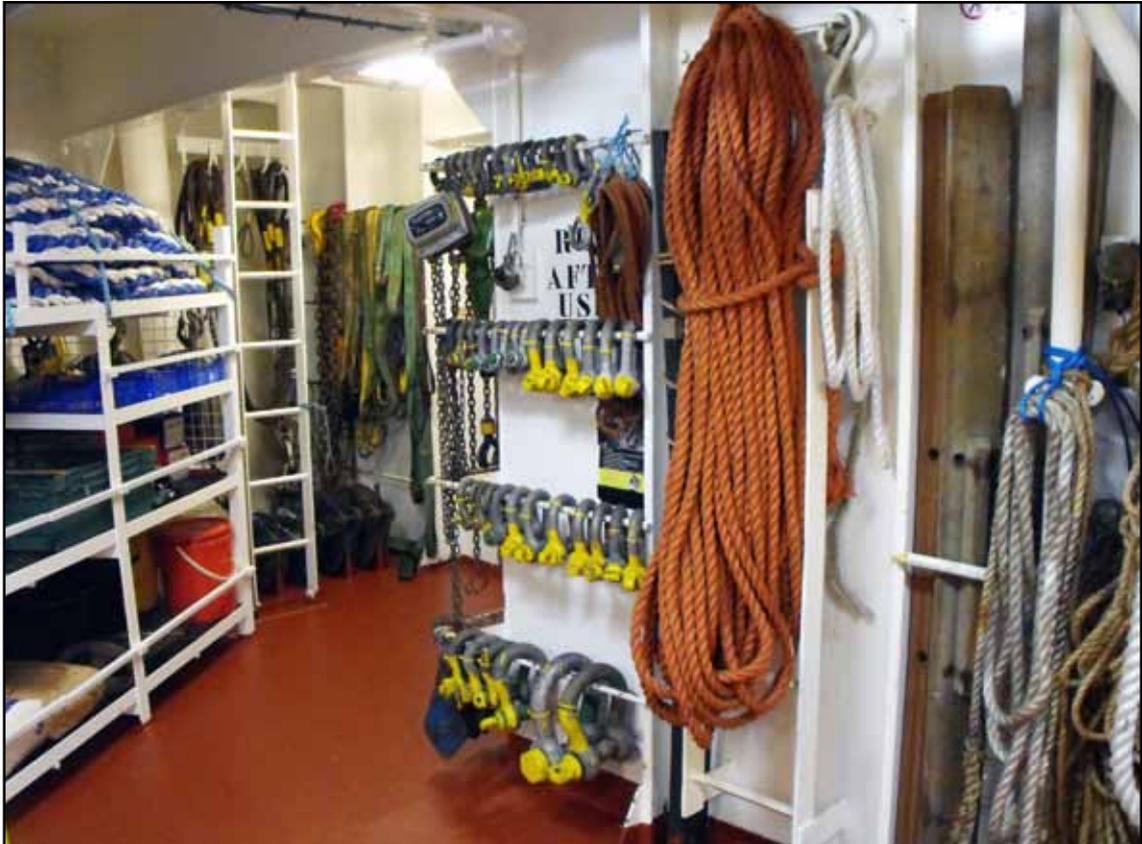
Figure 12a

CEMEX had arranged for a sub-contractor (a member of LEEA) to conduct annual inspections of loose lifting equipment, fixed lifting pad eyes and lifting points. The sub-contractor used a system of colour coded tags to show which equipment had been tested. All loose gear was seen to be well organised on board, including a quarantine store for items damaged in use (**Figures 12a & 12b**).

Loose gear stowage and quarantine arrangements

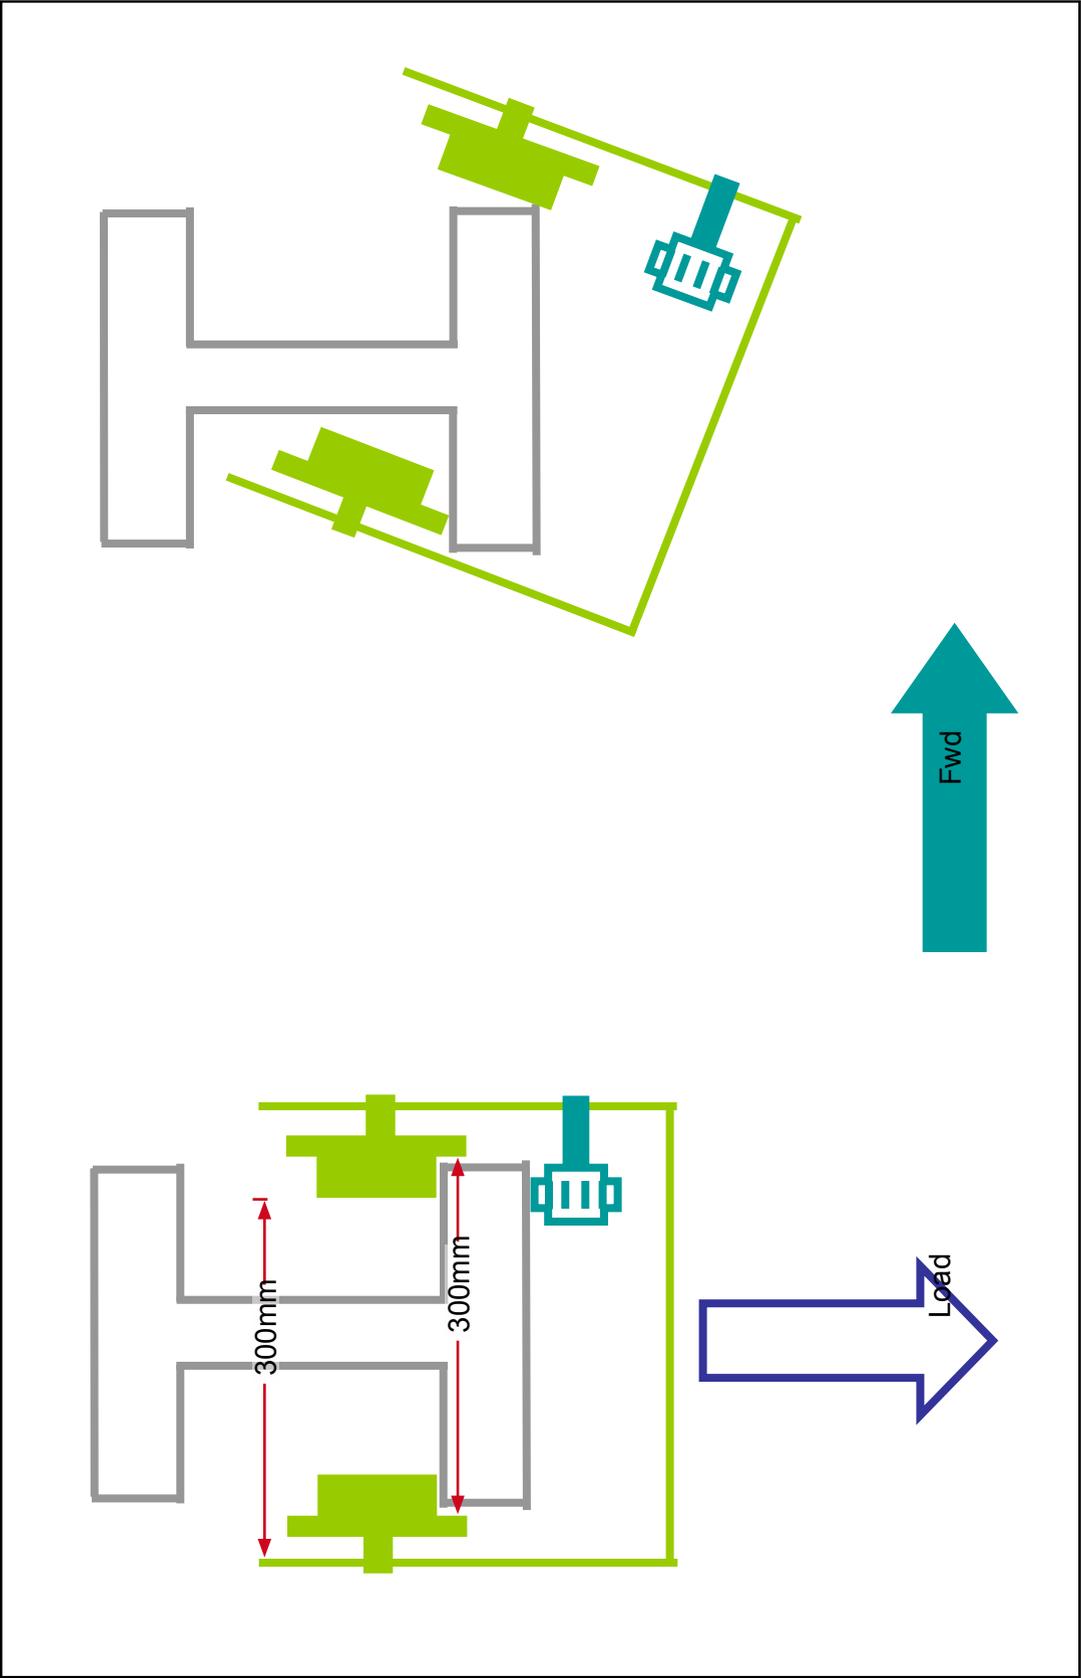
Figure 15

Once the wheels on one side of the trolley had climbed onto the lower flange of the I-beam, the dimensions of the trolley were such that the opposite wheels could drop off the other side of the beam (**Figure 15**). Thereafter, with no other means of restraint, the trolley became detached from the beam and fell.
