Report on the investigation of the collision between
the bulk carrier
Alam Pintar
and the fishing vessel
Etoile des Ondes
15 miles north of the Cherbourg peninsula
on 20 December 2009
resulting in one fatality
and the loss of the fishing vessel

Marine Accident Investigation Branch
Mountbatten House
Grosvenor Square
Southampton
United Kingdom
SO15 2JU

Report No 11/2010
September 2010

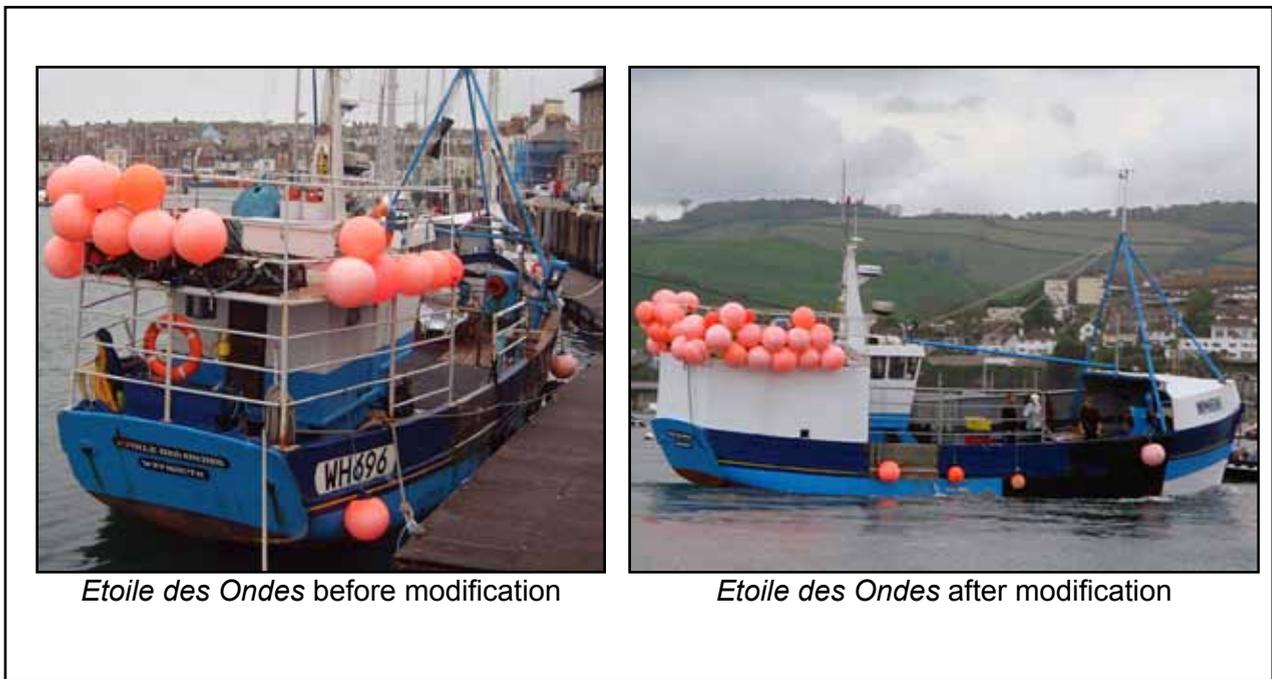
Figure 13

During *Etoile des Ondes*' last refit her bow and quarter areas had been enclosed with ply board sheets to provide shelter to the crew when on deck (**Figure 13**). These modifications restricted the view astern from the wheelhouse and it now required the lookout to make a positive effort to look astern. This area was also used to stow any spare fishing buoys that were not deployed.

A risk assessment should also be conducted whenever structural modifications to vessels are being planned. Although there were valid reasons for enclosing both the bow and stern areas of *Etoile des Ondes* (**Figure 13**), ie protection of the crew, they were made without considering the effect of the modification on the visibility from the wheelhouse. The ability to keep a good, all round lookout should be considered before undertaking any changes.

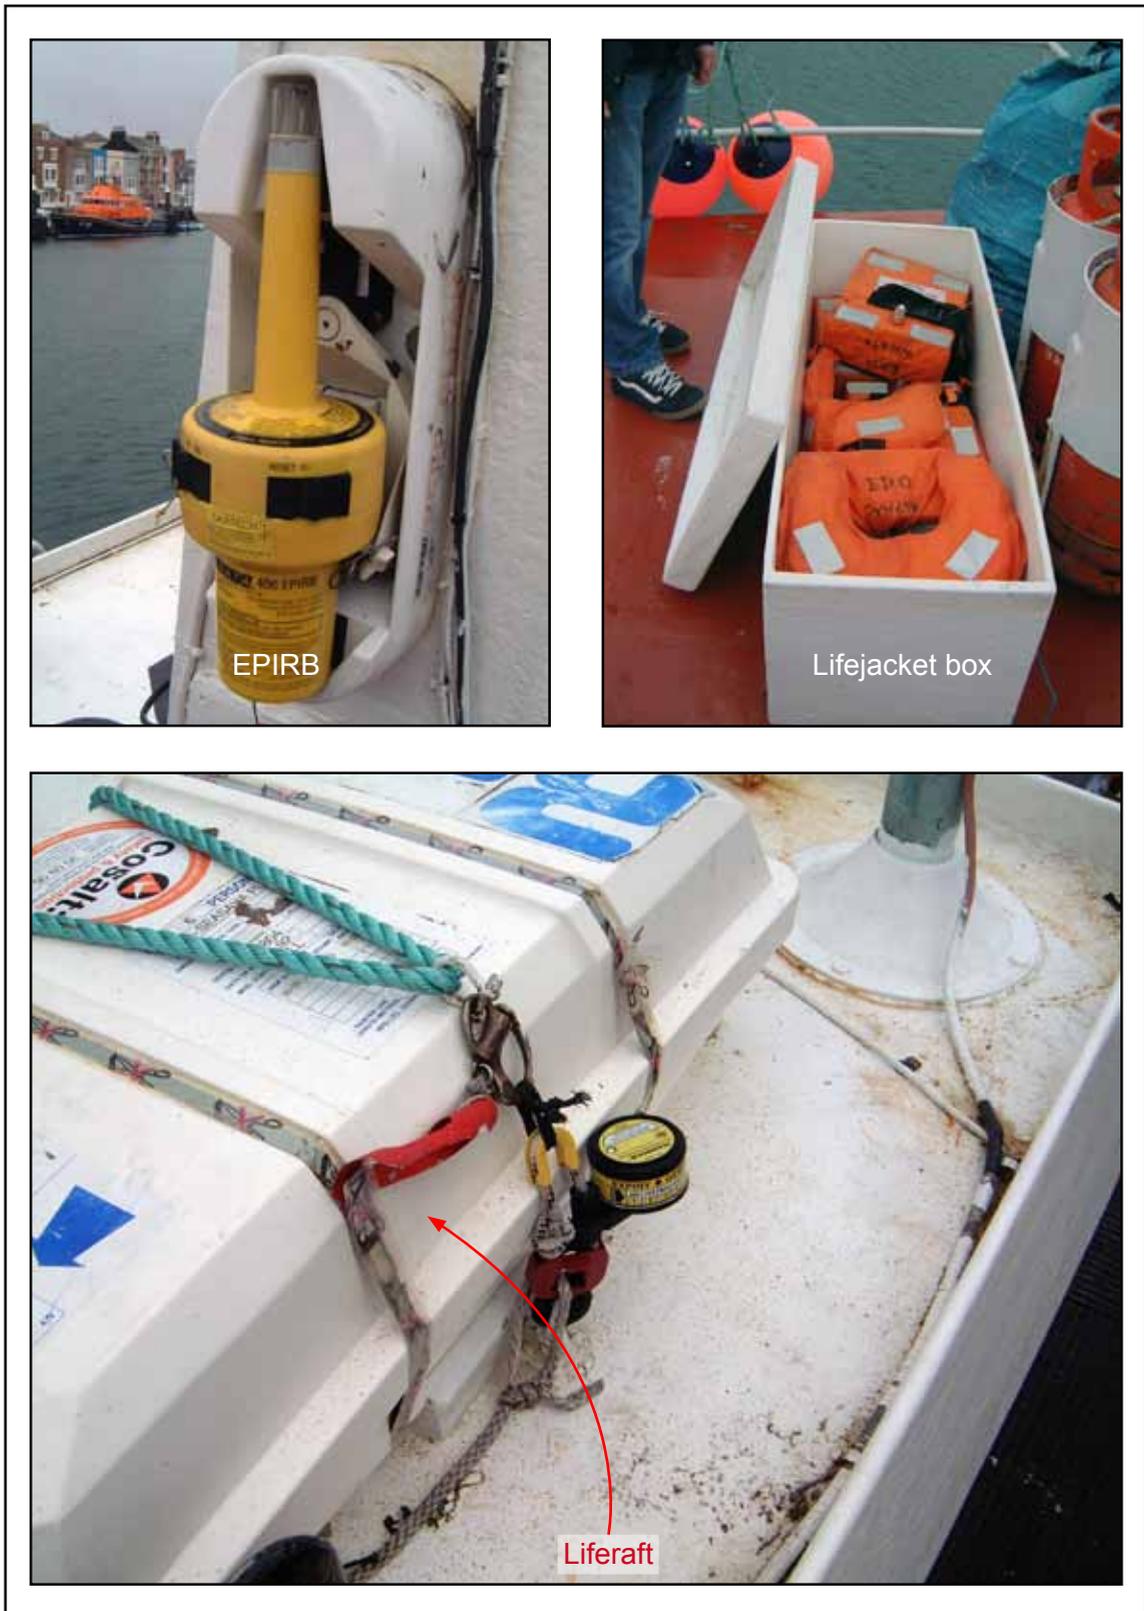
Etoile des Ondes' EPIRB, lifejacket box and liferaft
