Report on the investigation of
the uncontrolled descent of an
accommodation ladder from the container ship

Ever Elite

10 September 2009

Report No 8/2010
July 2010

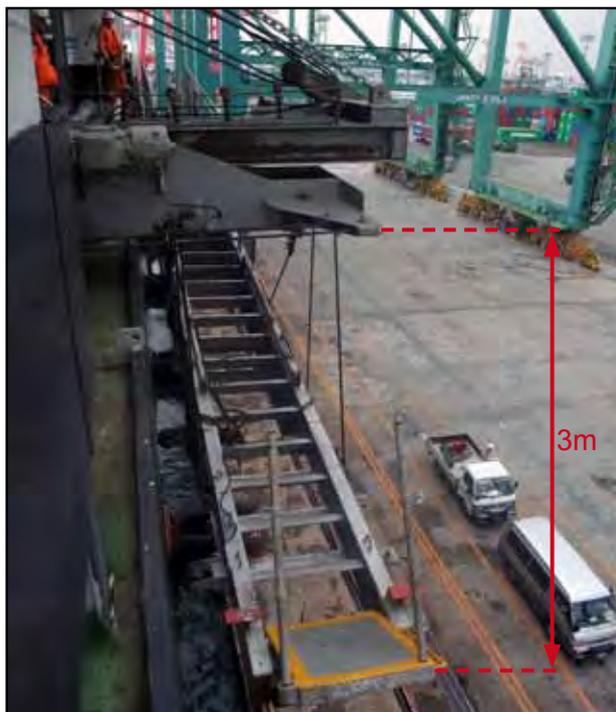
Figure 4

AB2 tested that the hoist winch was functioning by lowering the accommodation ladder approximately 1m and then slightly raising it. He then lowered it approximately 3m to allow his crewmate to walk under the davit frame (**Figure 4**). AB Huang stepped on to the upper platform and proceeded to the lower end where he rigged a section of collapsible handrails (**Figure 5**). He then went to the lower platform to make the rails secure while AB2 secured the safety ropes around the upper platform.

Accommodation ladder preparation

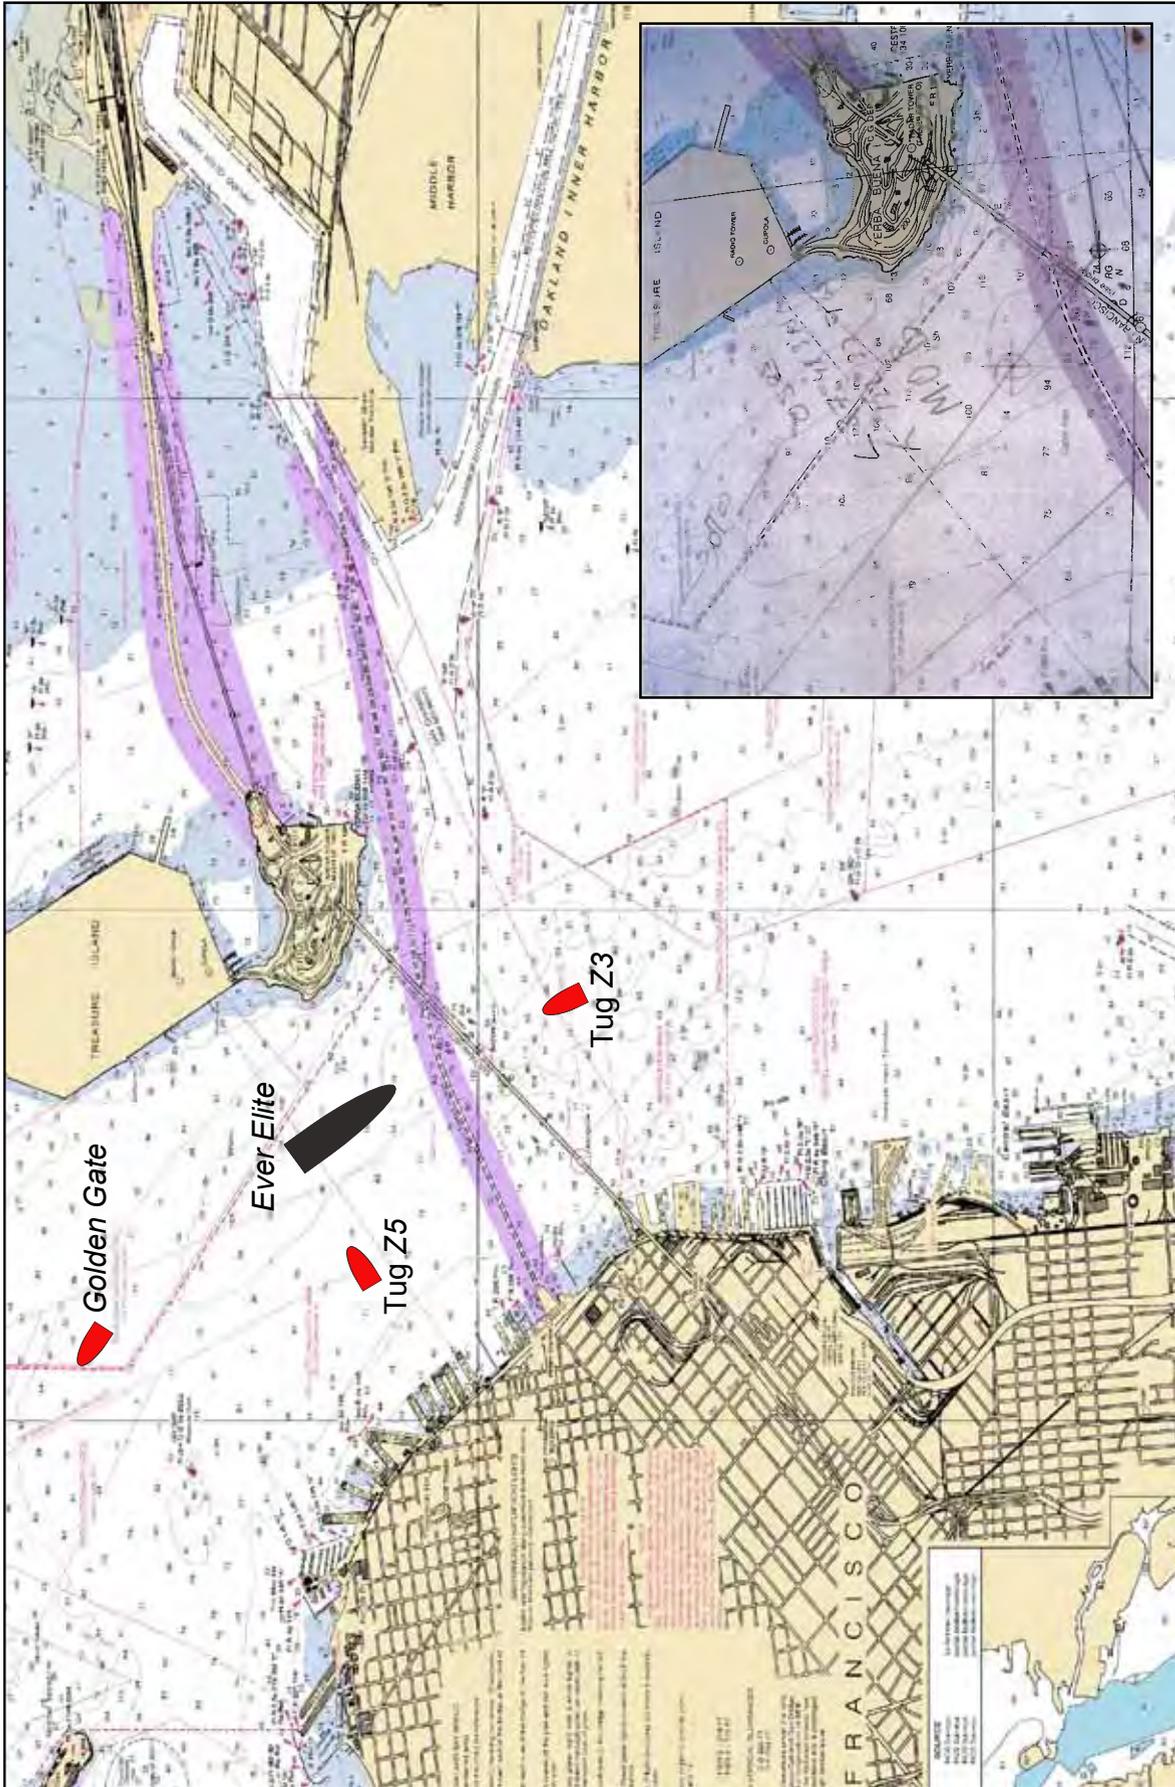
The ship was a quarter of a mile from the Oakland Bay Bridge. Her engine was set at half ahead and she was making between 5 and 6 knots through the water. The trainee pilot had the con and had committed the vessel to pass under the bridge. Two tugs were standing by: Z5 was positioned north of the bridge ready to take a line and Z3 was stationed to the south (**Figure 7**).

The pilot instructed the trainee pilot to continue conning the ship and released Z5 to help look for AB Huang. He also instructed the vessel traffic service to record the ship's position and requested the pilot boat *Golden Gate* be made available to assist. The deck cadet marked the position of the man overboard on the ship's paper chart (**Figure 7**).

Position of vessel at 05:05 when the man overboard alarm was raised

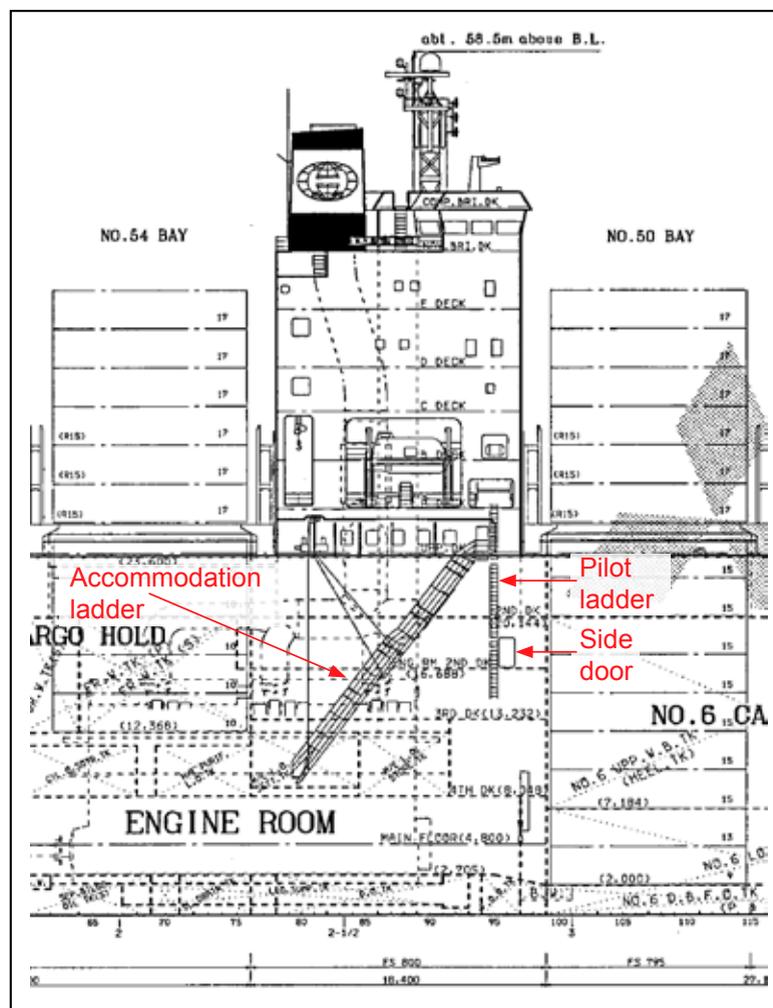
Figure 8

The telescopic ladder, its davit and its winches were built as a single modular unit which was stowed on its side on the upper deck between frames 78 and 95 (**Figure 8**). The unit was made of steel and weighed 5,450kg; it was designed to enable the ladder to be un-stowed, lowered to the quay, raised and re-stowed without the need for crew members to step onto the ladder while it was suspended from its hoisting gear.

Location of the accommodation ladder, pilot ladder and side door

Ever Elite was fitted with a side access door and fixed pilot ladder system on both her port and starboard sides at frame 95 (**Figure 8**). When rigged, the pilot ladder rested on the ship's hull just aft of the side access doors located on the 2nd deck. The distance from the waterline to the side access door was less than 9m.

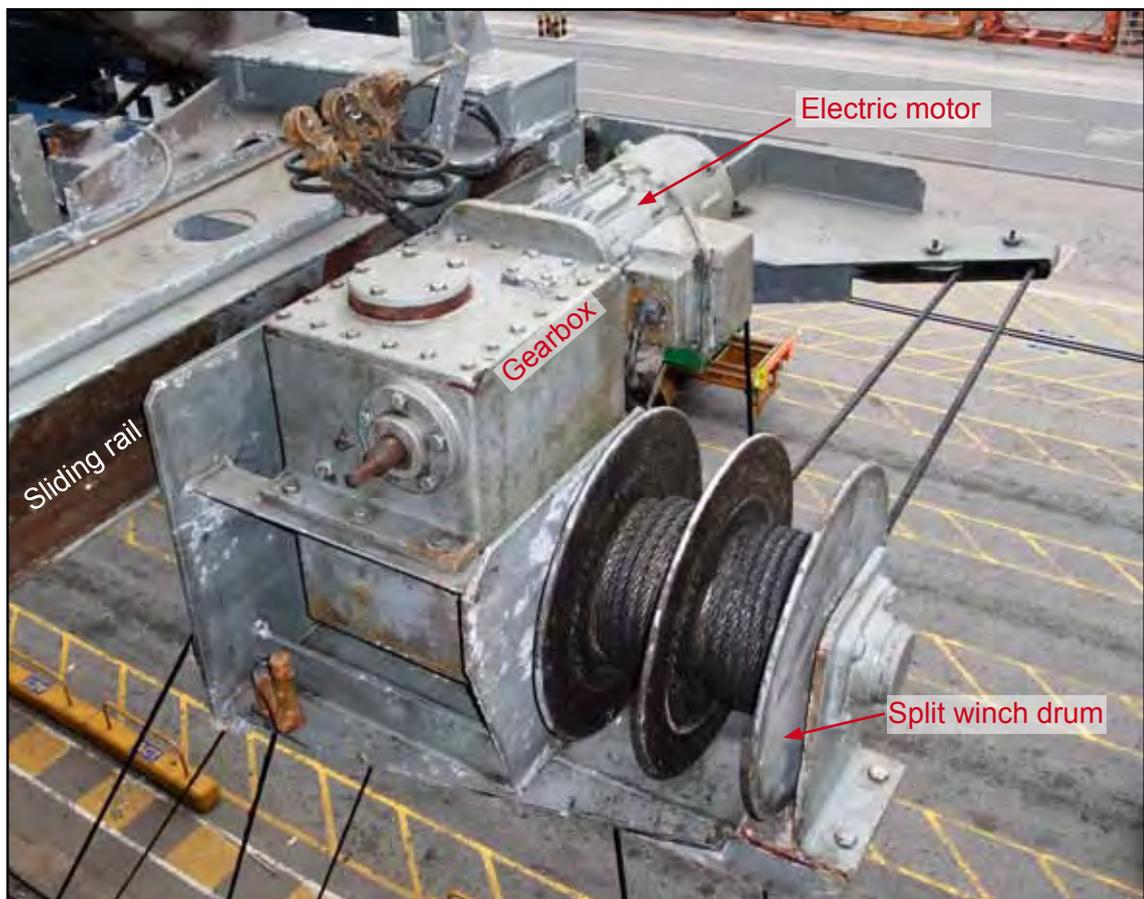
Figure 11

The hoist winch had a maximum drum load rating of approximately 970kg. Its split drum was driven by a 3.7kW electric motor via a two chamber reduction gearbox (**Figure 11**).

Hoist winch

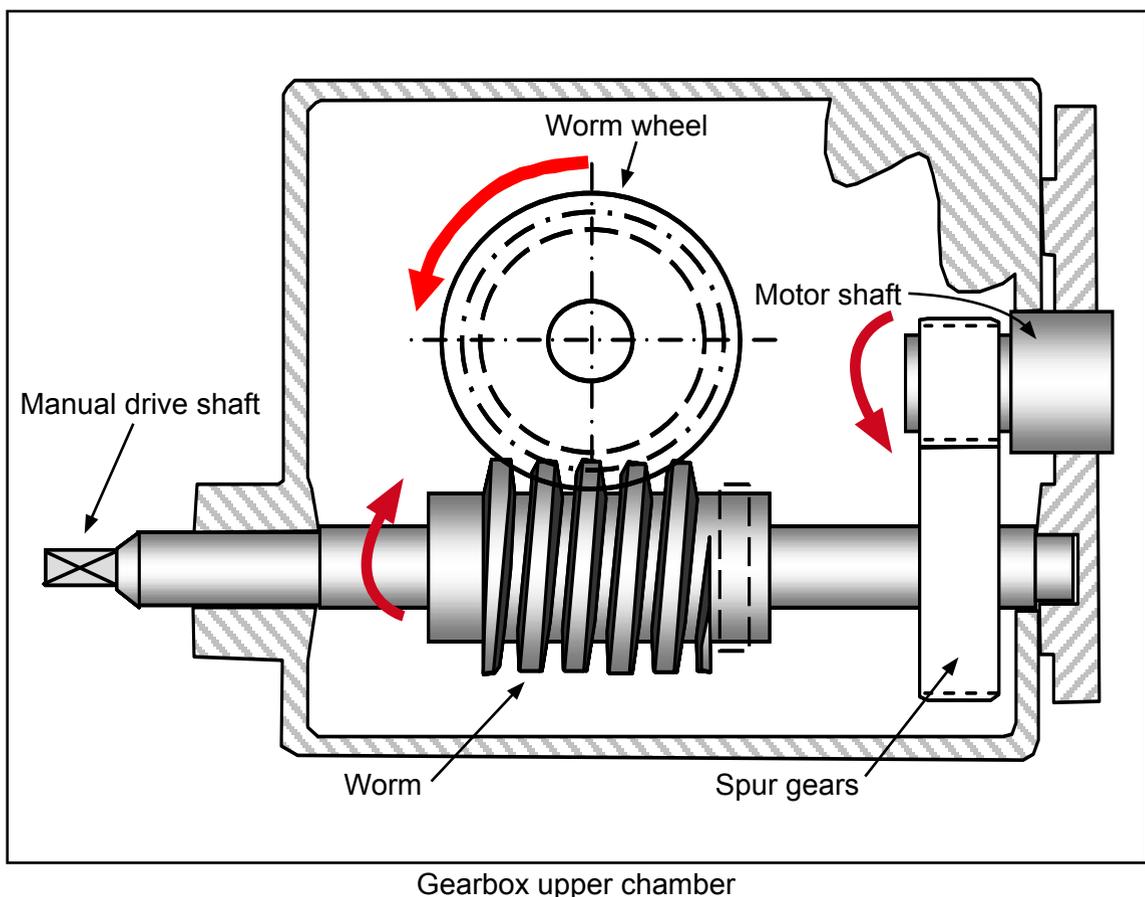
Figure 12

The motor was coupled to the upper chamber of the gearbox and drove a horizontal worm gear shaft via a set of spur gears (**Figure 12**). The worm meshed with a gear wheel to drive a vertical bevel gear shaft. This vertical shaft passed through the intermediate bearing housing into the lower chamber of the gearbox (**Figure 13**). Here, its spiral bevel gear teeth meshed with those on the external casing of the differential gear unit. The differential gear unit, supported horizontally between two bearing housings, drove the split winch drum.

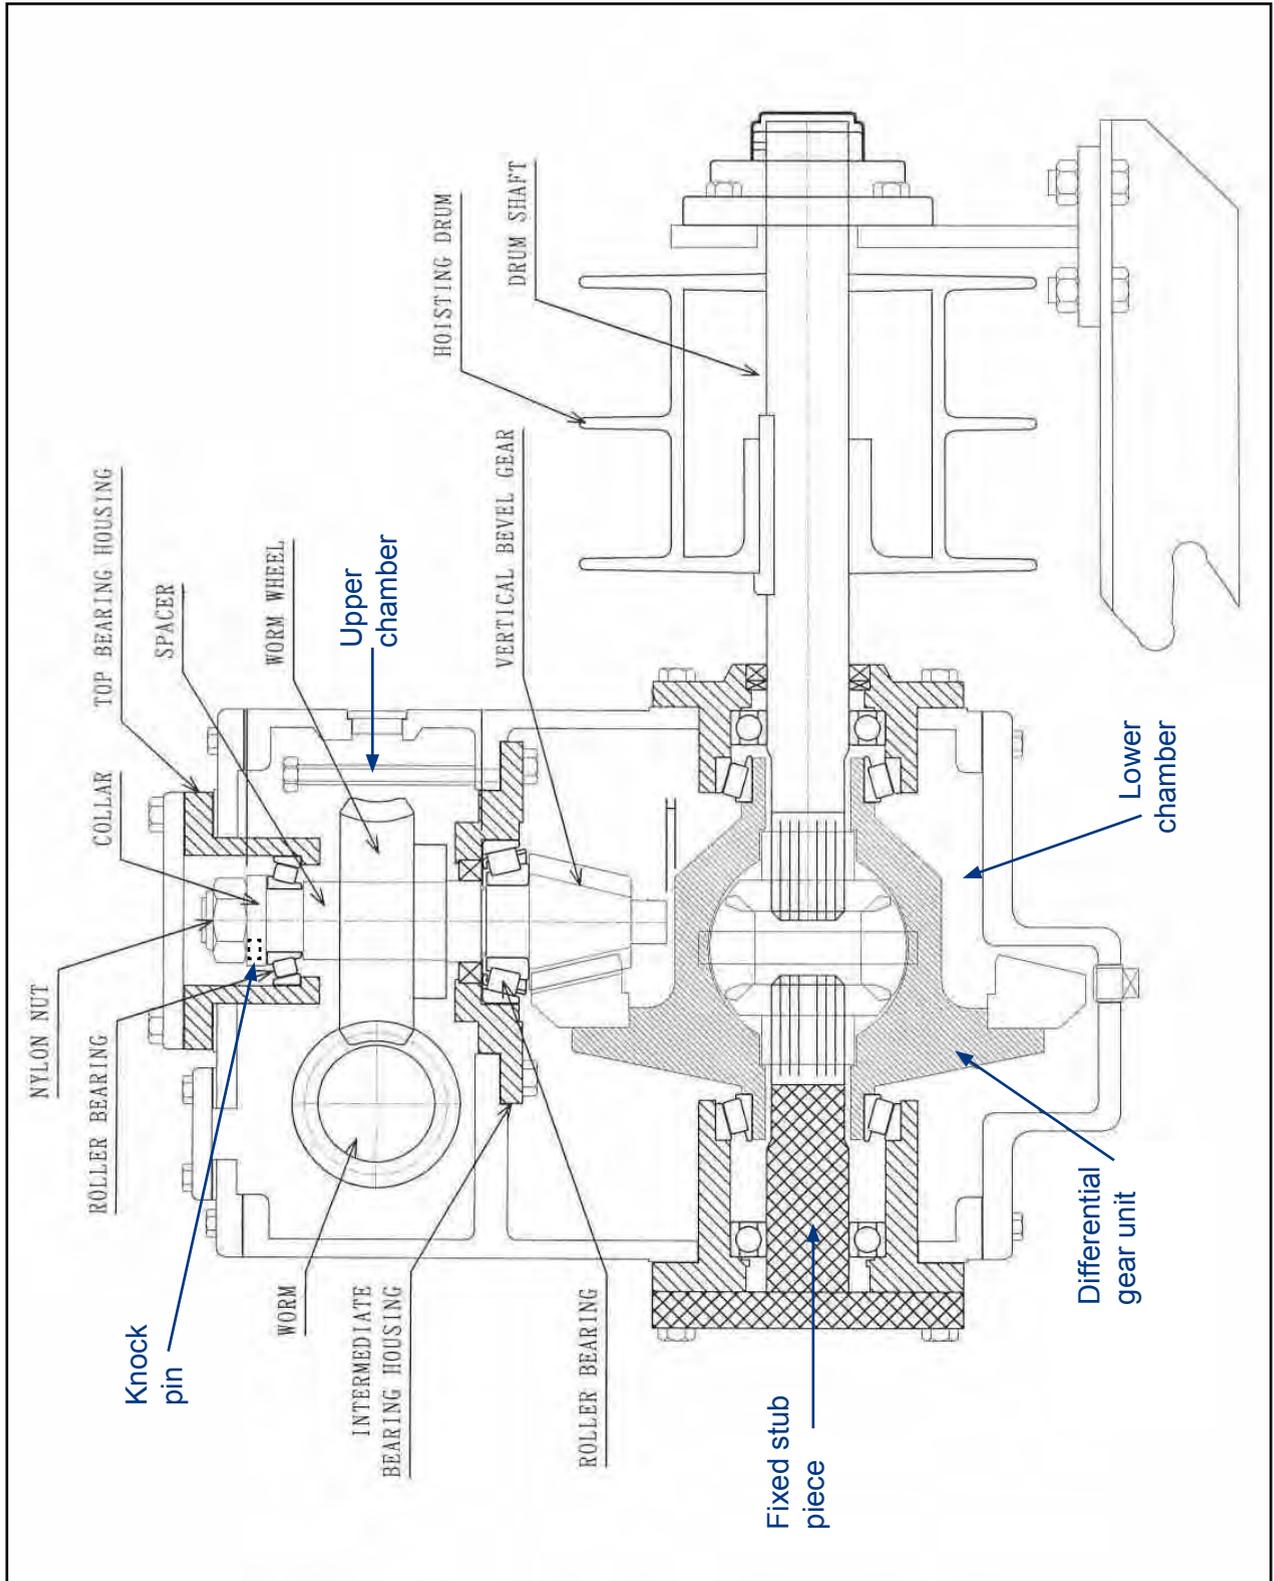
Figure 13

Exploded view of hoist winch gearbox

Nakano found evidence indicating that, prior to the failure, the vertical bevel gear shaft had dropped or was positioned at least 3mm lower than designed. It concluded that the failure of the intermediate bearing was probably the result of contact between its inner roller race and the teeth of the differential gear unit. The report identified two possible reasons why the shaft might have assumed this position: foreign body intrusion or the use of unauthorised parts.

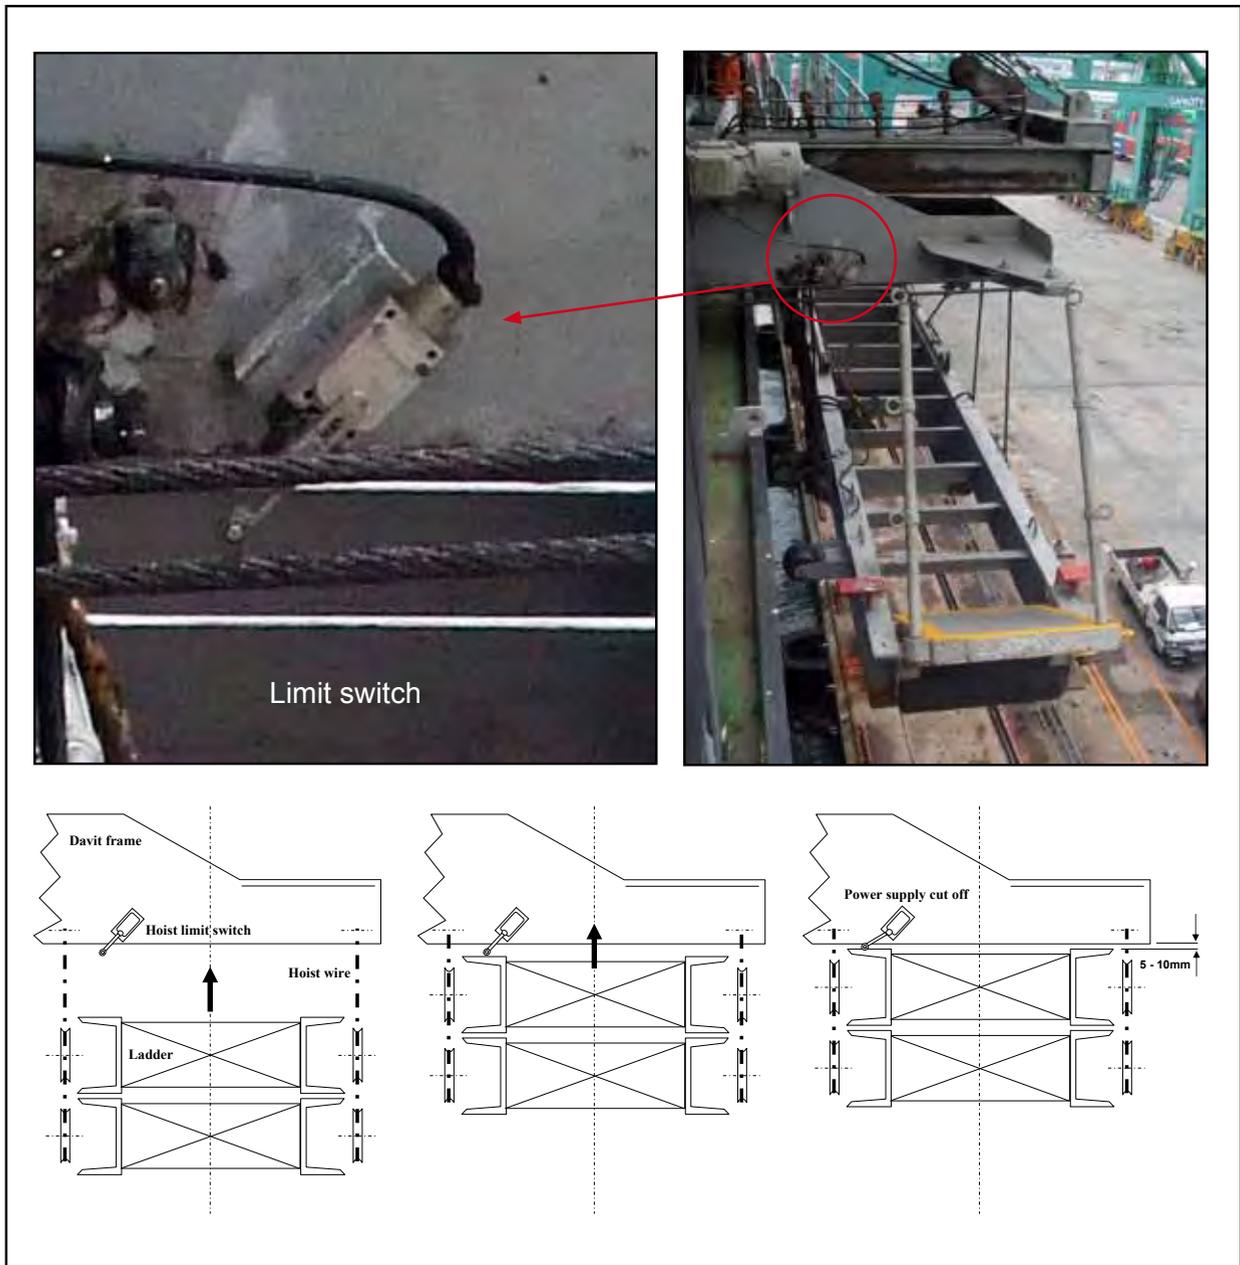
Figure 14

A limit switch was fitted to the underside of the davit frame to cut off the power supply to the hoist winch motor once the telescopic ladder reached its upper position (**Figure 14**). The limit switch was intended to provide a 5 to 10mm gap between the ladder and the underside of the davit frame. An overload current cut-off relay was also fitted in the electrical control circuit to protect the winch gearbox in case the limit switch failed or was incorrectly adjusted.

While observing the recovery of the starboard accommodation ladder, it was noted that contact was taking place between the ladder and the underside of the davit frame.

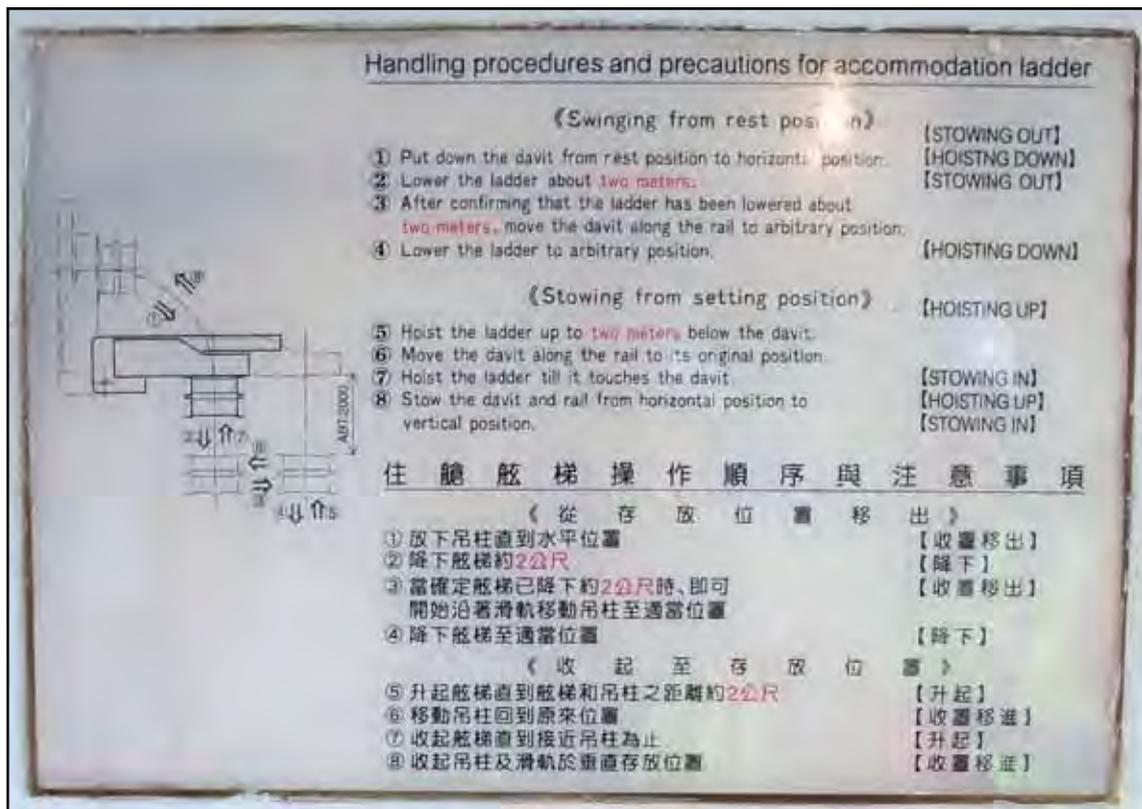
The handling procedure and the precautions to be taken detailed in the maker's manual were posted on the upper deck next to the accommodation ladders (**Figure 21**). The procedure explained how to operate the winches but it did not describe how to deploy, rig and recover the equipment.

Accommodation ladder procedure posted on the upper deck

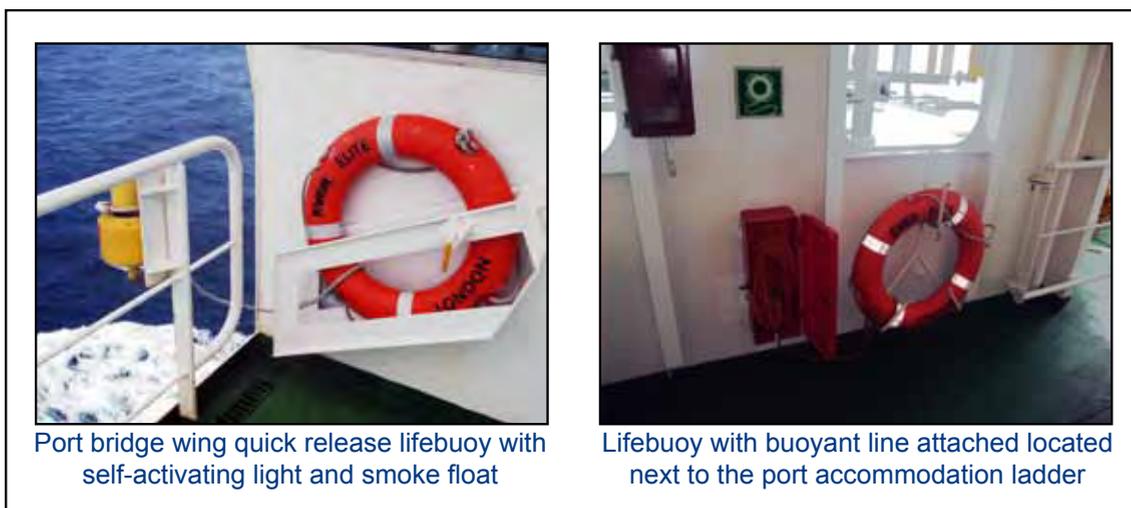
Figure 23

Ever Elite had 14 lifebuoys. These included two quick release lifebuoys with self-activating light and smoke signals which were sited on each bridge wing (**Figure 23**). The UK's Merchant Shipping (Means of Access) Regulations 1988 require a lifebuoy with a self-activating light and a separate safety line attached to a quoit or some similar device to be provided ready for use at the point of access on board the ship. The lifebuoy picked up by AB2 was located adjacent to the port accommodation ladder stowage position; it was attached to a buoyant safety line and was not fitted with a self-activating light.

Lifebuoys provided on board *Ever Elite*
