Report on the investigation of  
the capsizing of the fishing vessel

***Aquila***

with the loss of three lives  
Bo Faskadale Reef, Ardnamurchan  
on 20 July 2009

**Report No 5/2010**  
**April 2010**

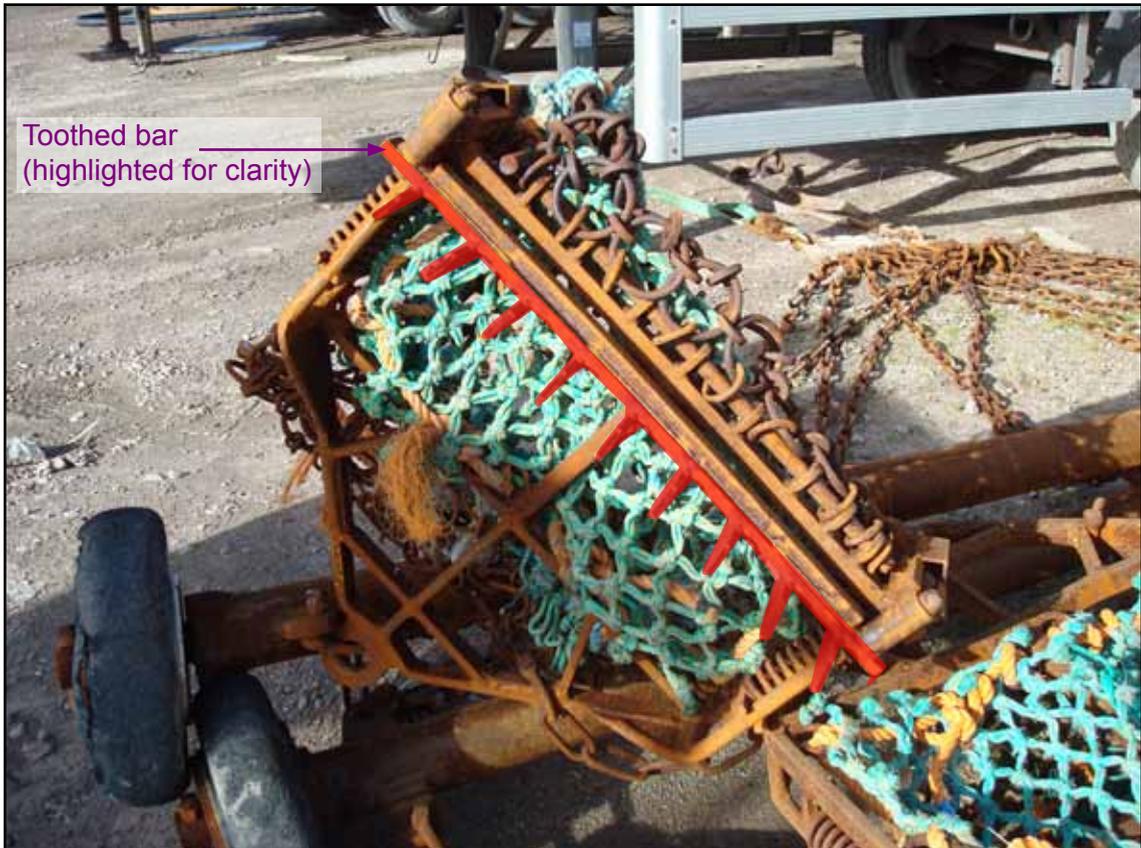
Dredge bag from *Aquila*, showing toothed bars

*Aquila* dredged for scallops by towing two wire warps, one from each side, attached to which were steel spreader bars which each held seven dredges (**Figure 9**). The dredges consisted of a frame with a toothed bar at the front, to dig the scallops out of the seabed, with a collecting bag behind it. The bag was made of chain links forming a chain mesh on the bottom with netting on the top (**Figure 3**).

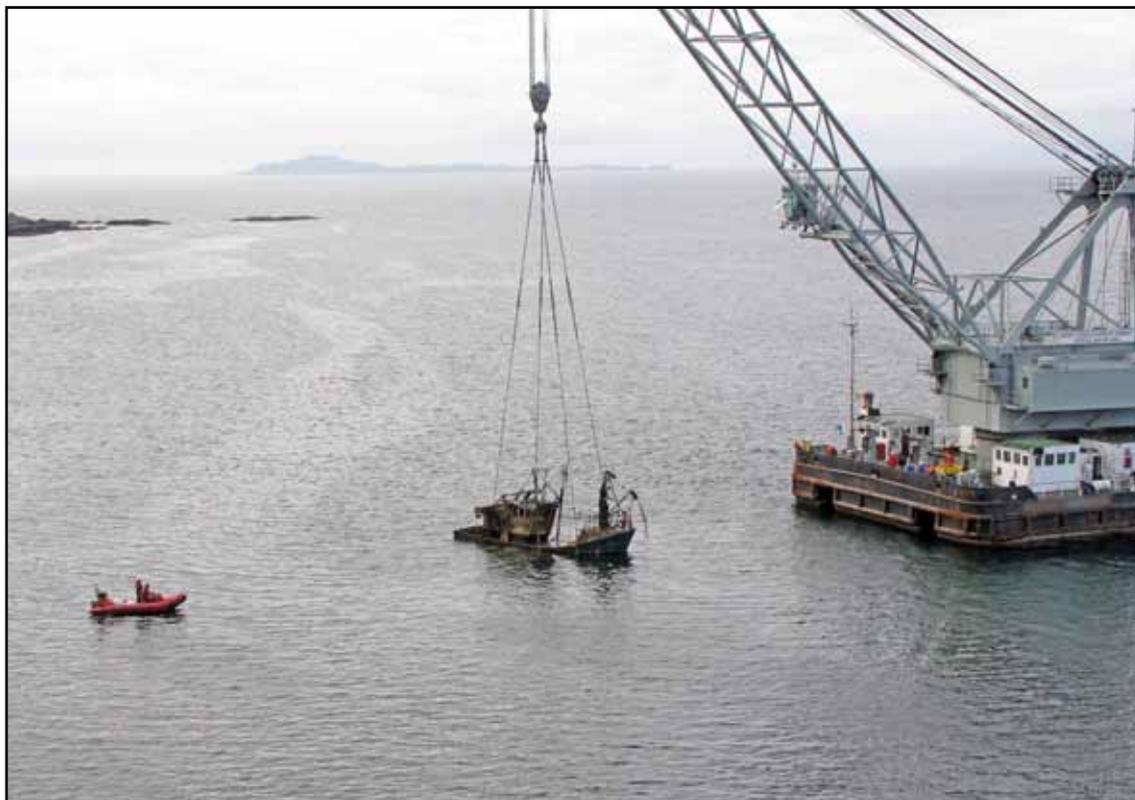
*Aquila* after salvage

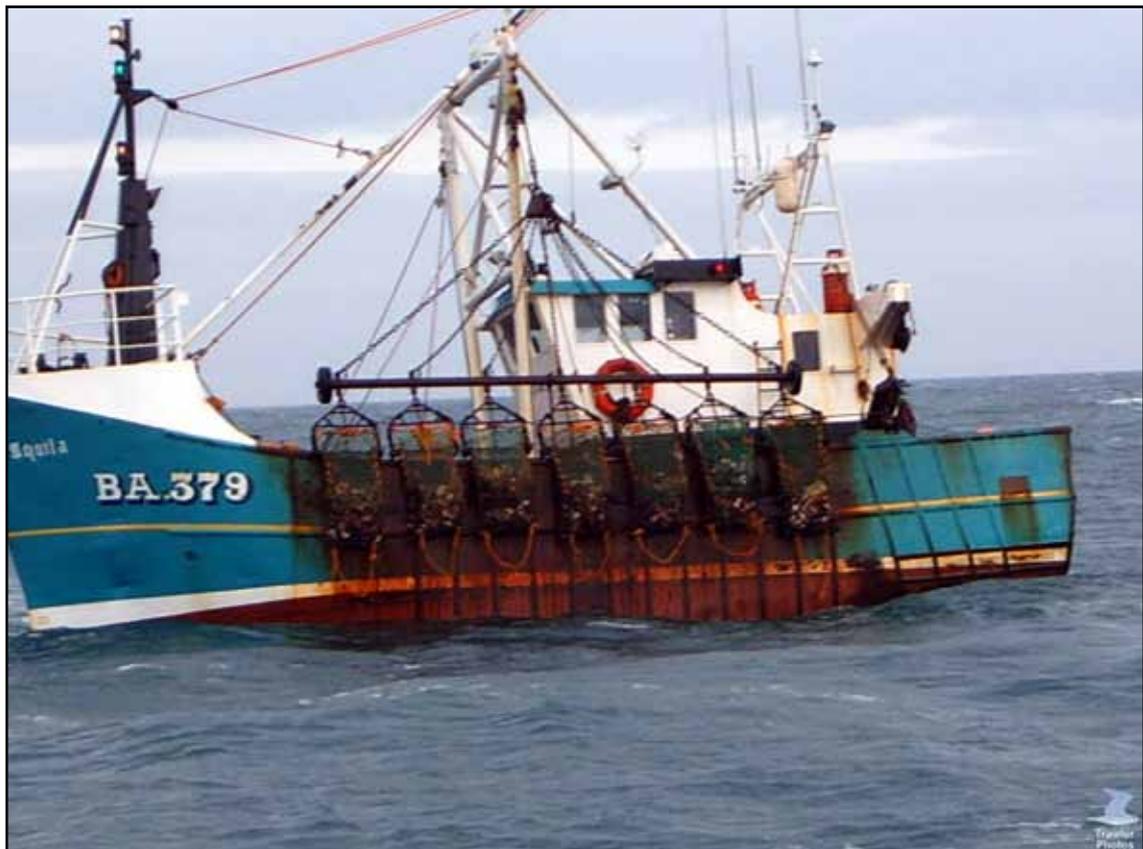
Figure 9

*Aquila's* seven dredges

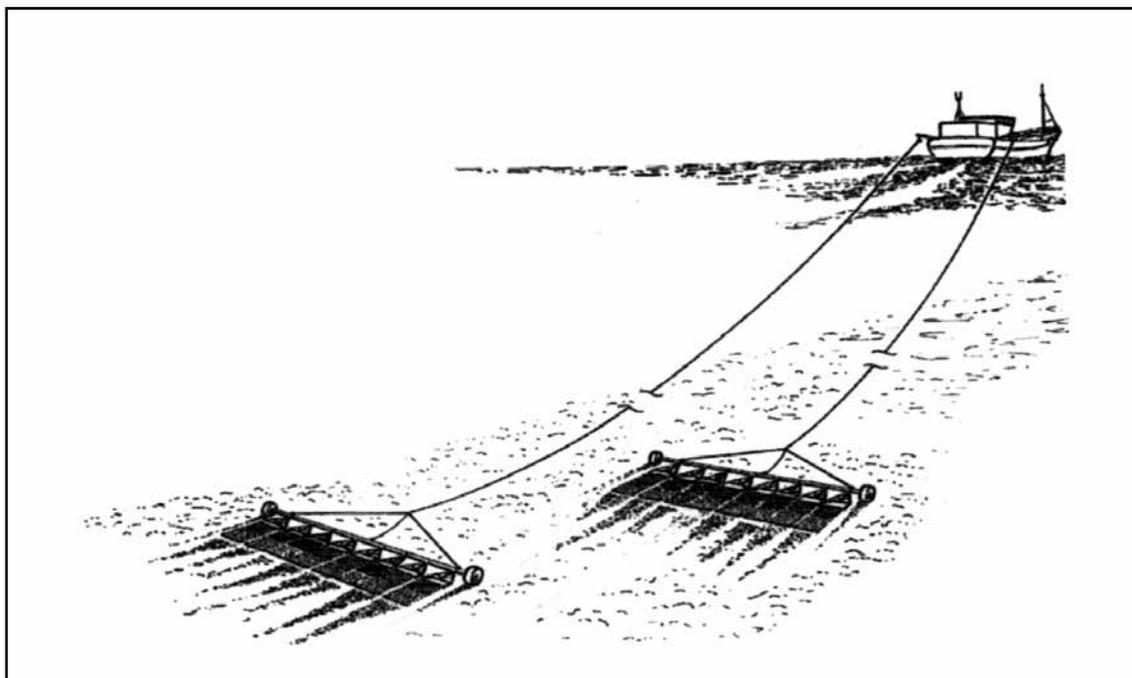
The dredges were towed astern of the vessel by two warps, which were set at differing lengths to avoid the steel bars fouling each other as they were dredged across the seabed (**Figure 10**). On *Aquila*, at the time of the accident, the starboard warp was set to be 20m longer than the port warp.

Drawing of scallop dredges
