Report on the investigation of
the grounding at high speed of the RIB

Sooty

Calve Island, Isle of Mull

**Report No 22/2009
October 2009**

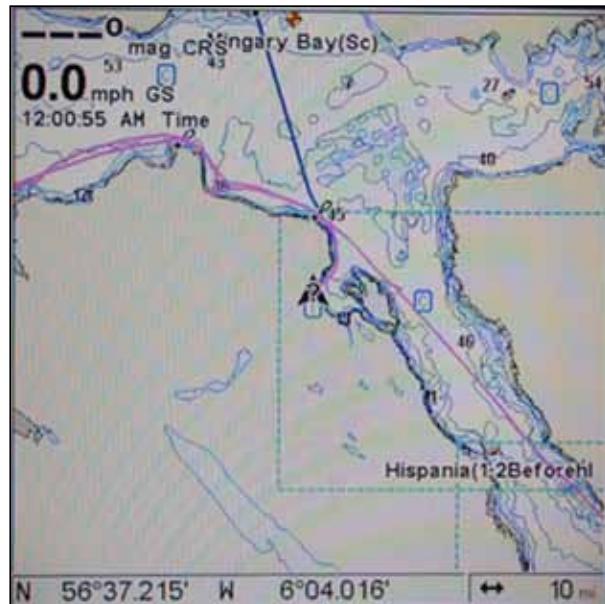
Figure 2

Passage was made from the north of Mull by following historic trails displayed on a mapping GPS¹ (**Figure 2**). In the vicinity of Tobermory Bay, course was adjusted to pass close to the north shore and the speed was reduced when passing the local RNLI station. By the time *Sooty* passed the buoys marking the designated fairway for local fishing vessels, speed had been reduced to about 10 knots. Half way along the fairway, course was altered to port and *Sooty* navigated through a number of craft secured to swinging moorings (**Figure 3**).

Historical track from GPS mapper 18 May 2009

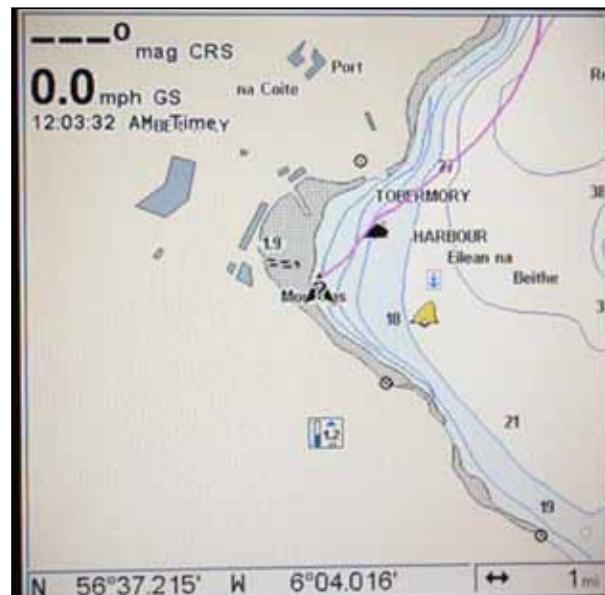
Figure 3

Entry into Tobermory 18 May 2009

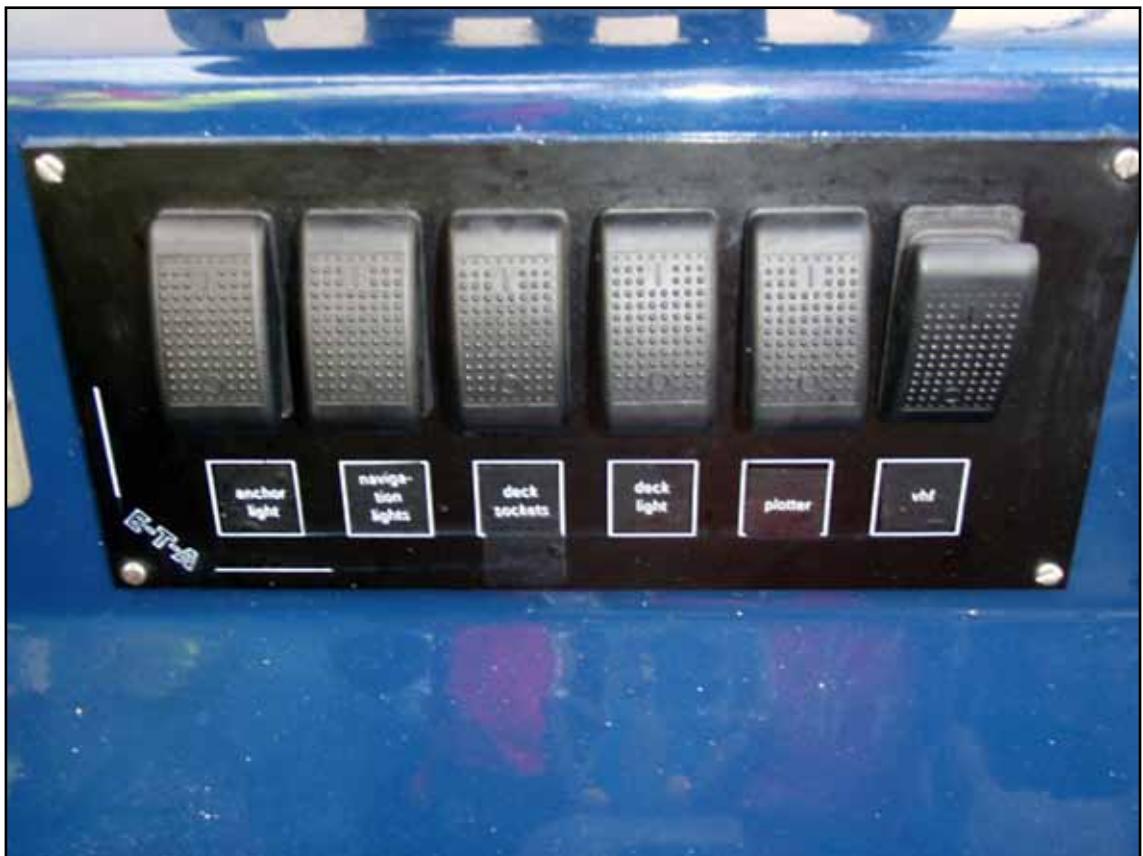
Figure 4

On their return to *Sooty*, the crew tidied loose diving equipment while the coxswain started the engine and switched on all six rocker switches (**Figure 4**) that supplied power to a deck socket, an all round white navigation light, sidelights, deck floodlight, mapping GPS and the VHF. It was reported that the coxswain then switched on the mapping GPS at the display unit and secured the engine kill-cord around his left leg.

Position of rocker switches

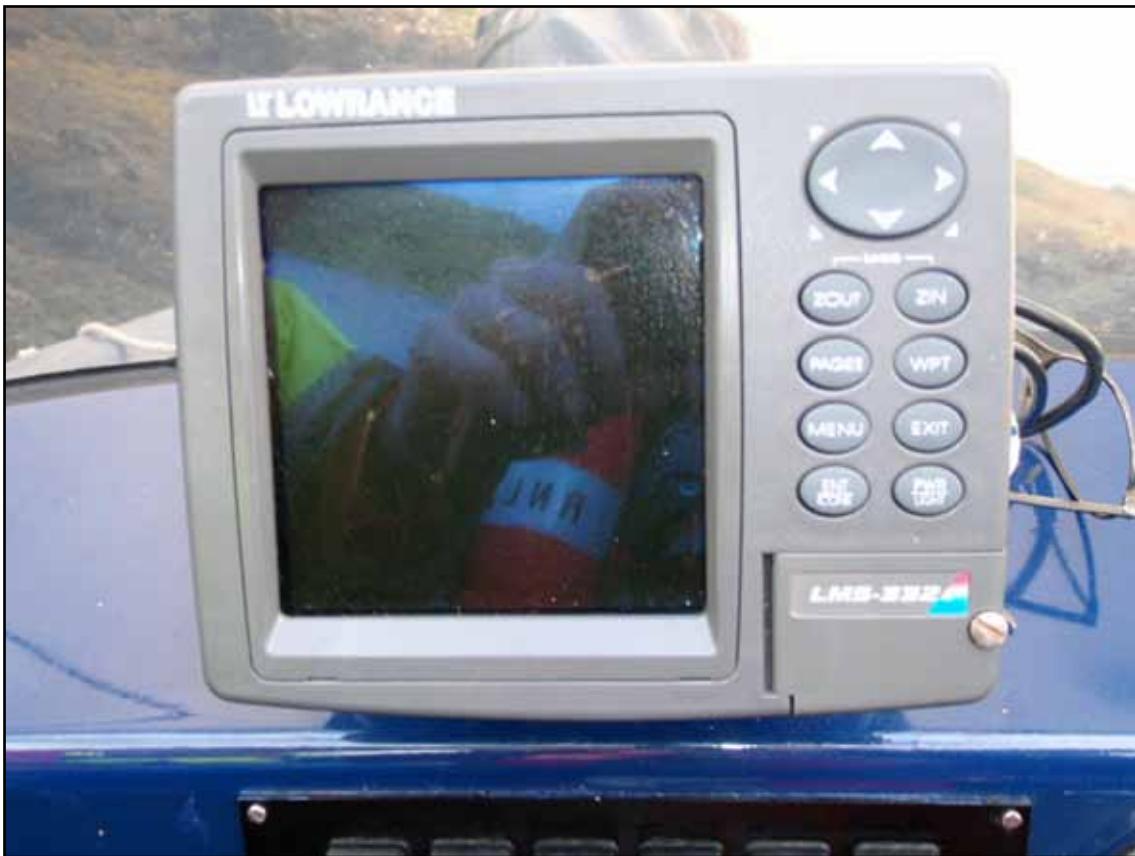
Figure 15

The Lowrance LMS 332 fish finding sonar and mapping GPS (**Figure 15**) was removed from the craft for detailed examination. Initial inspection revealed that the unit had a facility for creating and saving an historic trail. A trail is a record of the path that the unit has taken, and can be useful for repeating a journey along the same track. It was set to the factory default, allowing 2000 trail points to be saved automatically whenever the unit was switched on and data available. When the 2000th trial point was reached, the unit recorded back

Lowrance GPS unit removed from *Sooty*

over the first trail point. The default automatic setting creates a trail by placing a trail point every time the unit changes direction. It was not possible to recover speed, course and time data from individual track points.

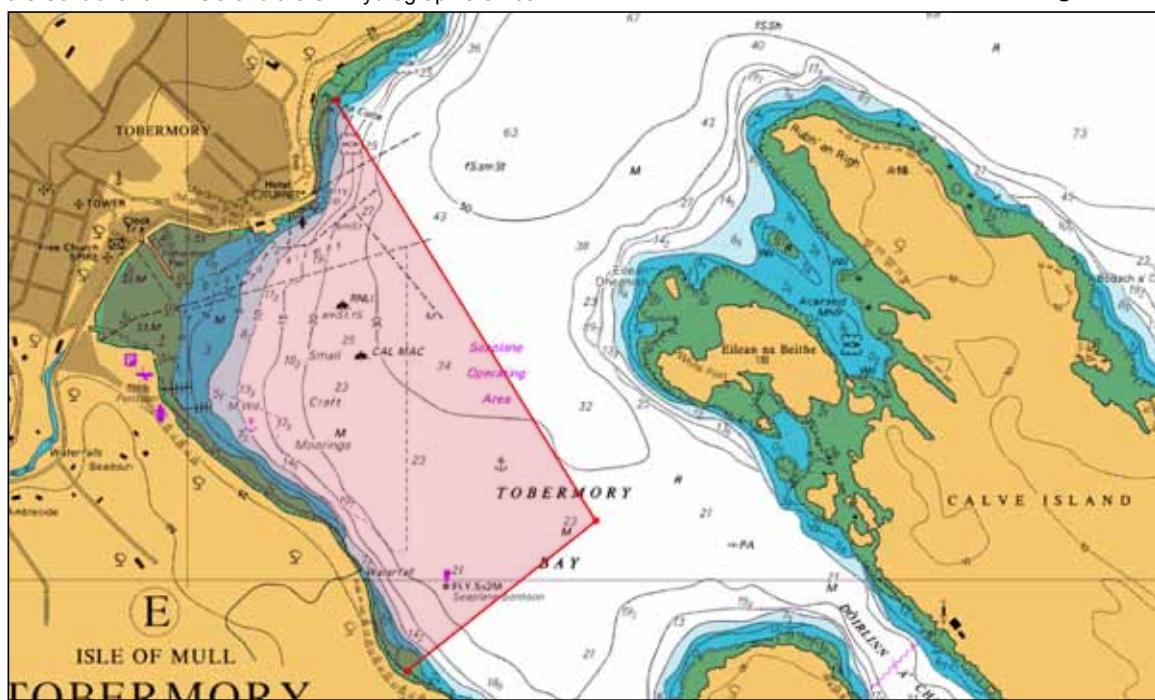
Figure 16

Control of the town's three piers is exercised independently by the RNLI, Caledonian Maritime Assets Limited (CMAL) and the Fisherman's Association. The THA limits were defined by the Crown Estate and are shown in **Figure 16**. This accident occurred 4 cables outside the THA area of jurisdiction.

THA limits of jurisdiction
