Report on the investigation of the release of cargo vapours
resulting in two casualties on board the chemical tanker

Jo Eik

6 May 2009

**Report No 24/2009
November 2009**

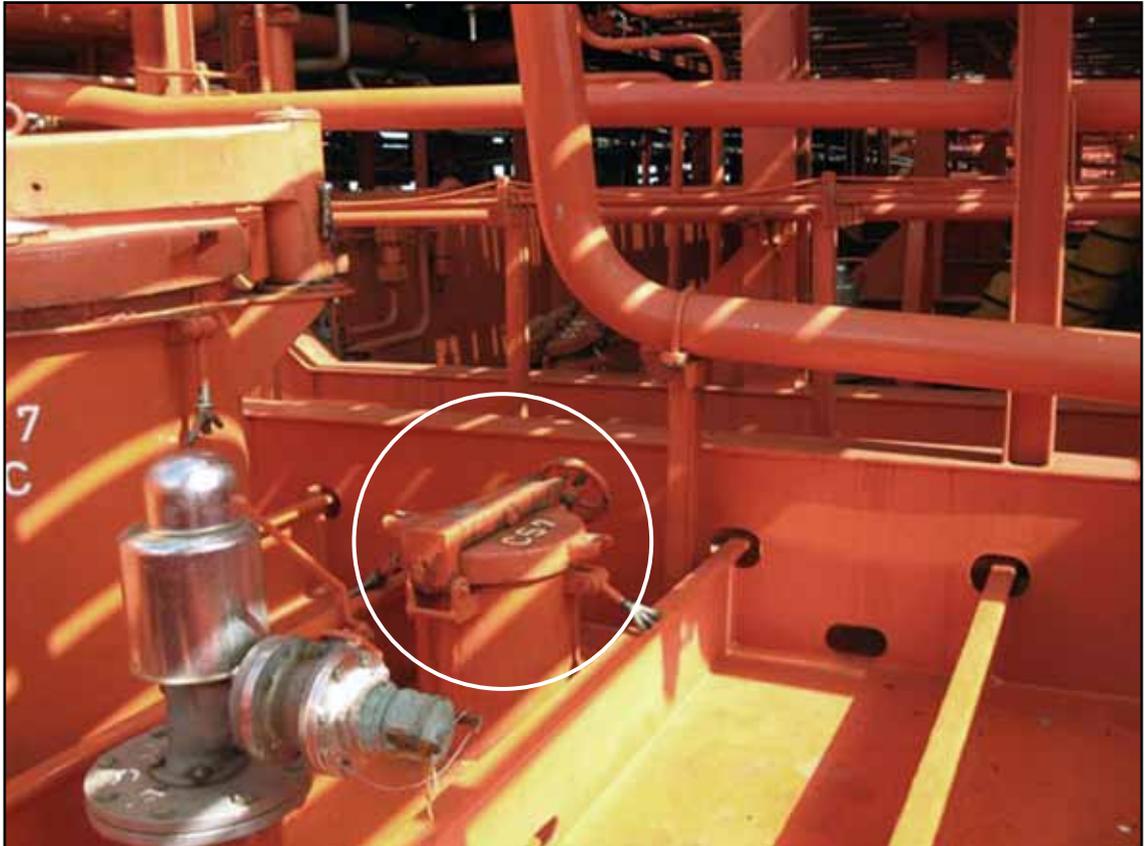
At 1500 the Intertek OCA surveyor and the Vopak loading master met with the chief officer. The surveyor was accompanied by an AB from *Jo Eik*, who opened up the Butterworth hatches of cargo tanks P6 and S6 for Sylfat cargo sampling. He then took samples of the CST from cargo tanks CS6, CS7 (**Figure 3**) and P10. During sampling the surveyor wore his full face respirator. The AB wore no respiratory protection.

Cargo tank CS7 Butterworth hatch

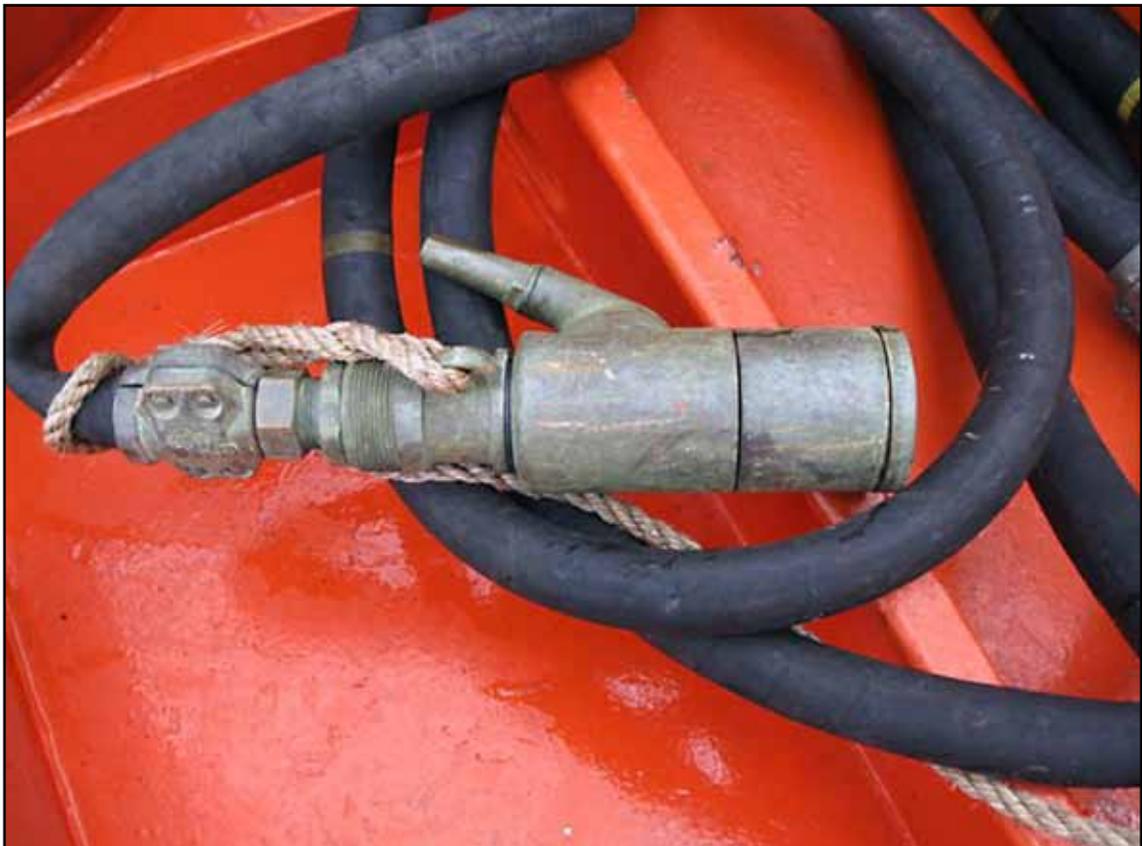
Figure 12

There were 12, Cloud 700, portable tank washing machines also carried on board (**Figure 12**). The machines were fitted with 9.5mm nozzles that also discharged 21 m³/hr of washing medium at 10 bar. The machines and hoses were lowered through the Butterworth hatches using a natural fibre rope, and progressively secured at a number of pre-determined levels to ensure complete cleaning.

Once the washer was secured, with the weight of the machine supported by the hose, the hose was often reported to be crimped against the top of the Butterworth hatch coaming because hose guides were not carried on board. Butterworth hatches were then normally dropped onto the hose to form a partial seal. However, it was reported that the hatches were sometimes left in the fully open position.

Cloud 700 portable tank washing machine

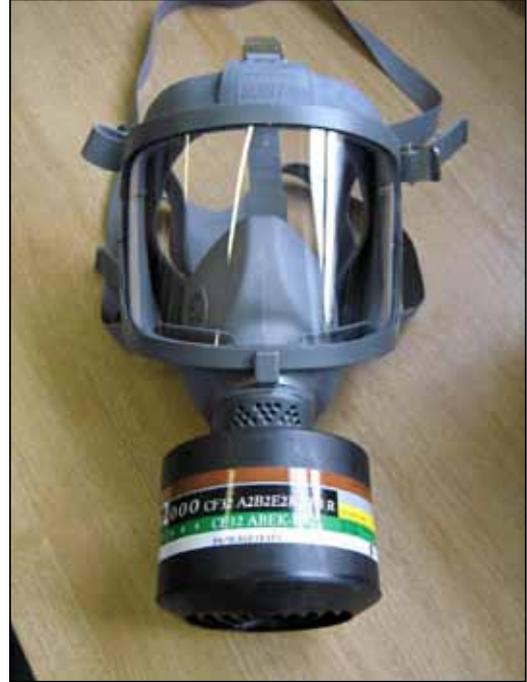
Figure 14

Vopak terminal staff were equipped with Scott Sari full face respirators fitted with a Pro 2000 combined filter to EN 14387; 2004, EN 12941 and EN 12942 standards (**Figure 14**). The filter protected against organic and inorganic gases including H₂S to a concentration of 1.0% / volume.

Vopak Terminal Scott Sari full face respirator fitted with a Pro 2000 combined filter

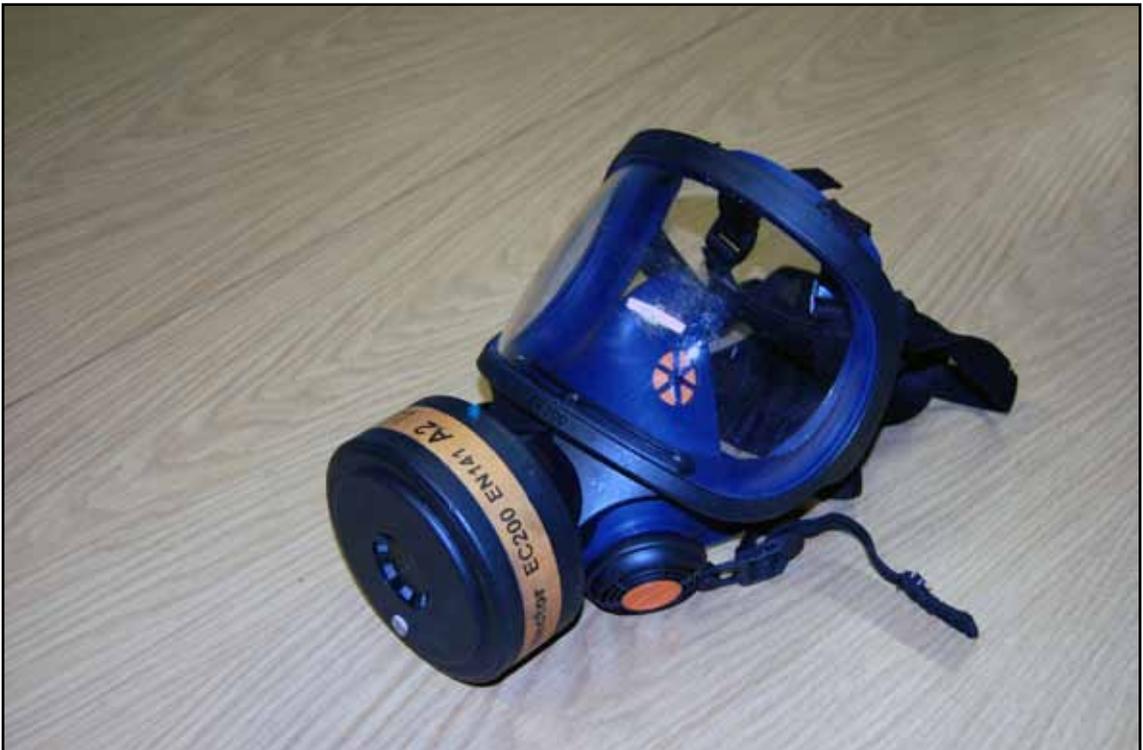
Figure 15

Intertek OCA provided its surveyors with full face respirators and a wide range of filters. In this case the surveyor's respirator was fitted with an EN 141 A2 filter (**Figure 15**) which provided protection against organic compounds but at concentrations up to 0.5% / volume. Importantly, it did not protect against inorganic compounds such as H₂S or mercaptans.

Intertek OCA surveyor's respirator fitted with an EN 141 A2 filter

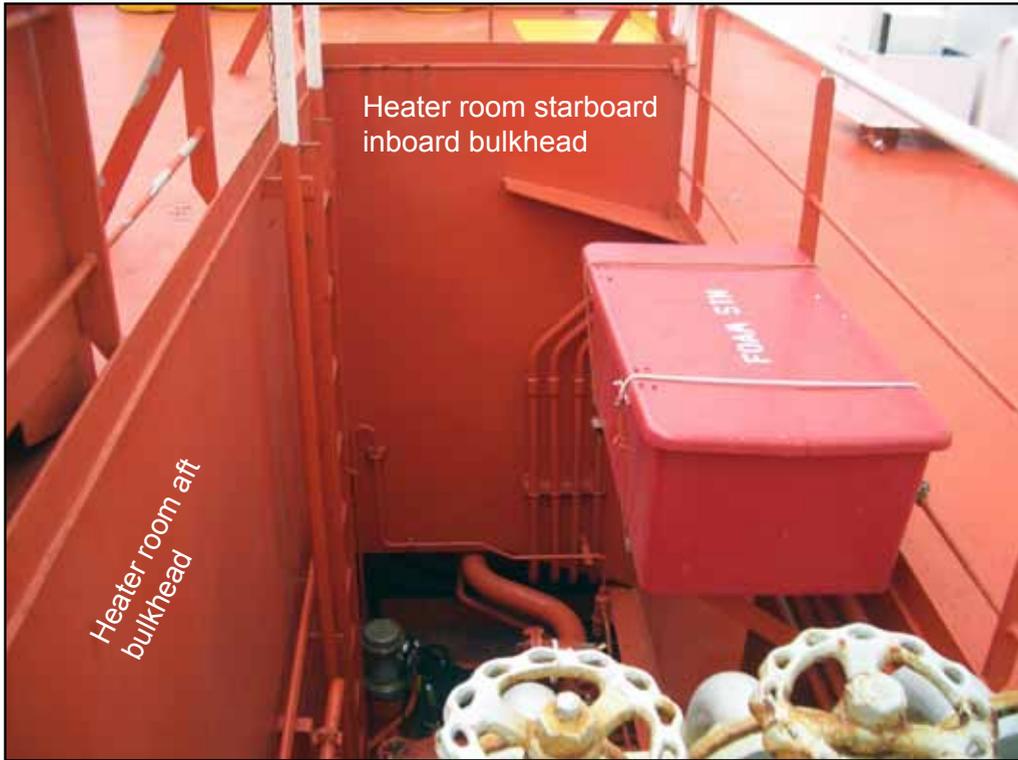
The inboard Butterworth hatch was far more enclosed, and the airflows were considerably restricted by the nature of the construction around the hatch. The heater room bulkheads were forward and to starboard of the hatch (**Figure 18**). At deck level the area was confined by the deck deep longitudinals (**Figure 19**). Aft of the space was the forward bulkhead of the superstructure and the area above was partially covered by the transverse walkway – **Figure 20**. The port side was largely obscured by pipework, and at the extreme port side the bulwark flare further enclosed the area (**Figure 21**).

Heater room bulkheads

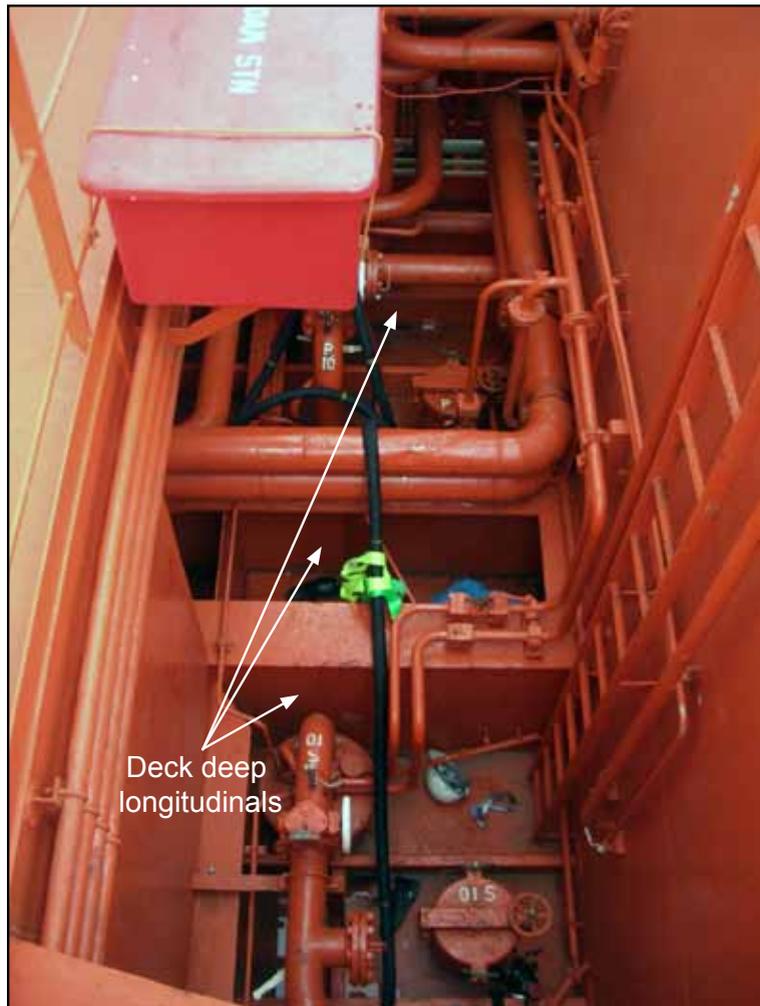
Figure 19

Deck deep longitudinals

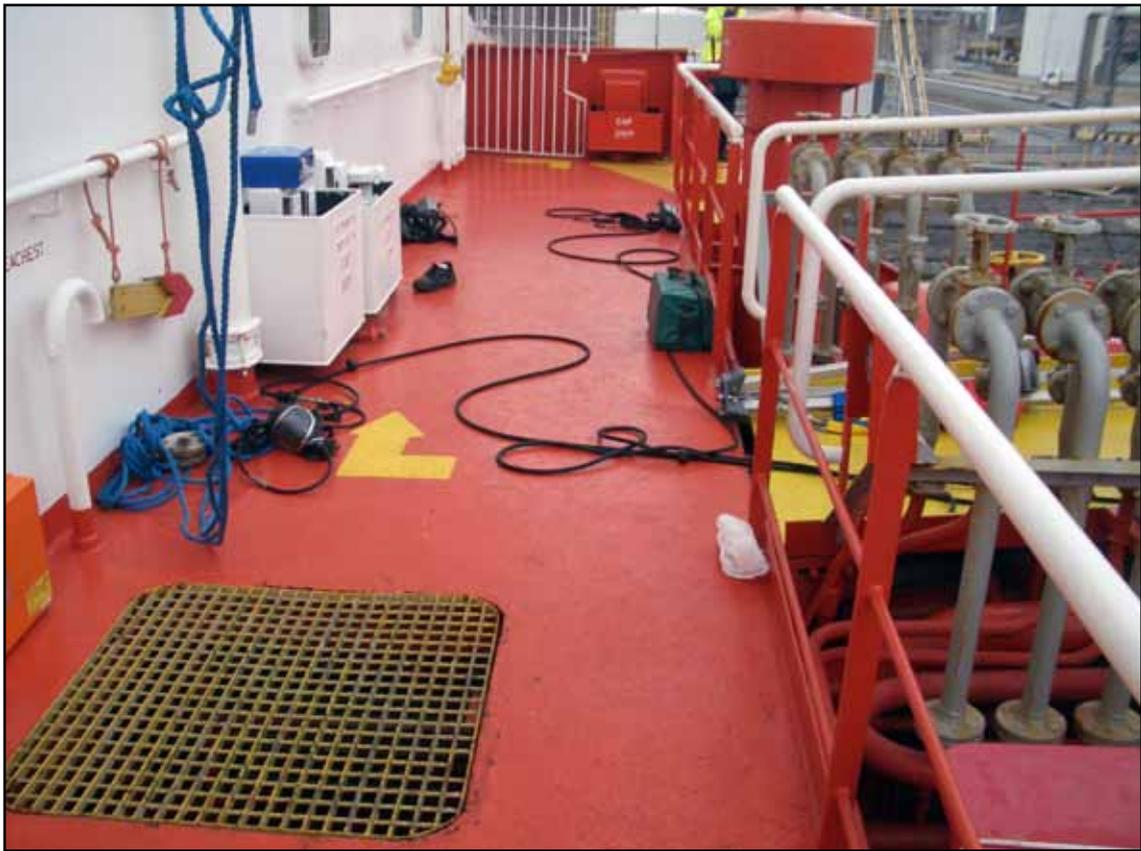
Figure 20

Transverse walkway (shown in condition post casualty recovery)

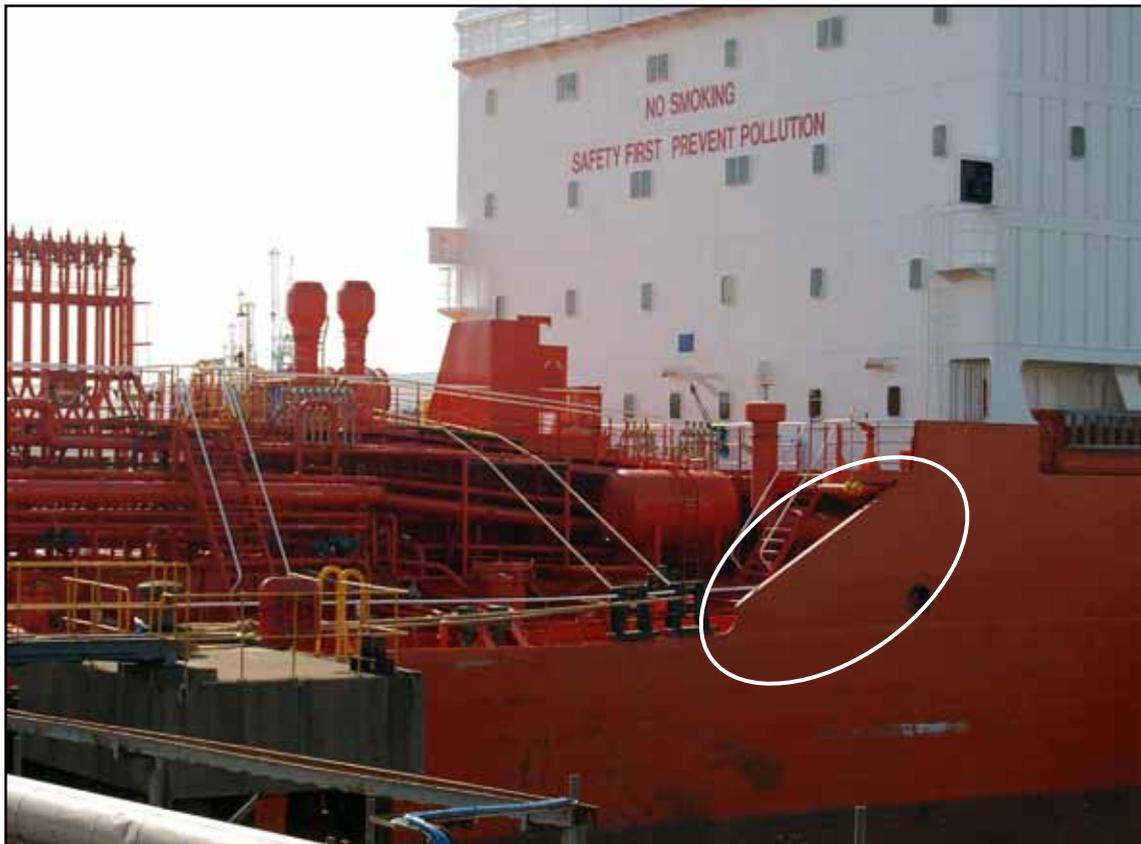
Figure 21

The outboard Butterworth hatch area was reasonably well exposed to airflows across deck, with the exception that it was partially shielded by the port bulwark flare adjacent to the ladder giving access to the upper deck from the main deck (**Figure 17**).

Port side bulwark flare
