Report on the investigation of
the grounding of the sail training vessel

TS Royalist

near Chapman's Pool
off the south coast of the United Kingdom

Report No 26/2009
December 2009

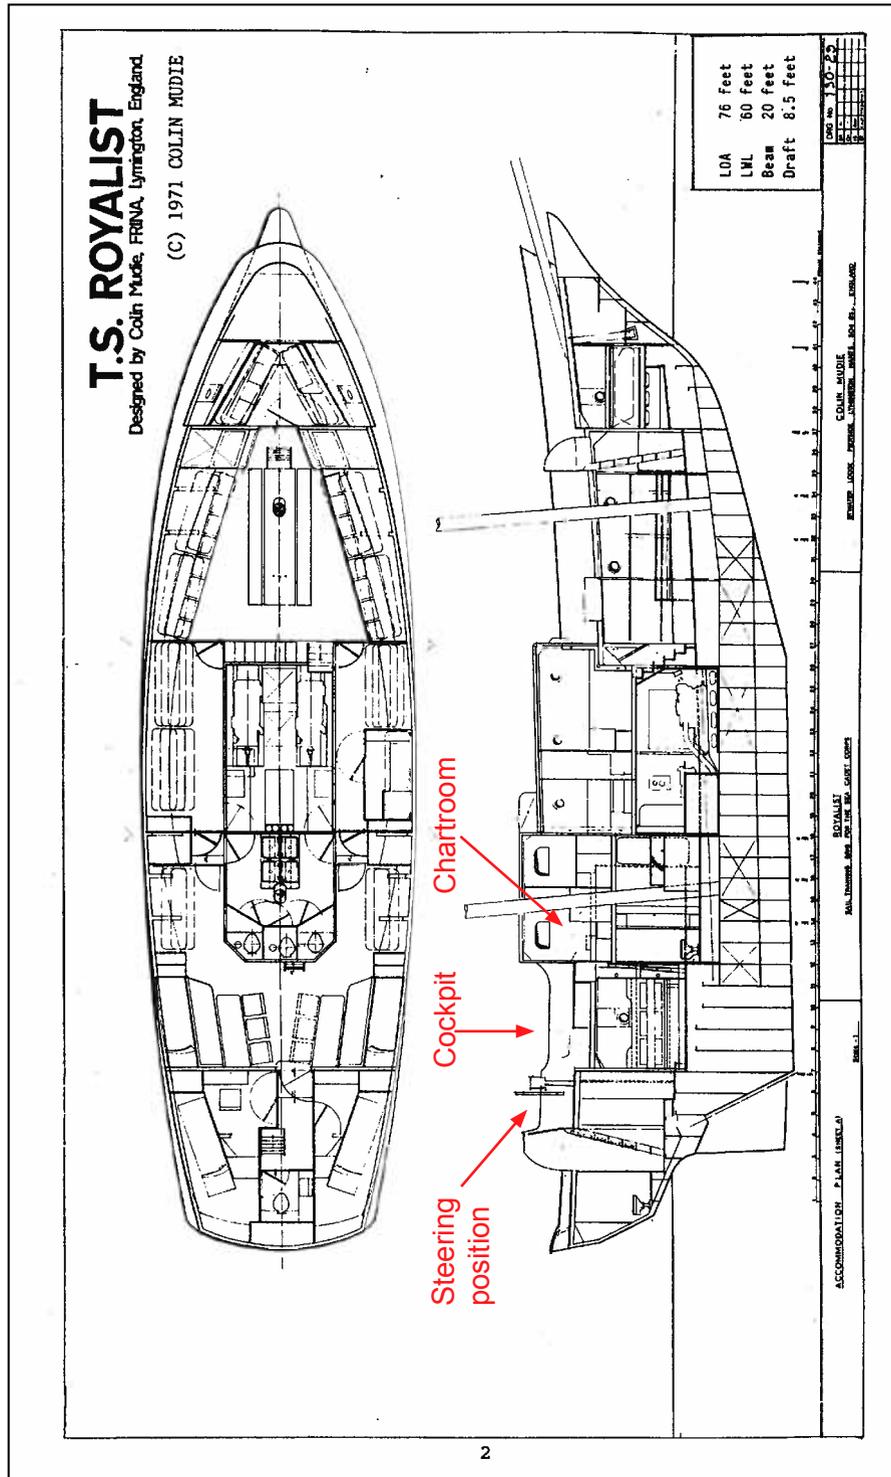
Figure 8

The deck layout was traditional in that she had a deckhouse and an enclosed open-topped cockpit. There were two companionways leading from the cockpit into the deckhouse; the starboard companionway led forward past the galley and down into the accommodation below; the port companionway accessed the small chart room in which all the navigational aids and radio equipment were situated. The wheel, standard magnetic compass, and engine controls were located in the enclosed cockpit and a relative wind direction indicator was sited in front of the helm position (Figures 8 and 9).
