Report on the investigation of
a fatal accident on
Wellservicer
3 miles SE of Aberdeen, Scotland
1 April 2009

Report No 1/2010
January 2010

Wellservicer

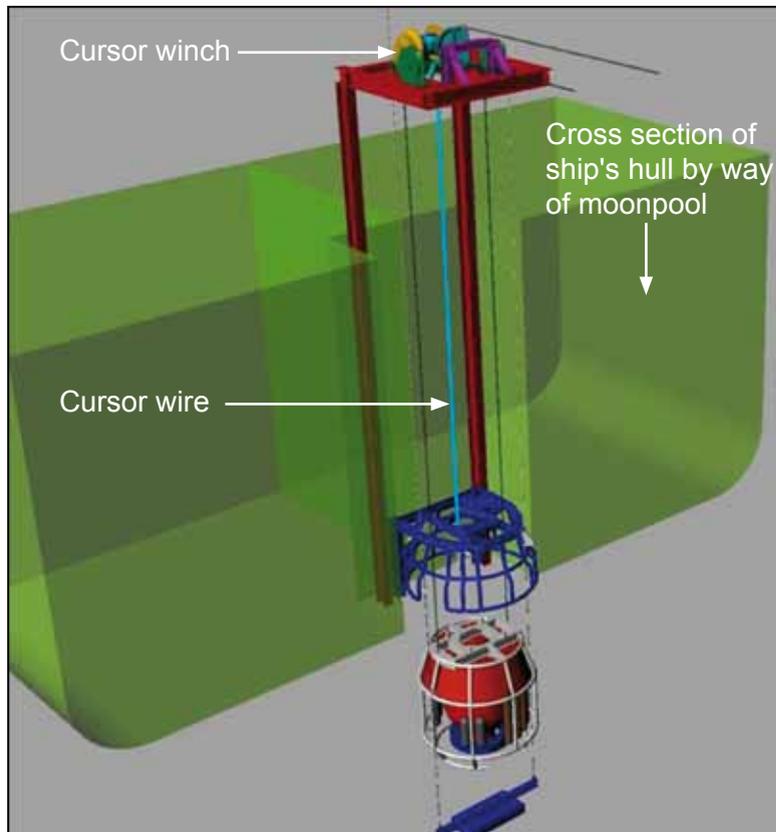
Figure 2b

The project required the bell's recovery system to be converted from a passive to an active cursor system (**Figures 2a and 2b**). In the existing passive system, the dive bell was recovered to the moonpool by means of two overhead wires, which allowed it to mate with its cursor at the ship's keel; the cursor and bell then ran on two vertical rails up to the bell trolley from the bottom of the moonpool. The passive cursor was simply a securing arrangement with no lifting capability. Once mated with the cursor, the bell effectively became integral with the vessel, rolling and pitching with her movements. It was essential that this operation was carried out smoothly and efficiently to prevent damage to the dive bell, or injury to occupants. The bell and cursor were both carried aloft to the trolley (**Figure 3**) by the same wires that hoisted the bell from deep sea level, and they were then secured by bell locking pins (**Figure 4**) before being "trolleyed" to the saturation chamber. Cursor supports (**Figure 5**) were then inserted into the legs of the trolley to take the weight of the cursor as the bell was lowered onto the chamber's "transfer under pressure" (TUP) trunking, where divers transferred from the bell to the chamber below. Taking the weight of the cursor on these supports prevented the 4t cursor resting on, and possibly damaging, the TUP trunking.

Active cursors have their own dedicated winch for use in an emergency. In such a situation, the cursor can attach to the bell by means of latch hooks, and carry it aloft in the event of failure of the bell's winch system. To achieve this, the bell has first to be recovered to the moonpool by separate clump wires (**Figure 6**). *Wellservicer* already had such a system in place for her aft diving bell.

Diagrammatic representation of an active cursor assembly (umbilical removed for clarity)

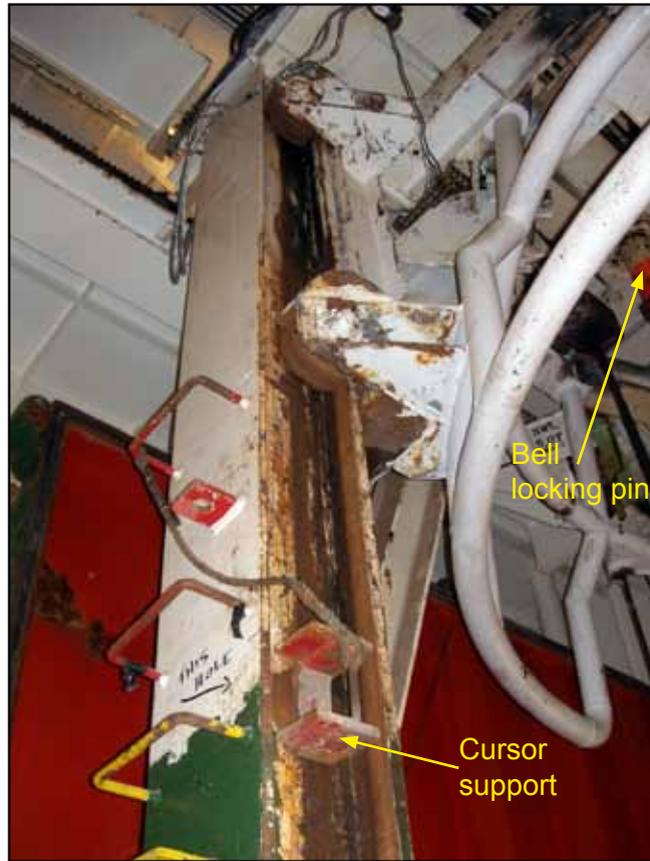
Figure 5

Bell trolley frame port leg, showing cursor support

- In normal diving bell launch and recovery operations, it was routine practice to put the cursor supports in place (**Figure 5**). In the rather different context of the modification process, the need for this routine might not have been evident to riggers focused on the technical challenges of the task⁸.

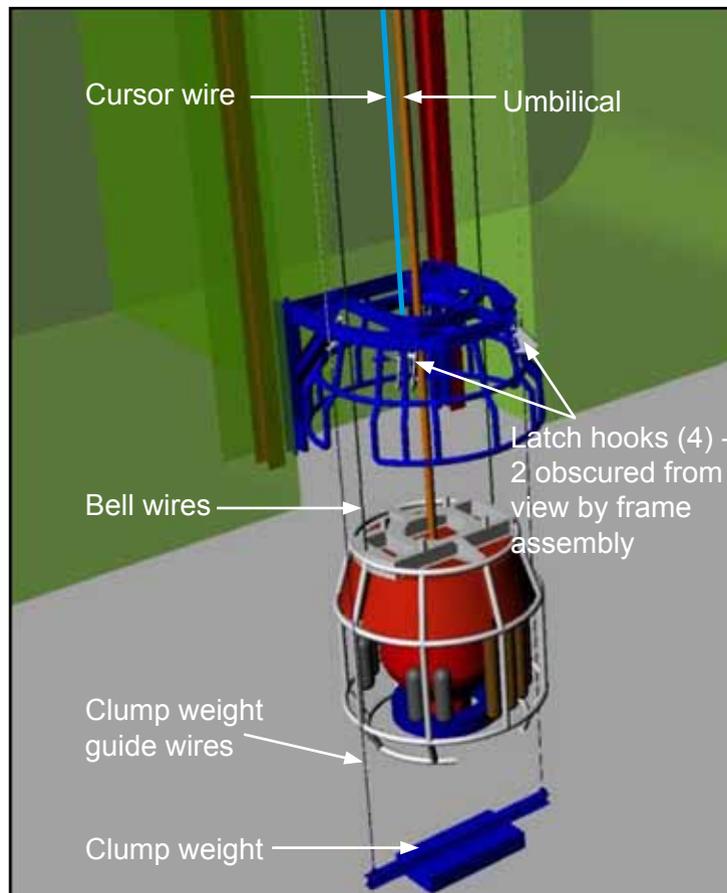
Figure 6

Diagrammatic representation of various wire attachments

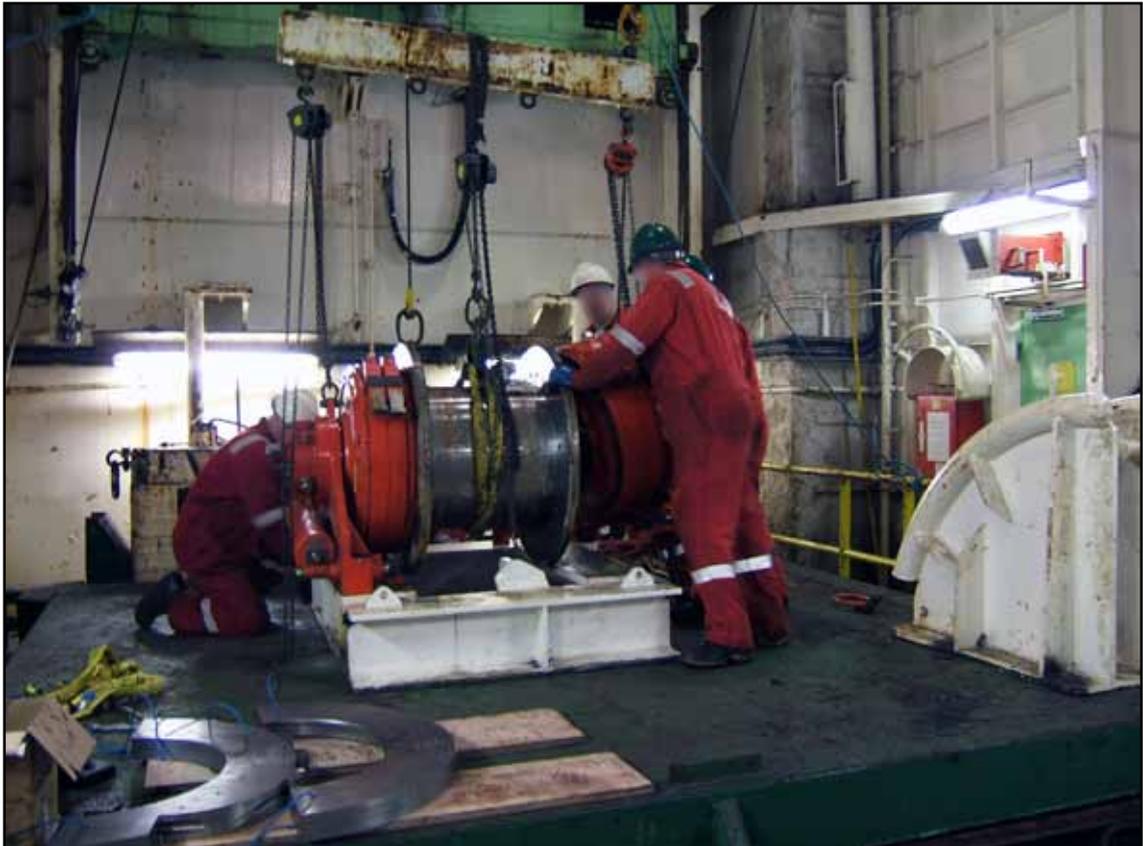
Figure 16

testing also included evaluation of the winch drum braking systems. Following load testing, the winch was stripped down into its component parts again before being transported to the dry dock in Holland. The components were hoisted from the dry dock bottom into the vessel up through the forward moonpool, and then re-assembled on board the vessel (**Figure 16**) before being installed on top of the bell trolley.

Winch being assembled in bell hanger
