Report on the investigation of
the shift of an articulated road tanker on board the
roll-on roll-off high-speed sea service cargo ferry

Stena Voyager

in Loch Ryan

Report No 21/2009
October 2009

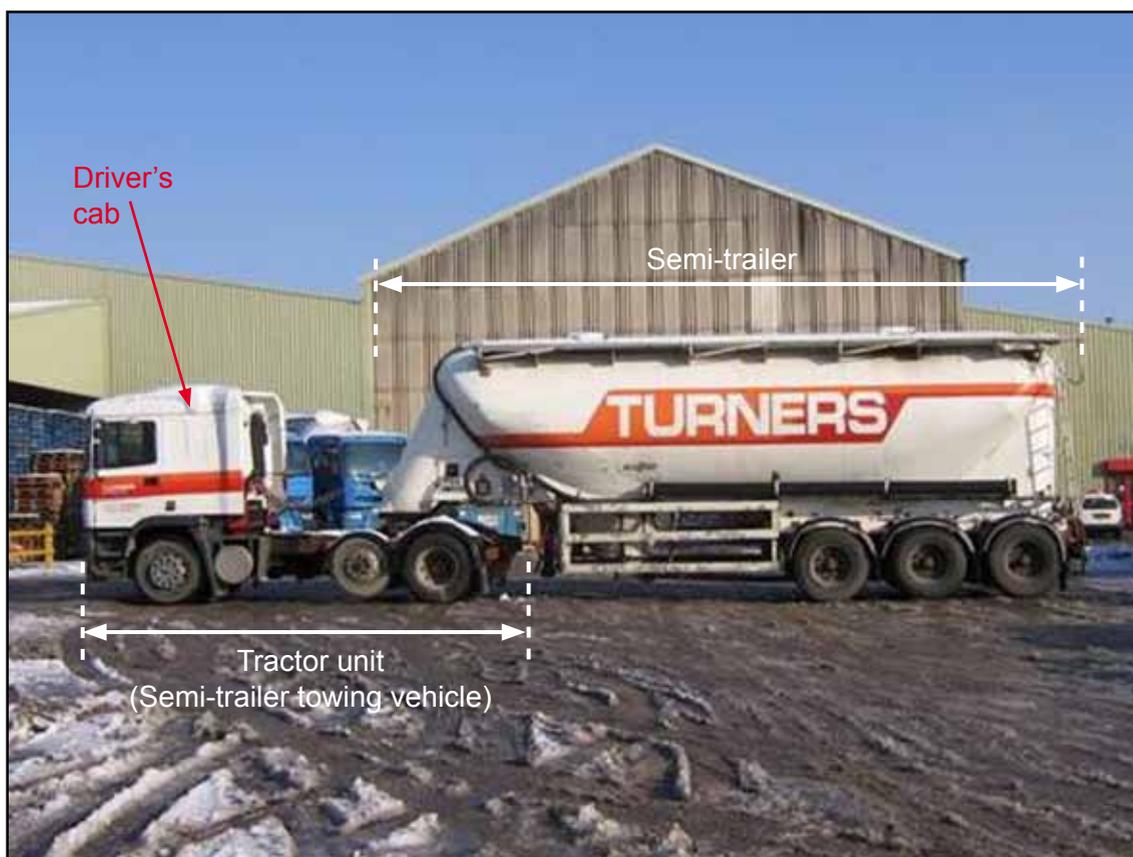
Figure 1

Turners (Soham) Ltd bulk powder articulated road tanker

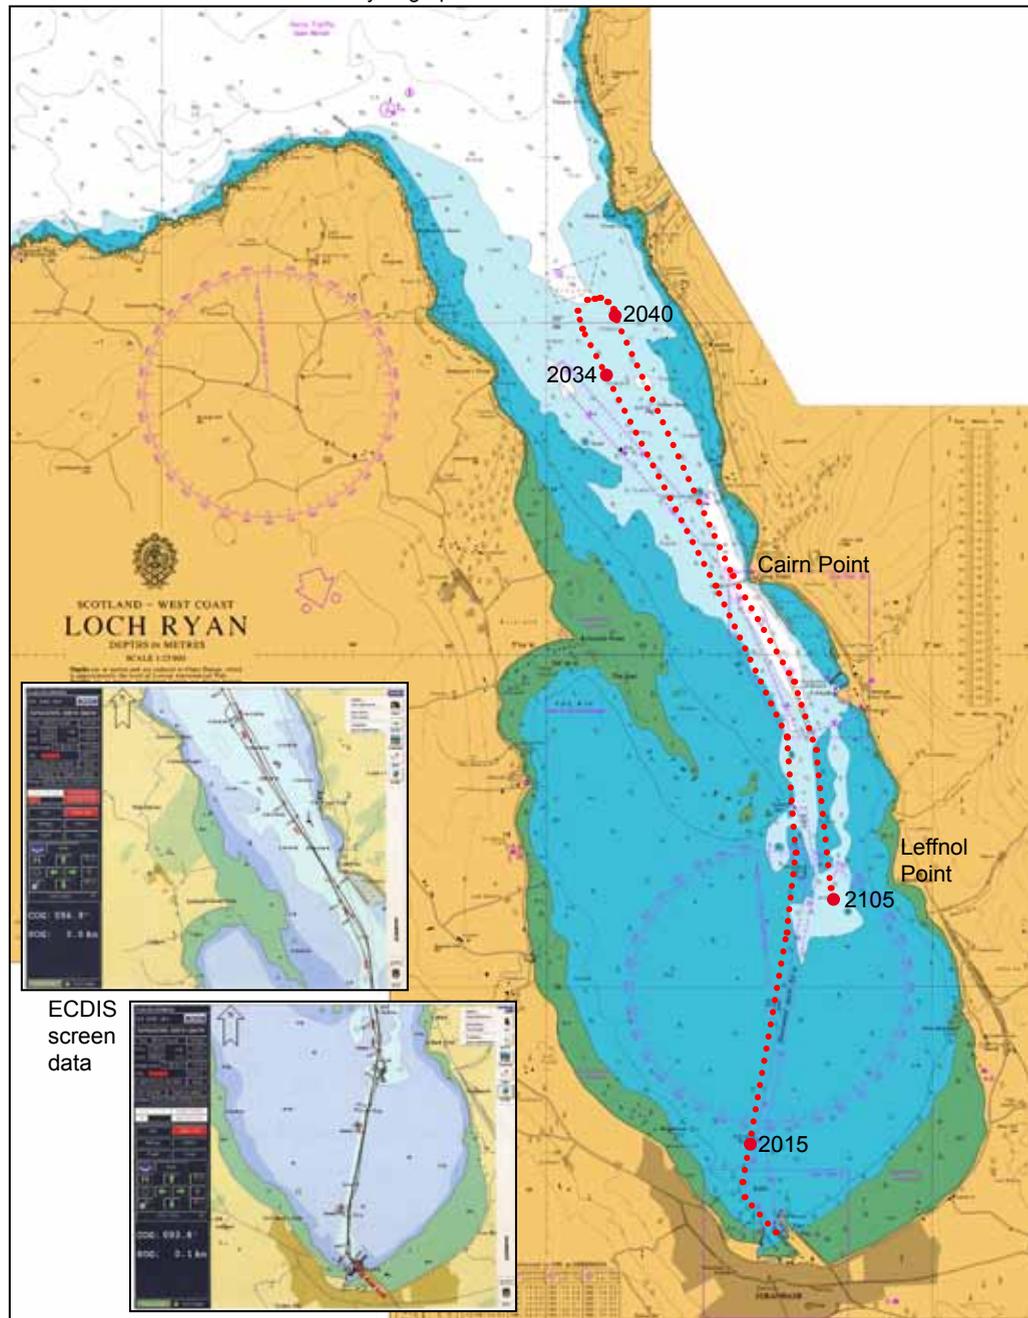
Figure 3

Loch Ryan chart and recorded passage

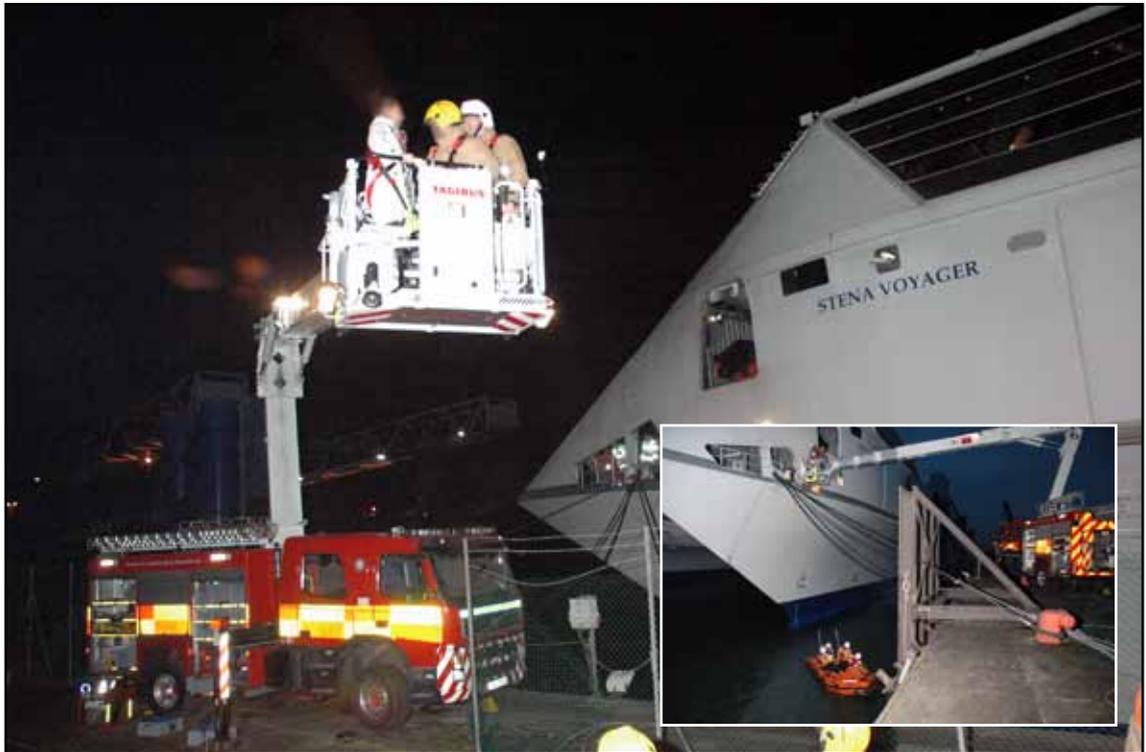
Figure 7

Without the linkspan, there was no means of disembarking the passengers, and they had to stay on board the ferry overnight. The following afternoon the fire service arrived at the terminal with a telescopic rescue platform and, at 1650, the passengers disembarked one at a time (**Figure 7**). A 500 tonne crane also arrived from the north east of England and, at 2245, the semi-trailer was lifted ashore and the tractor unit was recovered in board (**Figure 8**).

Removal of passengers by the Fire Service

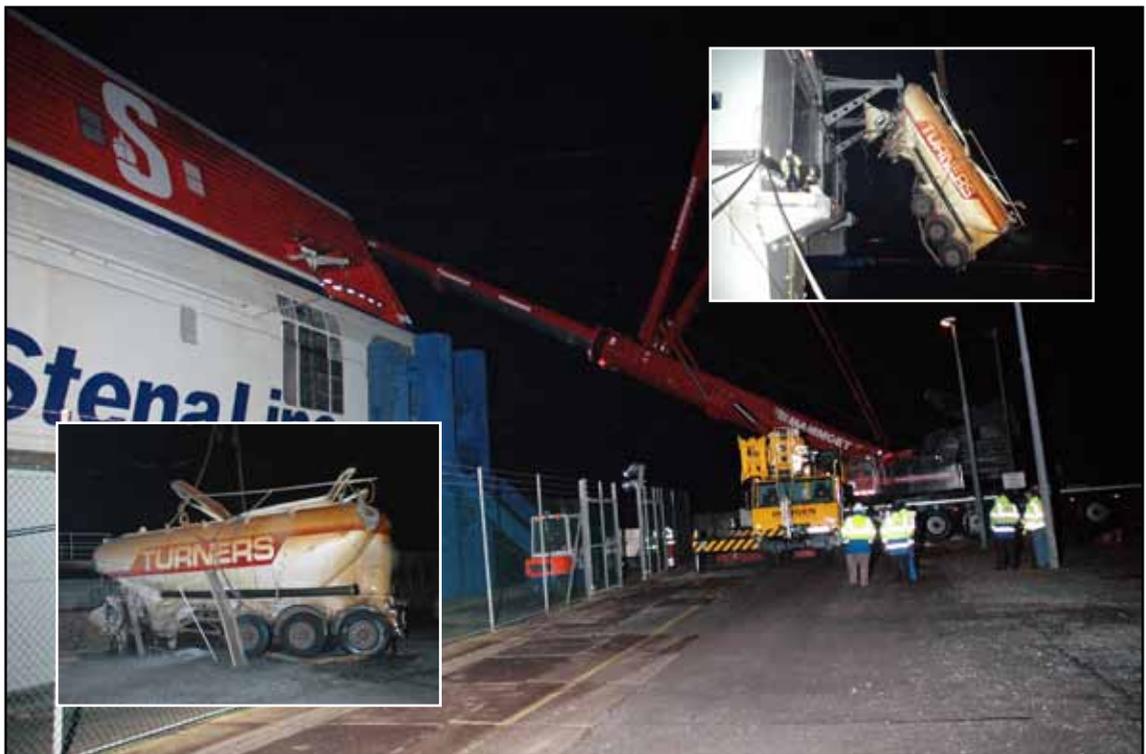
Figure 8

Road tanker recovery

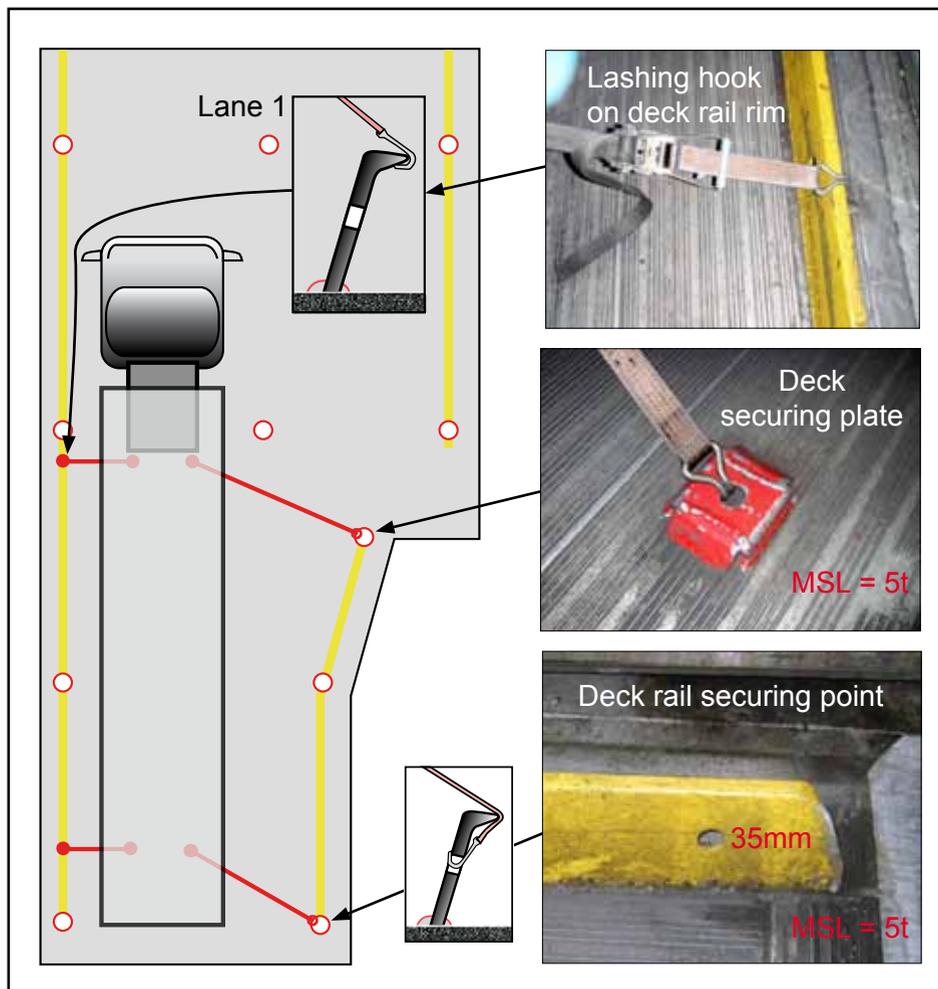
Figure 9

The road tanker was reported to have been secured to the vehicle deck using four web lashings and four rubber wheel chocks. Two lashings were attached to the side impact rails at the rear end of the semi-trailer, and two lashings were attached to ferry securing rings at the front end. The lashing hooks were secured to the deck of the ferry and tightened using their ratchet mechanisms. On the inboard side of the vehicle the forward lashing was attached to a deck securing plate and the aft lashing was attached to a deck rail securing point. On the outboard side, the two lashing hooks were placed on the upper rim of a deck securing rail (**Figure 9**).

Road tanker semi-trailer lashing positions

In this case, the lashings attached to the road tanker were not rigged in accordance with the guidance given in the codes of practice or the instructions contained in *Stena Voyager's* cargo securing manual. Consequently, the two outboard lashings would have provided minimal resistance in either the fore or aft directions as they had been attached to the top rim of the deck securing rail and would therefore have slid along or fallen off the rail as the vehicle rolled along the deck. The inboard lashings provided no restraint against movement in the aft direction; in fact, once tensioned they would have pulled the vehicle towards the stern (**Figure 9**).

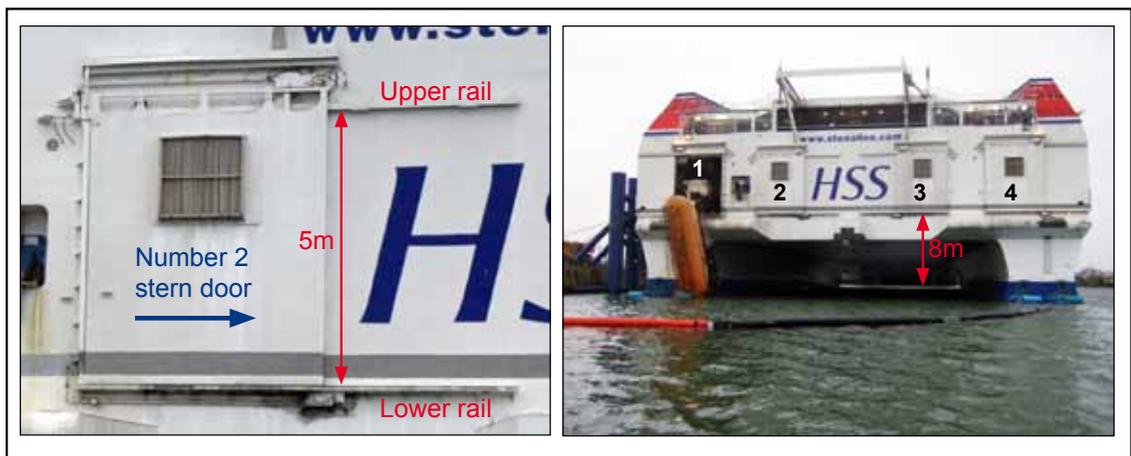
Figure 10

Stena Voyager's main vehicle deck had four lanes, each fitted with a 5m high aluminium sliding stern door at the aft end. The four stern doors were positioned 8m above the waterline and were not classed as watertight (**Figure 10**). Vehicles were driven on board through doors one and two, and off through doors three and four (**Figure 11**). The main vehicle deck had longitudinal serrations to reduce the risk of vehicles sliding from side to side. The area of deck adjacent to number one stern door, where the road tanker was parked, had an anti-slip coating.

Stena Voyager's stern doors

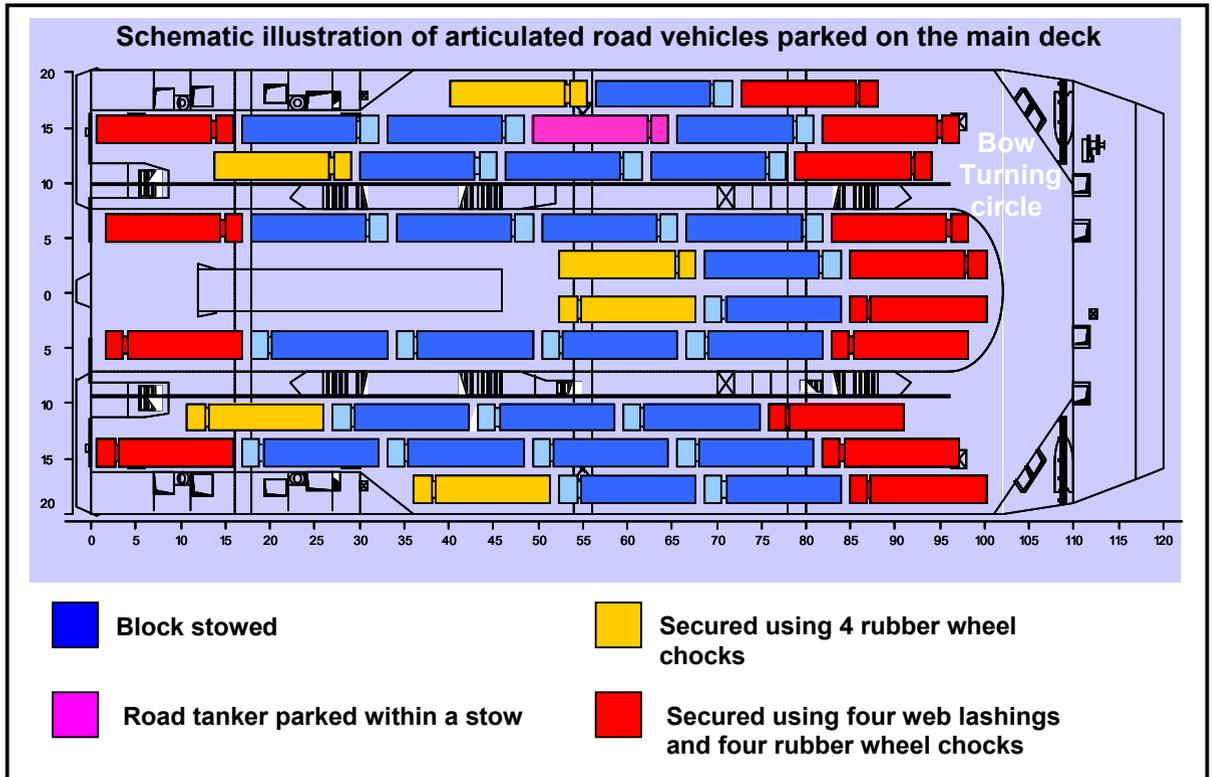
Figure 12

- All vehicles should be parked with their hand brakes on and engines in gear
- All freight vehicles at the forward end of each lane must be lashed
- All freight vehicles parked next to the stern doors must be lashed
- All vehicles at the fore and aft end of each stow must be chocked

Illustration of the freight vehicle stowage and securing requirements on board *Stena Voyager*

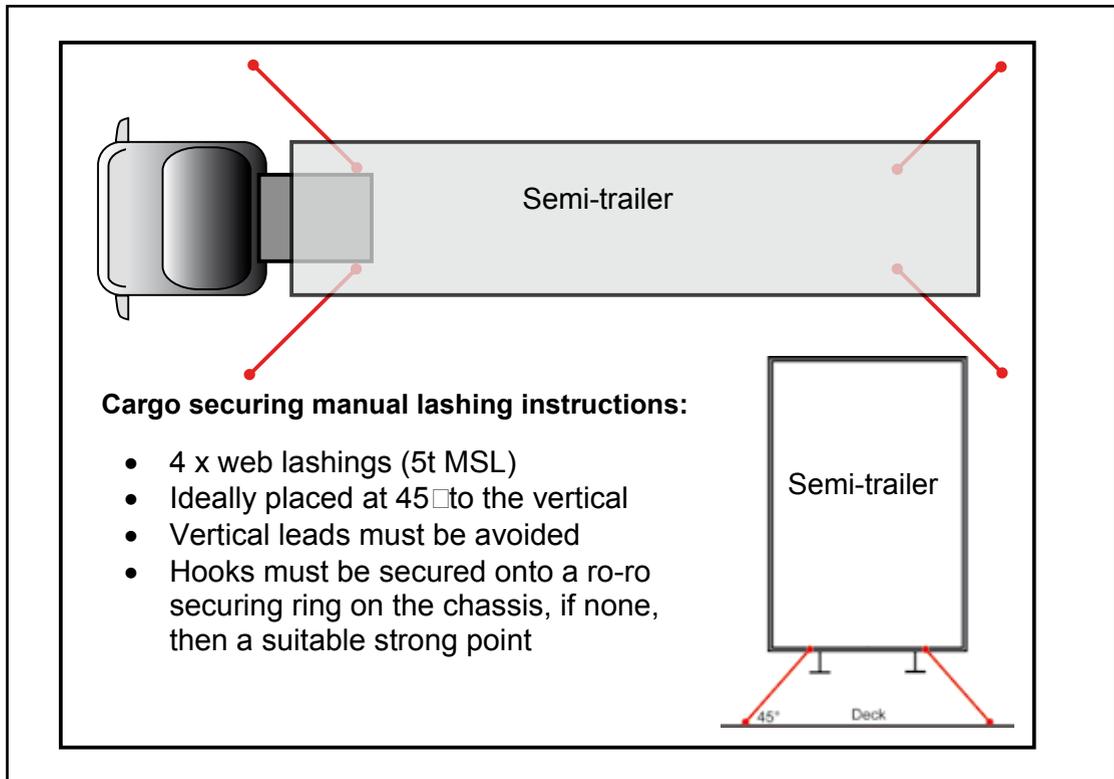
Conventional ro-ro² ferries traditionally use steel chain lashings to secure freight vehicles to the deck. Stena Line used polyester web lashing straps on its HSS 1500 vessels to help protect their aluminium decks. According to the cargo securing manual, the maximum securing load (MSL)³ for the freight vehicle web lashings was 5t. The freight vehicle lashings used on board *Stena Voyager* were 3.5m long and had a minimum breaking strength of 5t. They had a stainless steel securing hook at each end and were tensioned by a manual ratchet mechanism. The lashings were not individually marked and were not given a maximum working life. The onboard maintenance regime was limited to periodic visual inspections. *Stena Voyager's* cargo securing manual required the road tanker's semi-trailer to be secured to the deck using four web lashings (**Figure 14**).

Lashing arrangement prescribed in *Stena Voyager's* cargo securing manual

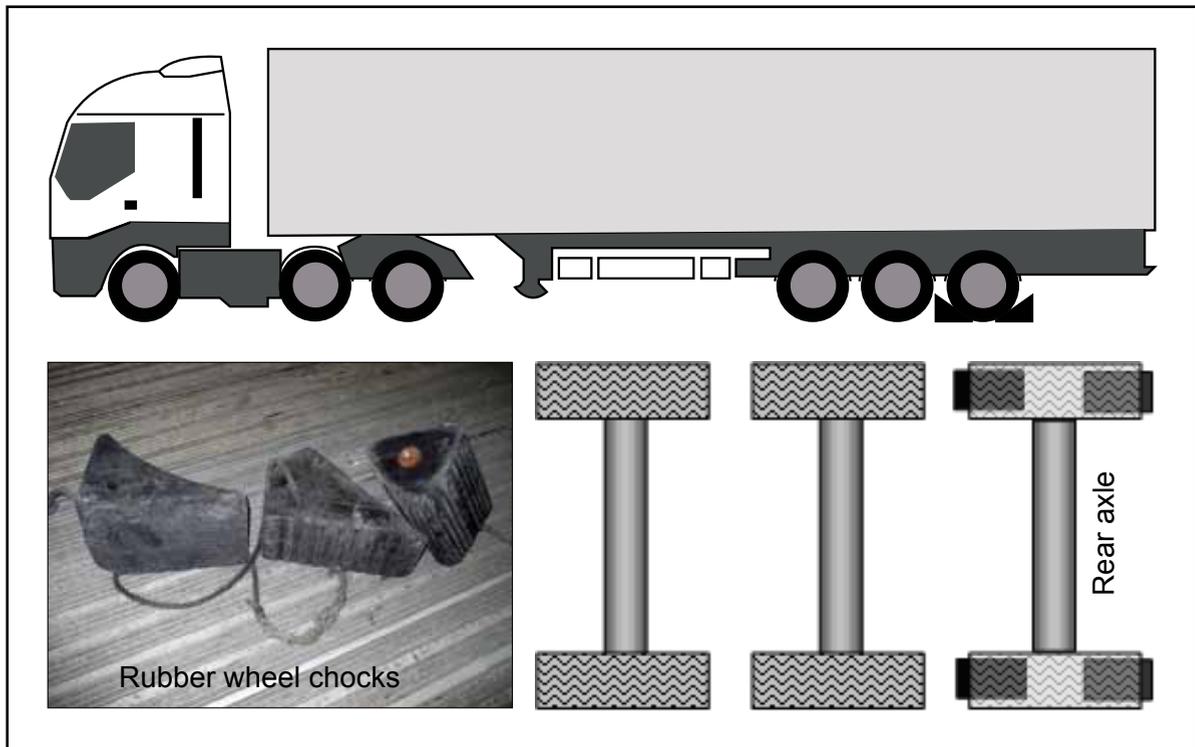
Stena Line used rubber wheel chocks to supplement the freight vehicle lashings on board the HSS 1500 vessels. Three different types were used on board *Stena Voyager*. The approved procedure was to place four chocks around the freight vehicle's rear wheels, two facing forward and two facing aft (**Figure 15**).

Stena Voyager chocking arrangements

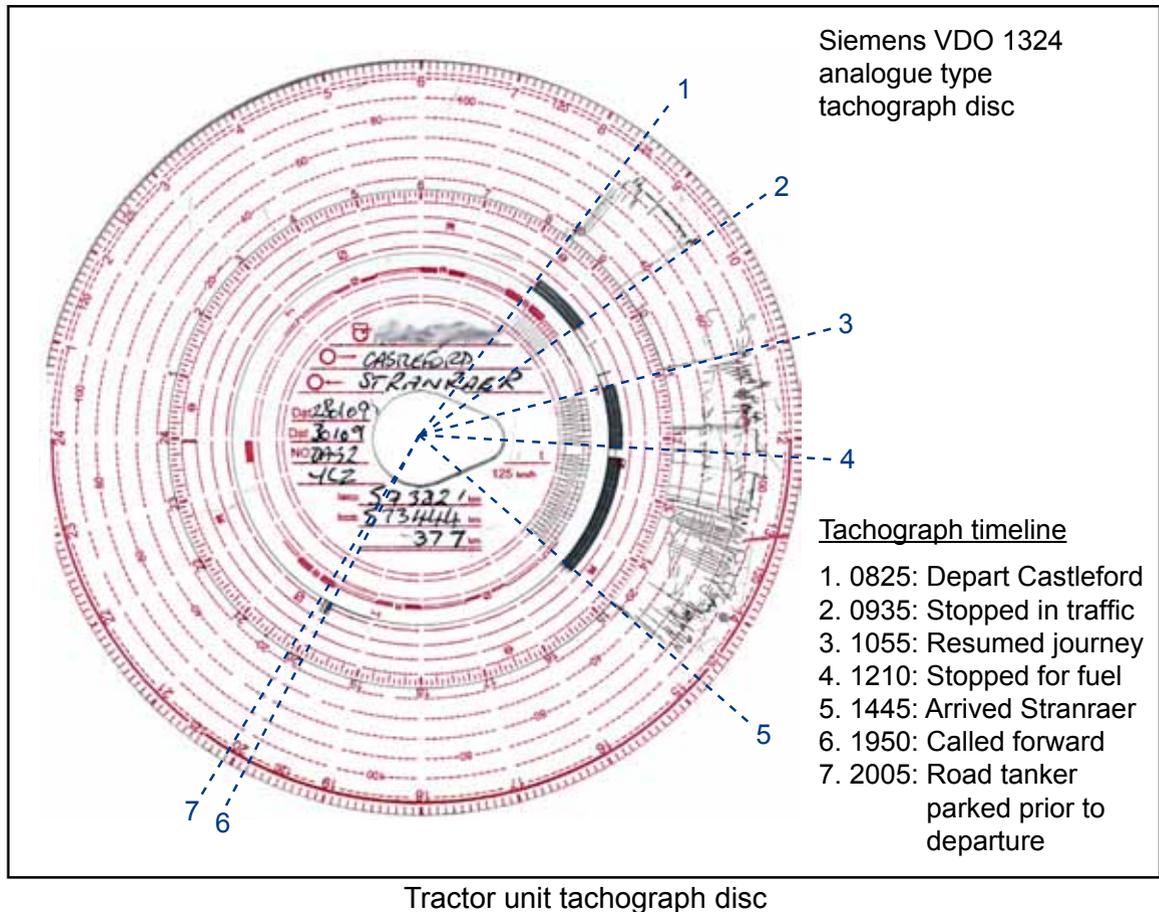
The tractor unit was fitted with a Siemens VDO 1324 analogue type tachograph. The tachograph is a precision instrument which records the speed of the vehicle and the distance travelled, on a circular chart (**Figure 18**). The circular chart covers a 24 hour period and is renewed daily.

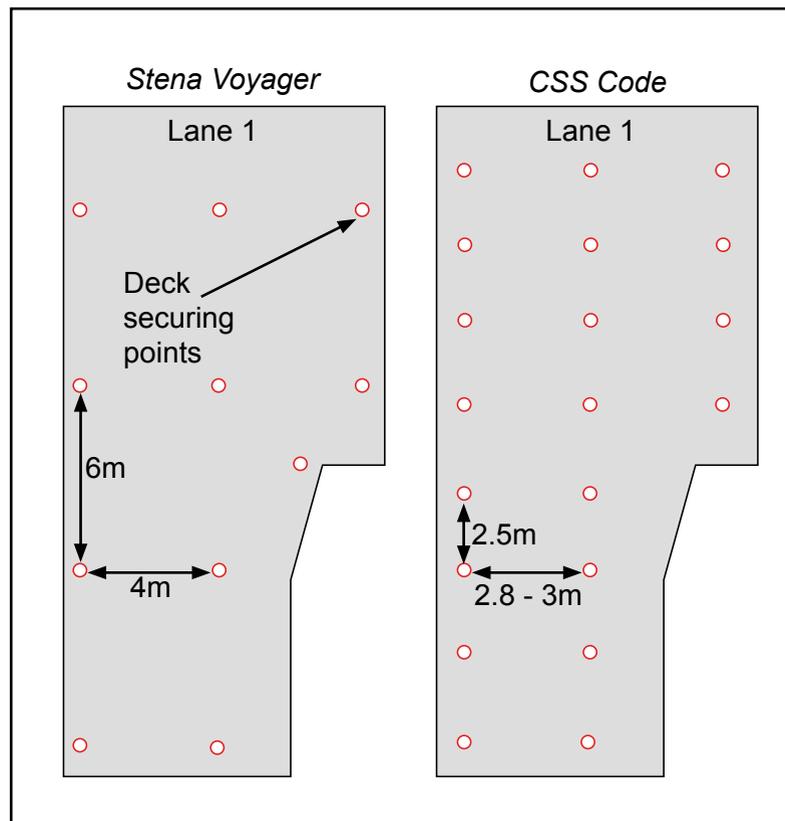
Figure 22

The resolution states the arrangement of deck securing points should be left to the discretion of the shipowner provided the minimum distance between them in the fore and aft direction does not exceed 2.5m and the athwartships spacing is between 2.8m and 3m (**Figure 22**). It also states that securing points on road vehicles should be designed for securing the road vehicle to the deck of the ship with no fewer than two, and no more than six securing points on each side of the vehicle. These guidelines apply to road vehicles, with the exception of

Deck securing point spacing

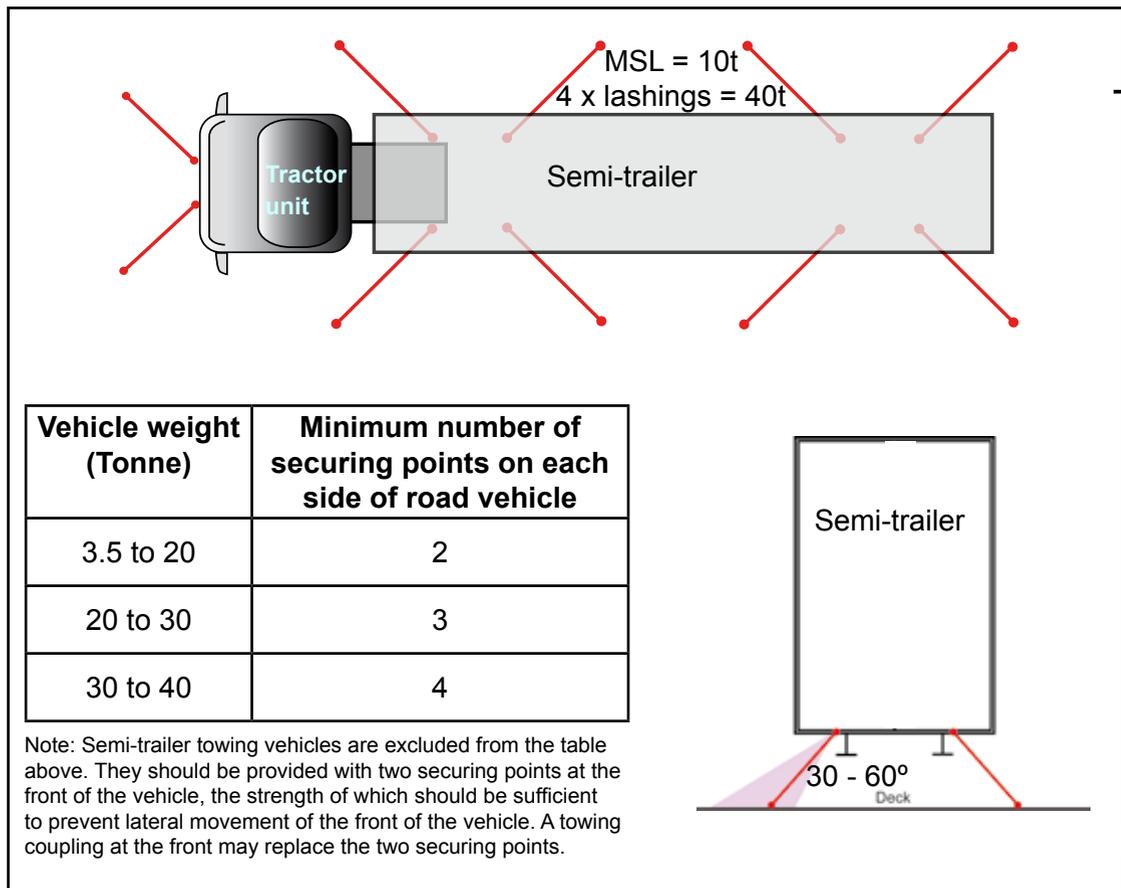
Figure 23

buses, weighing 3.5t and over. The total number of securing points on each side of a road vehicle is dependent on its weight. As a rule of thumb, the total MSL values of securing devices on each side of a unit of cargo (port and starboard) should equal the weight of the unit (**Figure 23**). Other guidance given in the resolution includes:

CSS Code ferry securing ring guidance
