Report on the investigation of
a person overboard during a passenger transfer from

HMS Westminster to Princess Rose

on the River Thames

Report 16/2009
July 2009

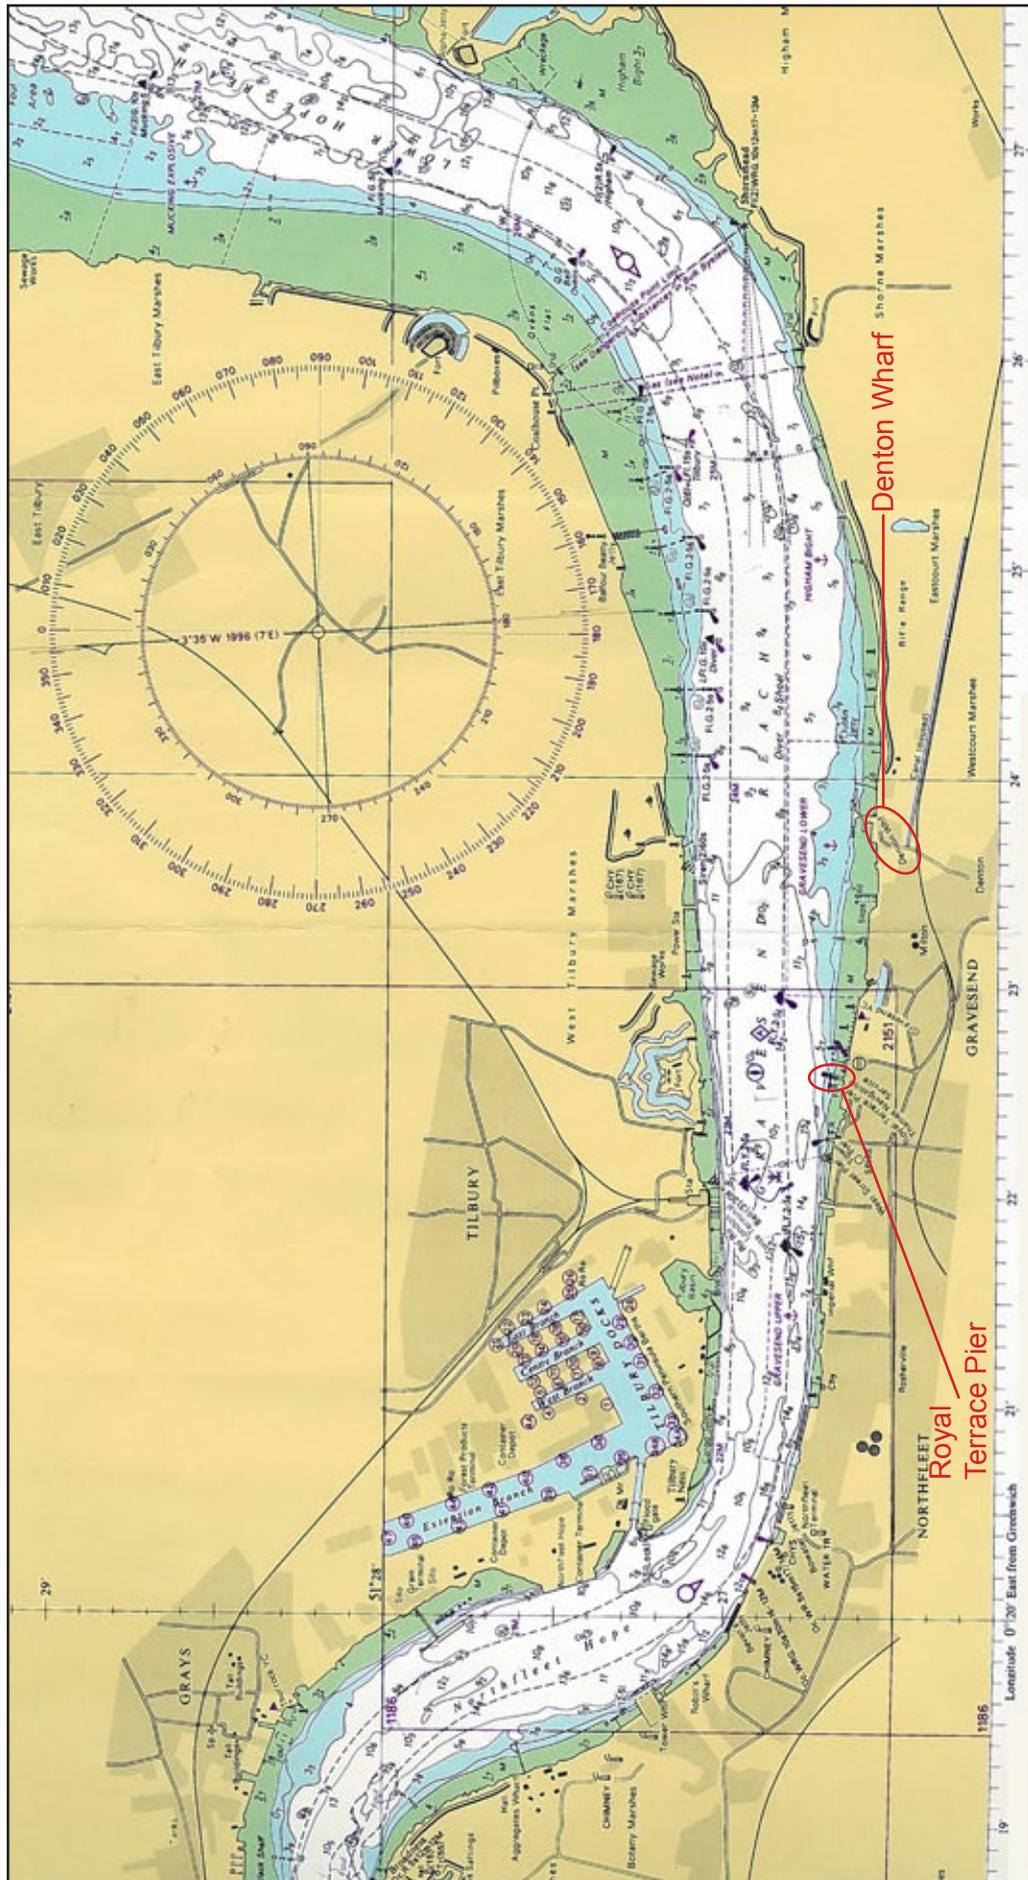
At 1317, while the fenders were prepared, the frigate started to reduce speed from 15 knots to 7 knots over the ground (**Figure 2**). Her heading had also been adjusted to 093°, which provided a lee on her starboard side from the brisk wind blowing over the port bow. During this period, the Gravesend 'E class' inshore lifeboat took up a position about 200m astern of *HMS Westminster* to act as a safety boat during the passenger transfer. The Thames pilot boat was also in close proximity astern, ready to disembark the pilot on completion of the boat transfer.

Gravesend Reach - Location used for passenger transfer

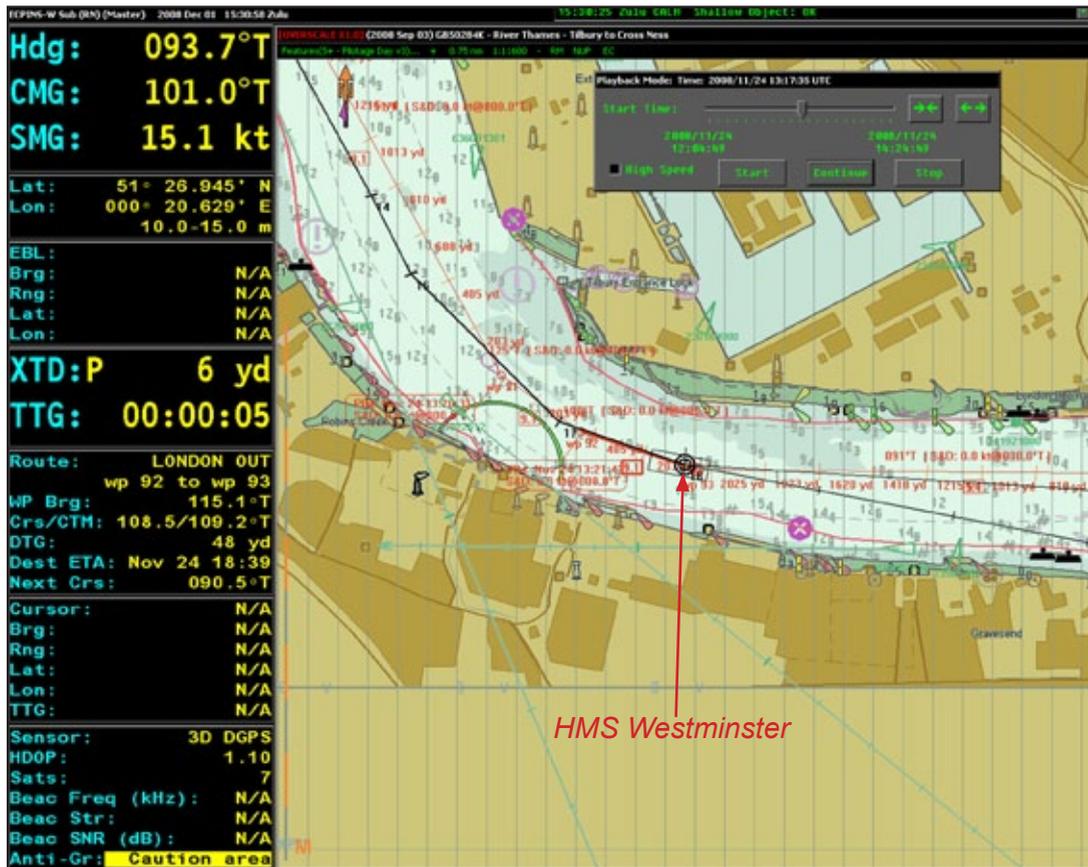
WECDIS download - HMS Westminster entering Gravesend Reach

At approximately 1321 (**Figure 3**), HMS Westminster's executive officer and OOW assessed from the starboard bridge wing that the river conditions were 'well within limits for transfer'. With the ship's speed now at 5 knots through the water and with the fenders in position, the executive officer gave approval for the boat transfer to commence. The fenders were not tied to the vessel's guardrails; they were being tended by hand.

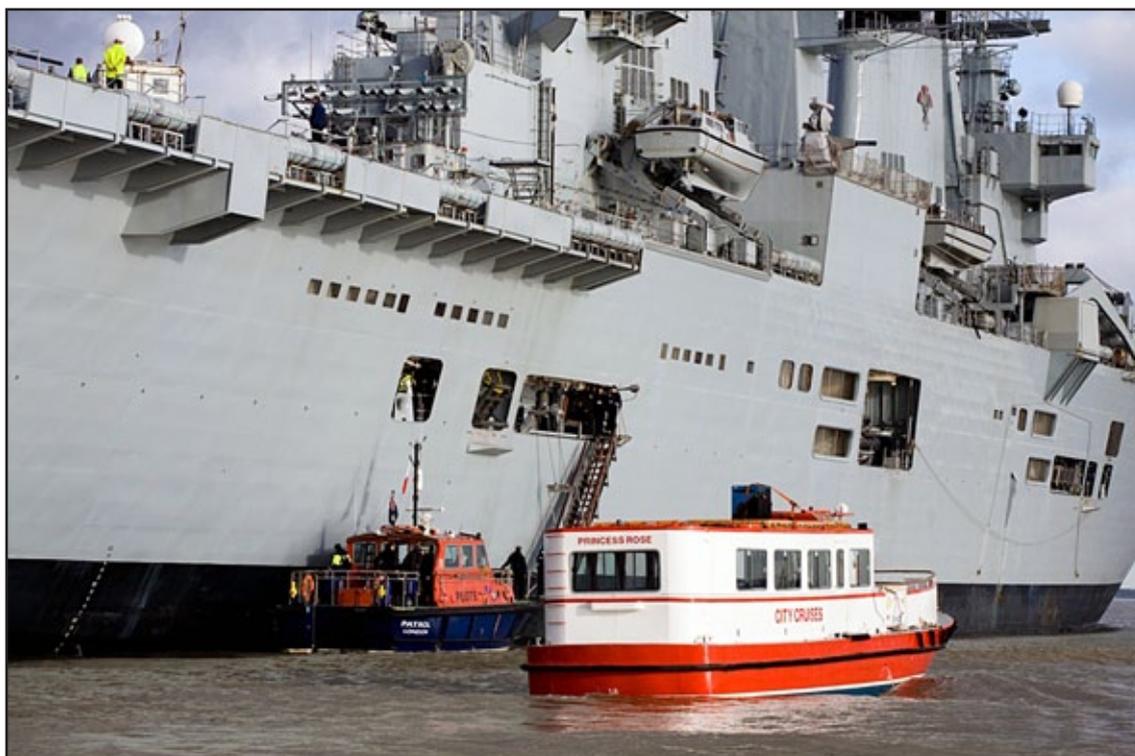
Figure 6

City Cruises used *Princess Rose* to transfer service and civilian passengers to and from warships visiting London on several occasions. These included transfers to vessels underway and making way using a pilot ladder, vessels underway but stopped using an accommodation ladder (**Figure 6**), and vessels moored to a buoy using an accommodation ladder. The company was content for the warship to determine the method used for the transfer, but had not assessed the risks associated with the three transfer methods used.

Example of an underway passenger transfer at slow speed using an accommodation ladder
