Report on the investigation of  
the entrapment of an engine room fitter  
in a watertight door  
on board the ro-ro passenger ship

***Eurovoyager***

approaching Ramsgate, UK

**Report 17/2009  
July 2009**

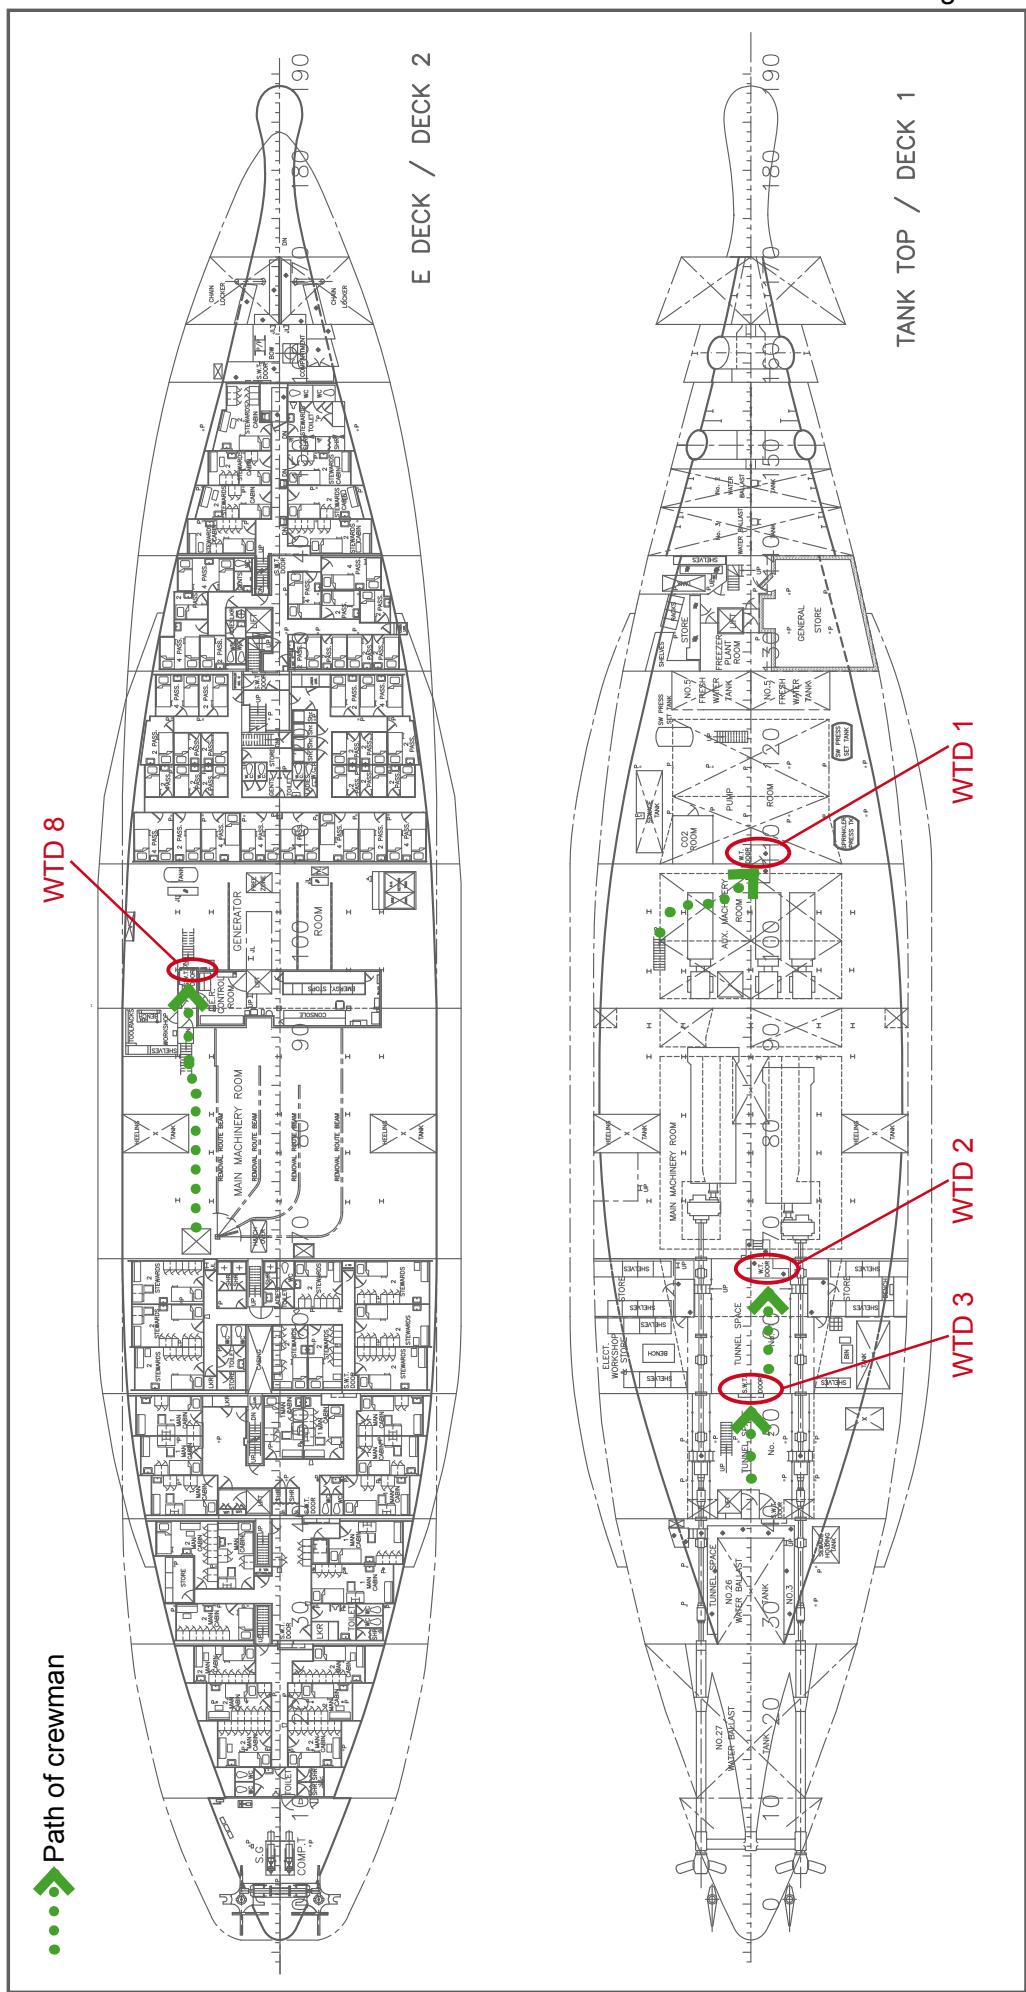
Figure 2

At around 0750 on 3 November, the fitter went to the engine control room (ECR) and made himself a cup of coffee. At 0759, as the vessel was departing Ostend, the master announced on the public address system that he intended to close the watertight doors. He then switched the doors to remote operation from the bridge. Just after 0800, the second engineer asked the fitter to tidy and clean the workshop. At 1123 the fitter left the workshop located aft of the main engine room for an early lunch. He went to the changing room which was forward of the auxiliary engine room, operating three watertight doors on his way (**Figure 2**). The changing room used by the engine ratings was an adapted machinery compartment. It contained a washing machine and facilities for cleaning hands. At 1126, as the fitter was coming out of the changing room in to the auxiliary engine room, he became trapped between the frame and door of watertight door number 1 (WTD1).

General Arrangement showing route taken by the filter

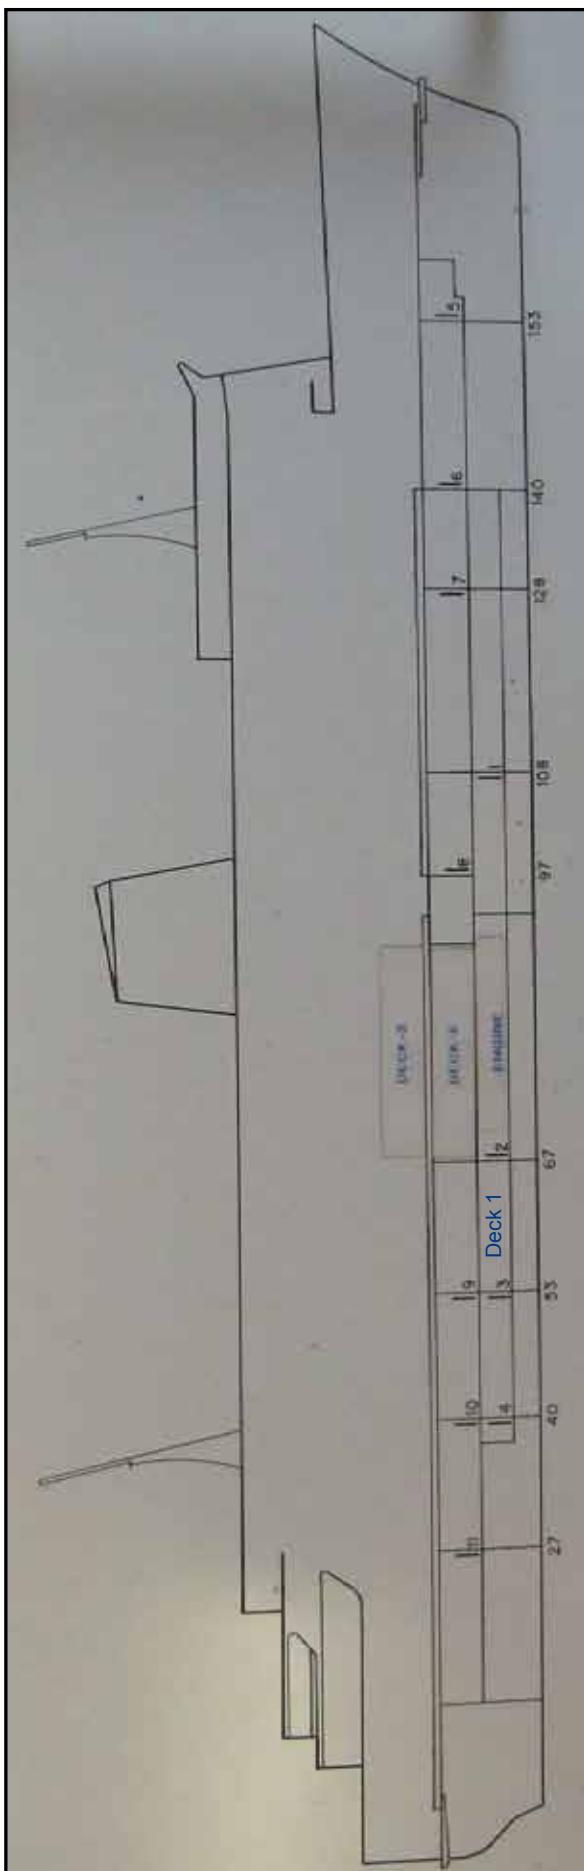
Figure 4

There were 11 watertight doors, excluding the bow and stern doors and 4 weathertight deck barriers. Four of these doors were located in the machinery space (Deck 1), and the remaining 7 on Deck 2 (**Figure 4**). All of the doors were made of solid steel and were identical in construction except for two in the accommodation, which were narrower. WTD1 measured 1800mm x 750mm (**Figure 5**).

Diagram showing the location of the watertight doors
