Report on the investigation into
the flooding and foundering of the grab hopper dredger

Abigail H

in the Port of Heysham

Report 15/2009
July 2009

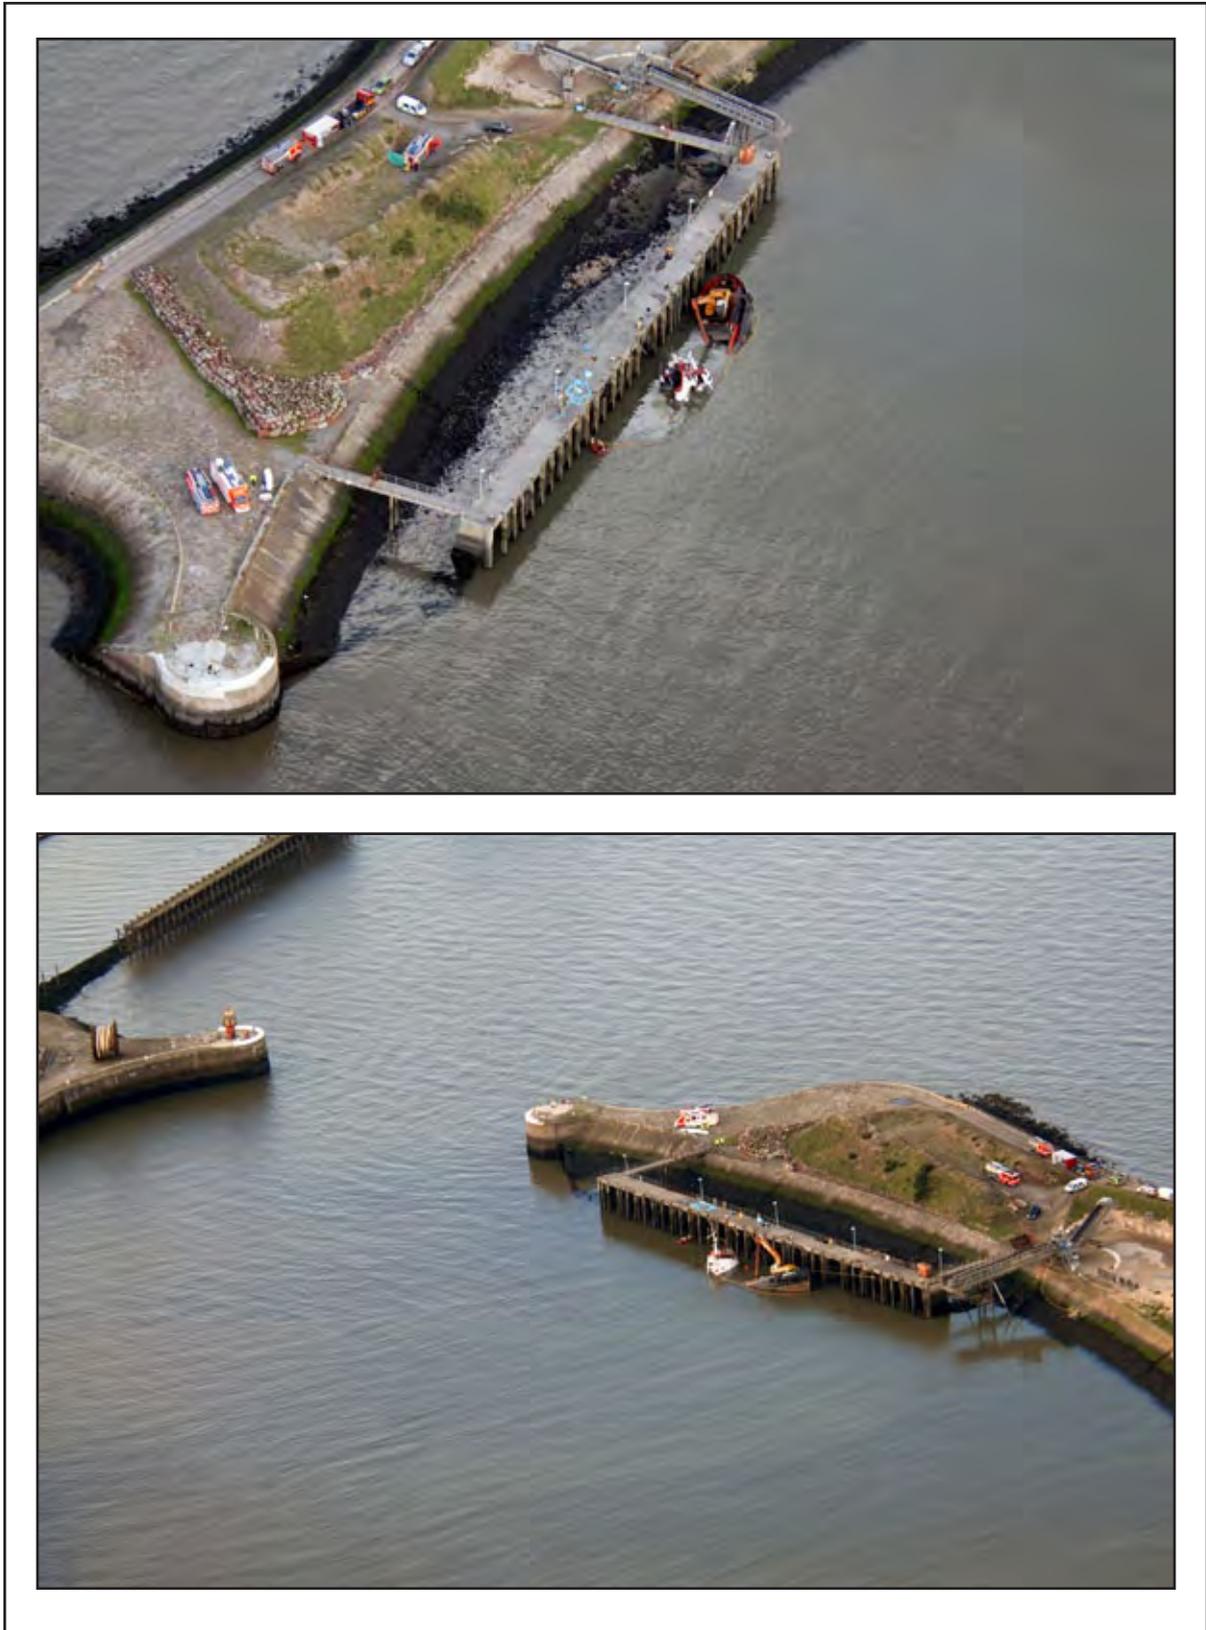
Figure 5

At 1020, the oil spill contractors arrived and began work. A police helicopter was working nearby and was asked to divert and take aerial photographs of the scene (**Figure 5**), but there was little more that the emergency services could do, and at 1230 they left the site.

Aerial photographs taken by Lancashire Constabulary Air Support Unit

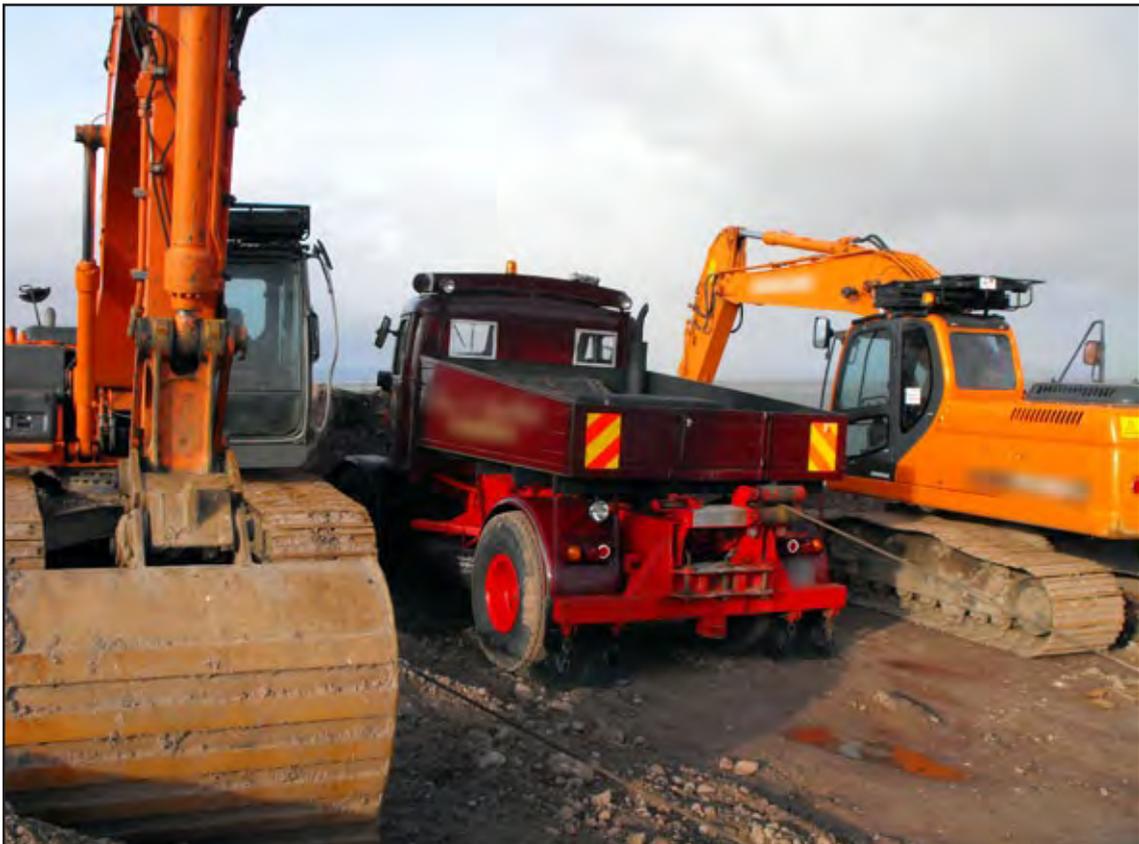
Figure 7

The salvage team was mobilised on 17 November and work on site began the following day. The condition of the vessel had deteriorated; the engine room was free-flooding and water had entered the buoyancy tanks and forward hold. Diving inspections did not find any significant damage or holes in the hull. Land winches were used in an attempt to heave *Abigail H* upright (**Figure 7**) and, on 25 November, the vessel was refloated by removing water from the flooded compartments and by lifting the stern using a floating crane (**Figure 8**).

Winches and excavators used to keep *Abigail H* upright during the salvage operations
