Report on the investigation of the fire on board the fishing vessel

***Vision II***

Alongside at Fraserburgh

**Report No 8/2009**  
**March 2009**

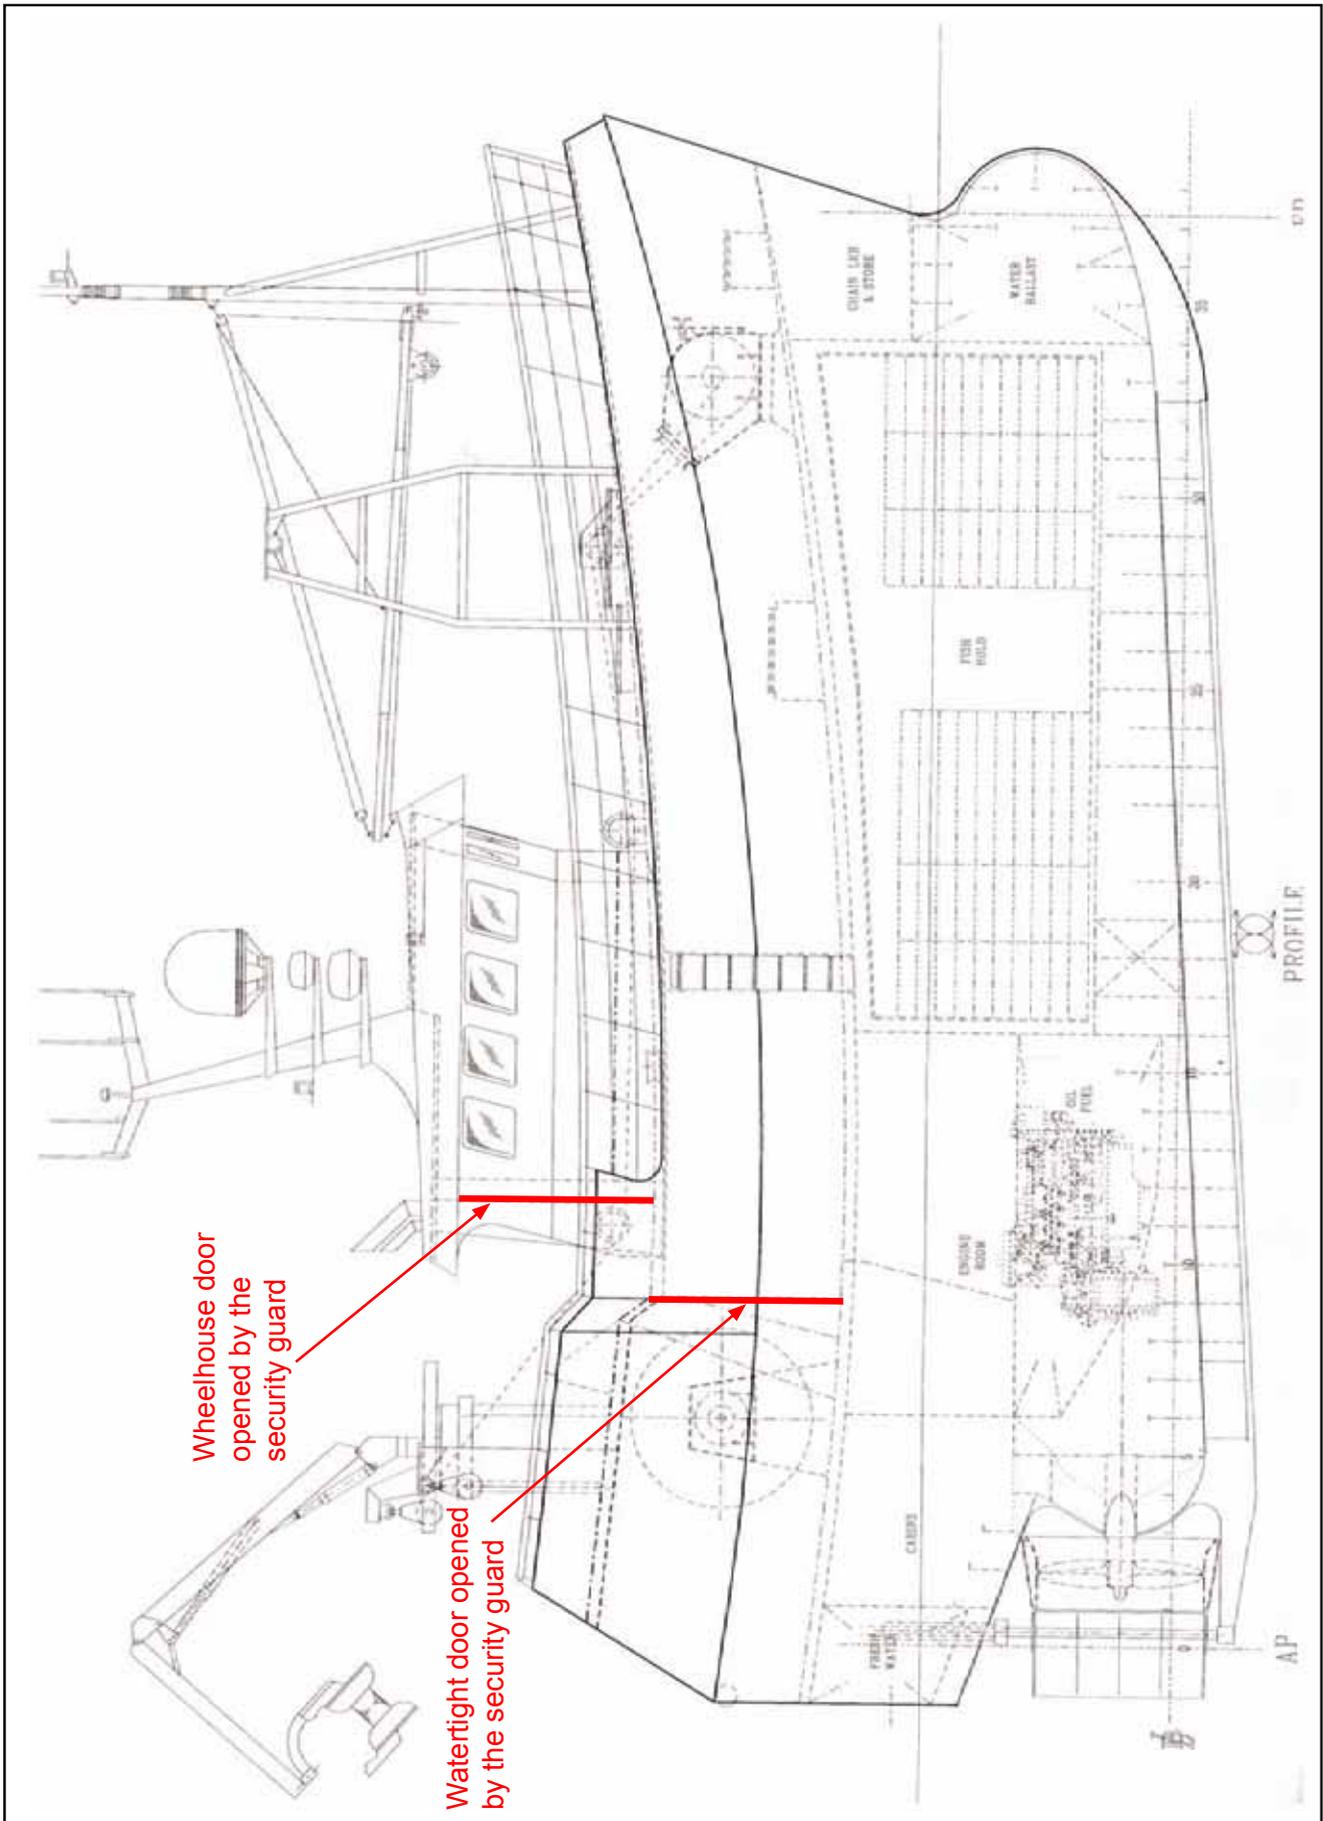
Figure 1

Knowing that people had returned to the vessel earlier, the security guard boarded and made his way to the watertight door at the aft end of the accommodation on the main deck (**Figure 1**). He lifted the middle dog, opened the door, and was immediately engulfed in thick black smoke. He then closed the door and secured it, again using one dog. The security guard then climbed up the adjacent vertical ladder and opened the wheelhouse door to see if there was anybody inside. He was engulfed by black smoke so shut the door and used his hand-held radio to raise the alarm.

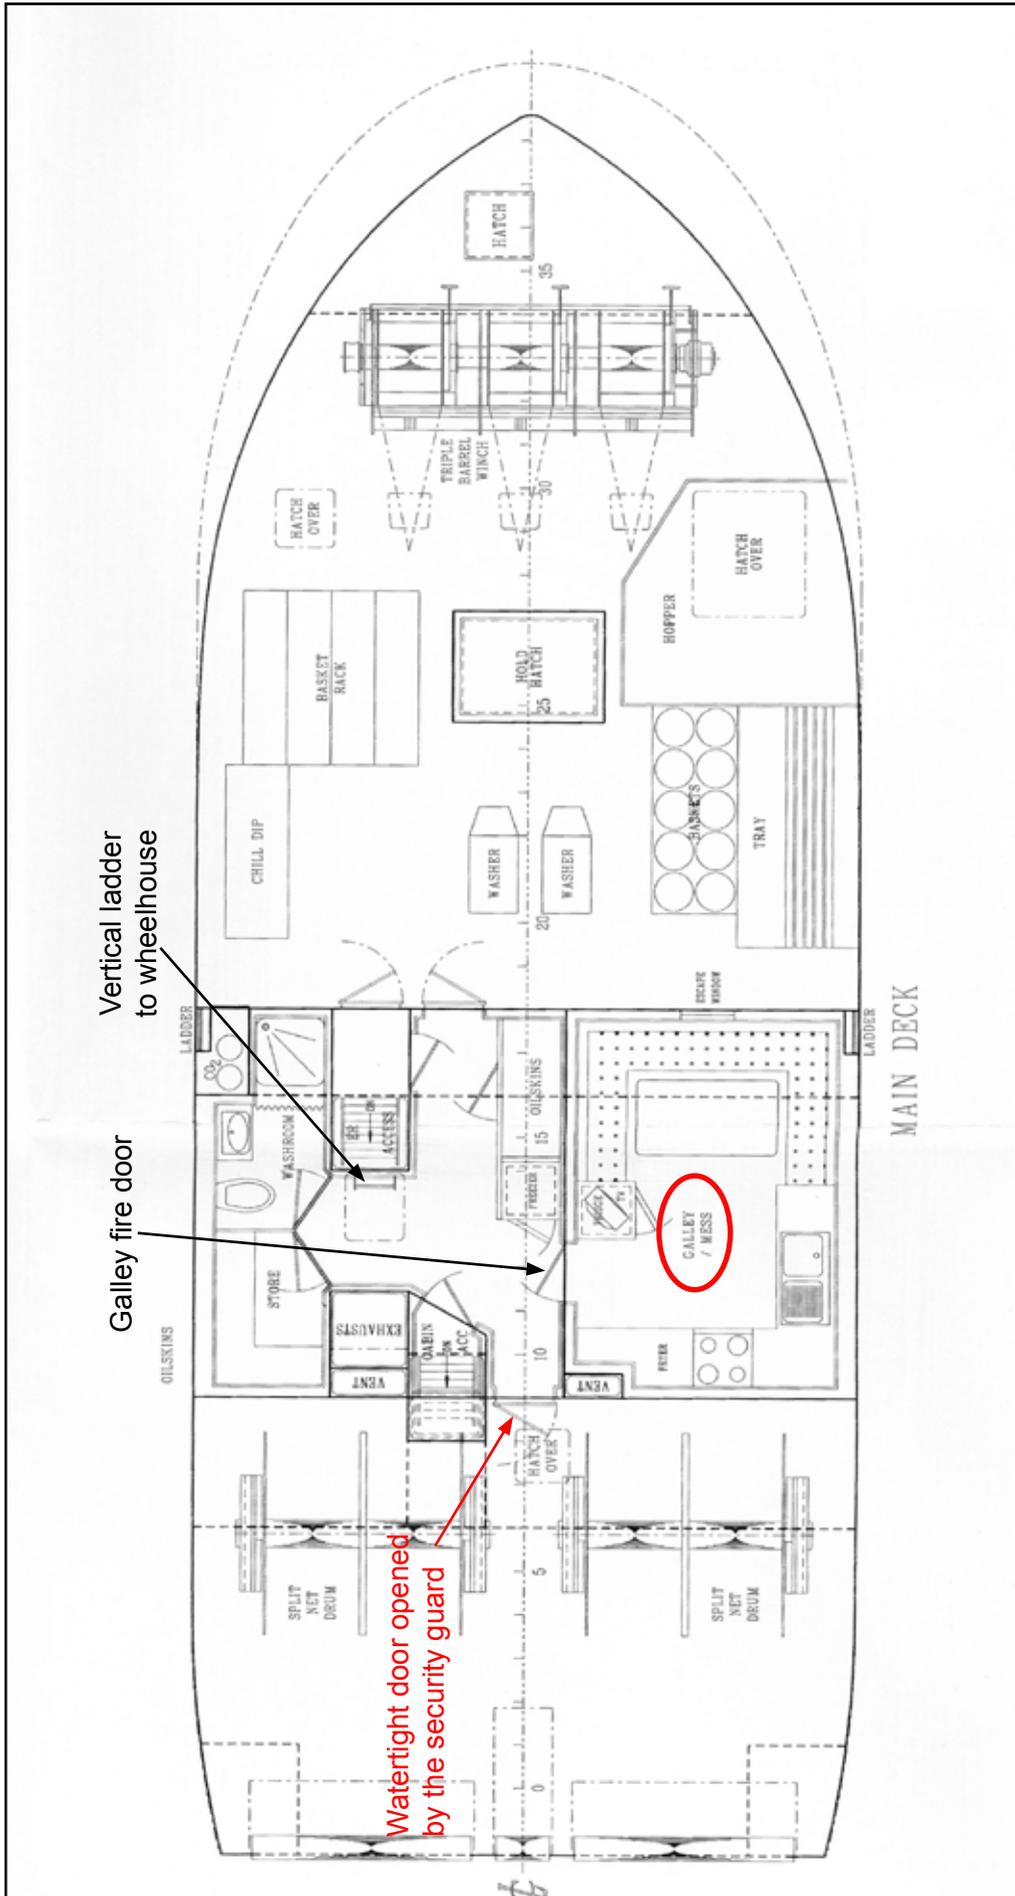
Figure 2

On 1 August at 0930, the fire investigation commenced on board *Vision II*, focussing predominantly on the galley and adjacent areas (**Figure 2**).

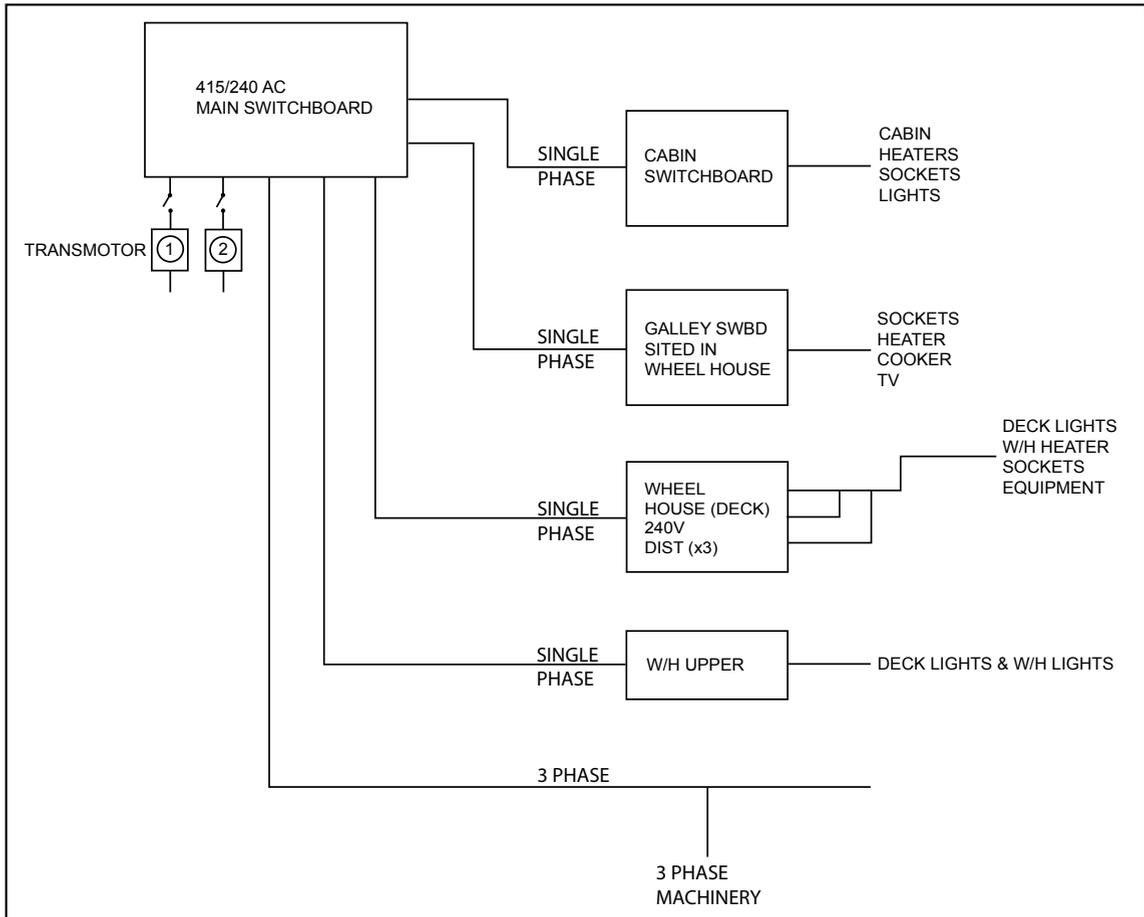
Figure 10

No electrical drawings were ever produced for *Amethyst / Vision II*, and the power distribution diagram system shown in **(Figures 10 and 11)** was derived from post fire examination and advice from the electrical contractor responsible for the vessel's original fit out.

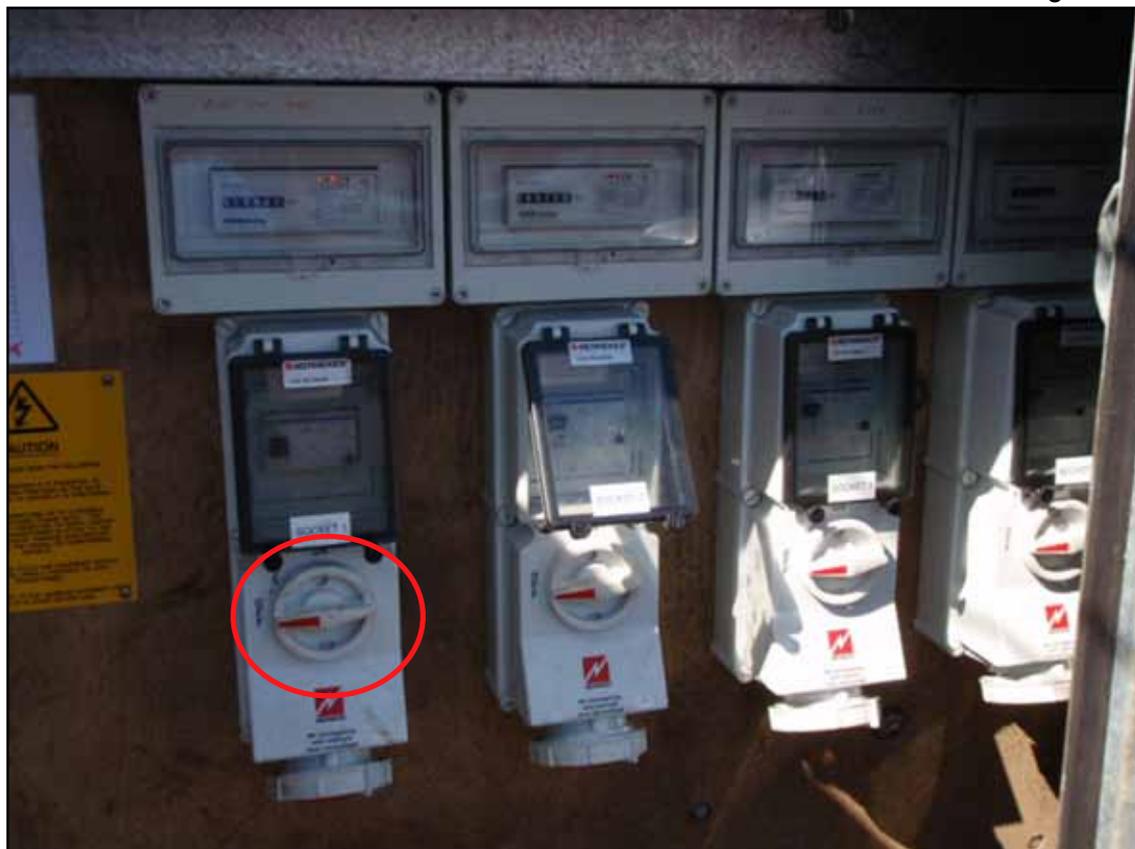
Shore power supply - Provost Park Jetty

The vessel's shore power lead was disconnected from the supply box by a member of the local lifeboat crew on his arrival at the scene of the fire. A qualified electrician, he noticed that the RCD had tripped, and he switched off the power and removed the plug.

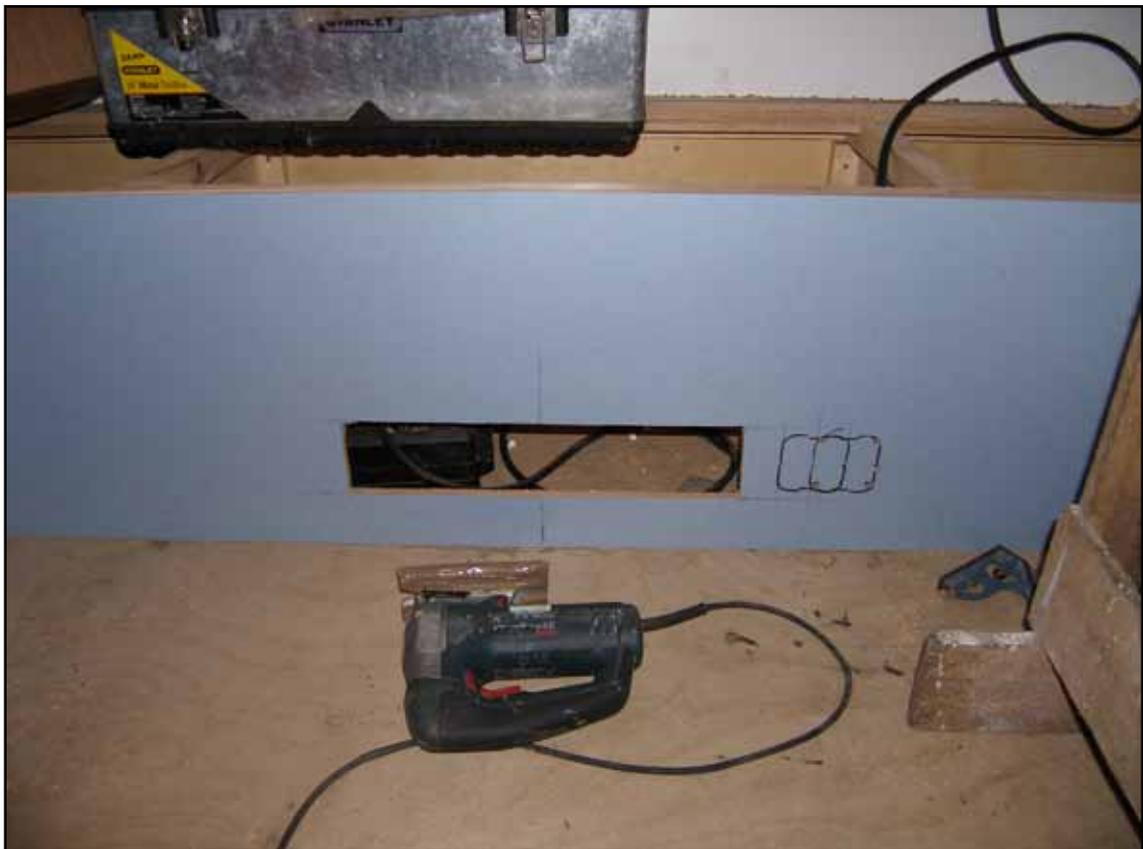
Figure 15a

*Vision II* was fitted with 'Heatstore Base Unit Fan Heaters' that complied with European Safety Standard EN60335-2-30 (**Annex C**). The heaters were specifically designed to fit in the space behind the plinth of domestic floor standing kitchen units (**Figures 15a, b and c**).

Heater aperture

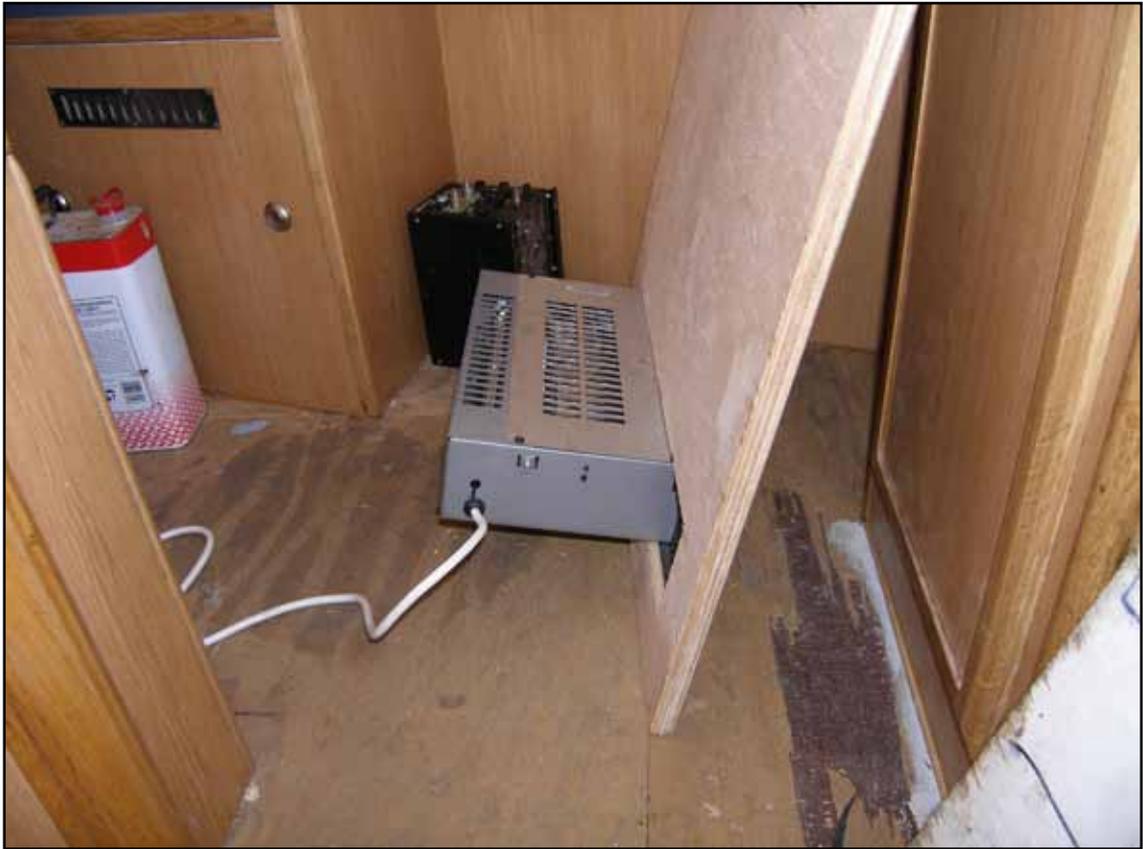
Figure 15b

Heater positioned through the aperture

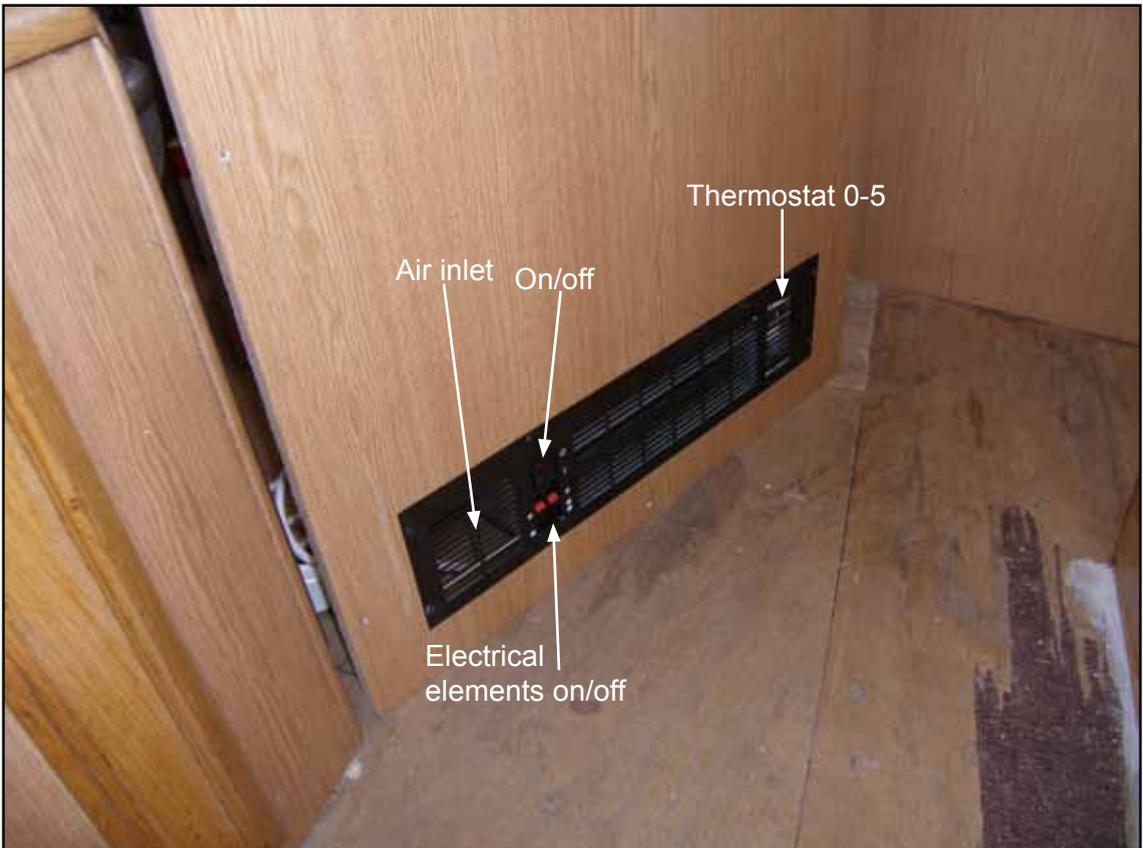
Figure 15c

Heater secured by six wood screws
