Reports on the investigations of  
the fire on board the fishing vessel

***Shark***

the foundering of the fishing vessel

**Report No 13/2008**  
**August 2008**

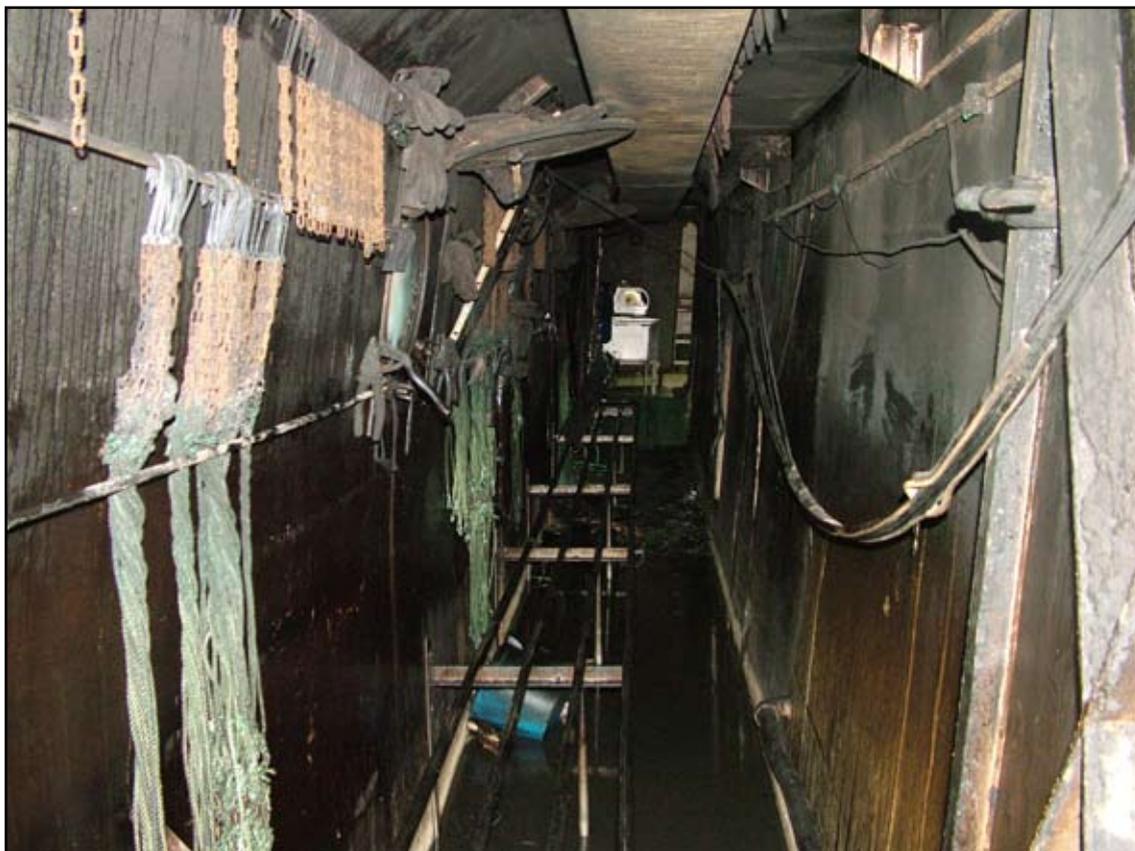
The labour intensive 10-hour long recovery was controlled by the bosun using the hauler on the fish processing deck. The catch was removed, processed and stored in the fish hold, and the hooks re-baited and placed in wooden boxes on the stainless steel rails located in the port working alleyway (**Figure 3**). The boxes were then transferred to the stern area, known as the fishing park, and placed in racks in readiness for the long-line to be laid once more through the stern shooting hatch.

Port working alleyway - looking forward

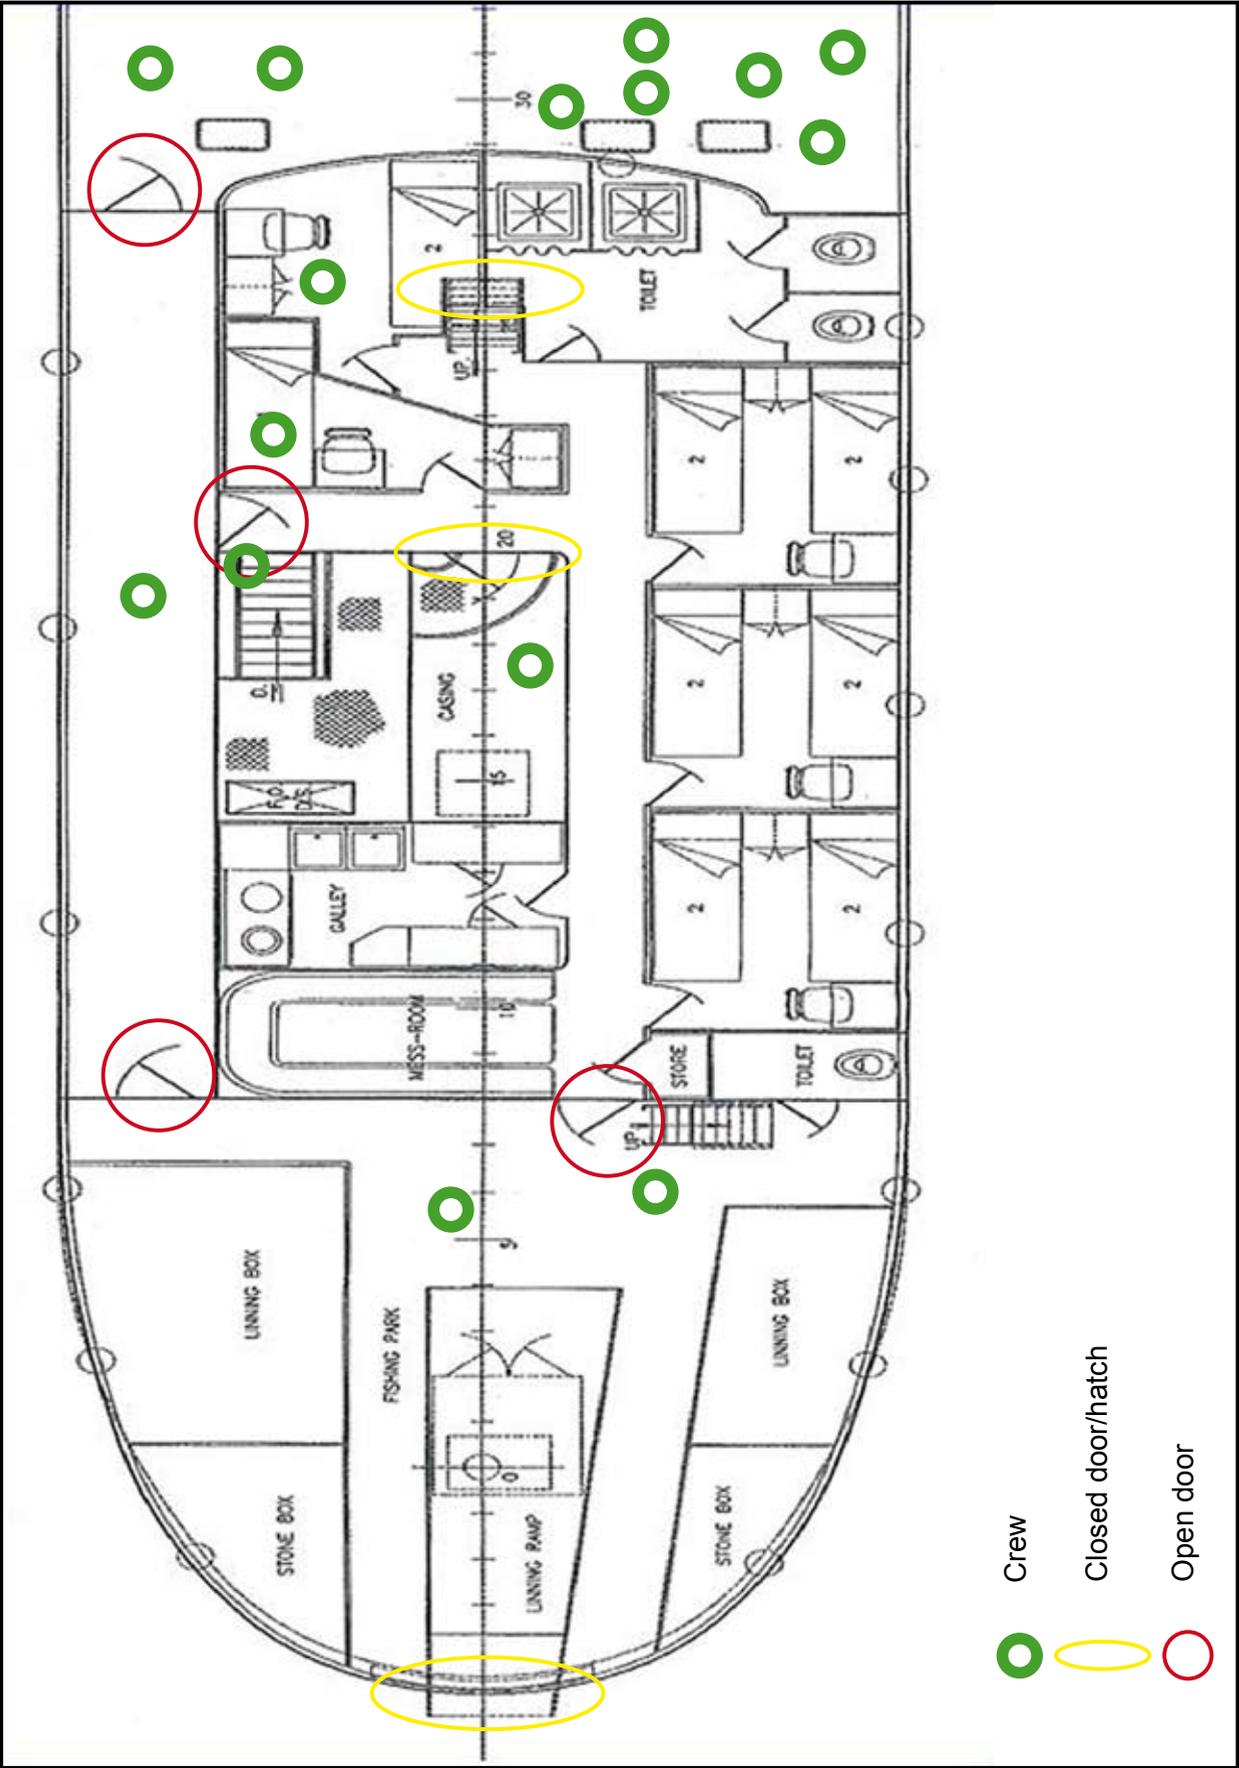
Figure 6

The long-line recovery proceeded steadily. The hooks were re-baited as normal and the long-line prepared for re-shooting. Immediately before 0630 the crew were distributed throughout the working areas, as shown at **Figure 6**. The drawing also shows the status of the main watertight and self-closing engine room and wheelhouse access doors. At this time the chief engineer, mate and cook were in their respective cabins and the skipper was in the wheelhouse.

Distribution of crew and door/hatch positions at 0630

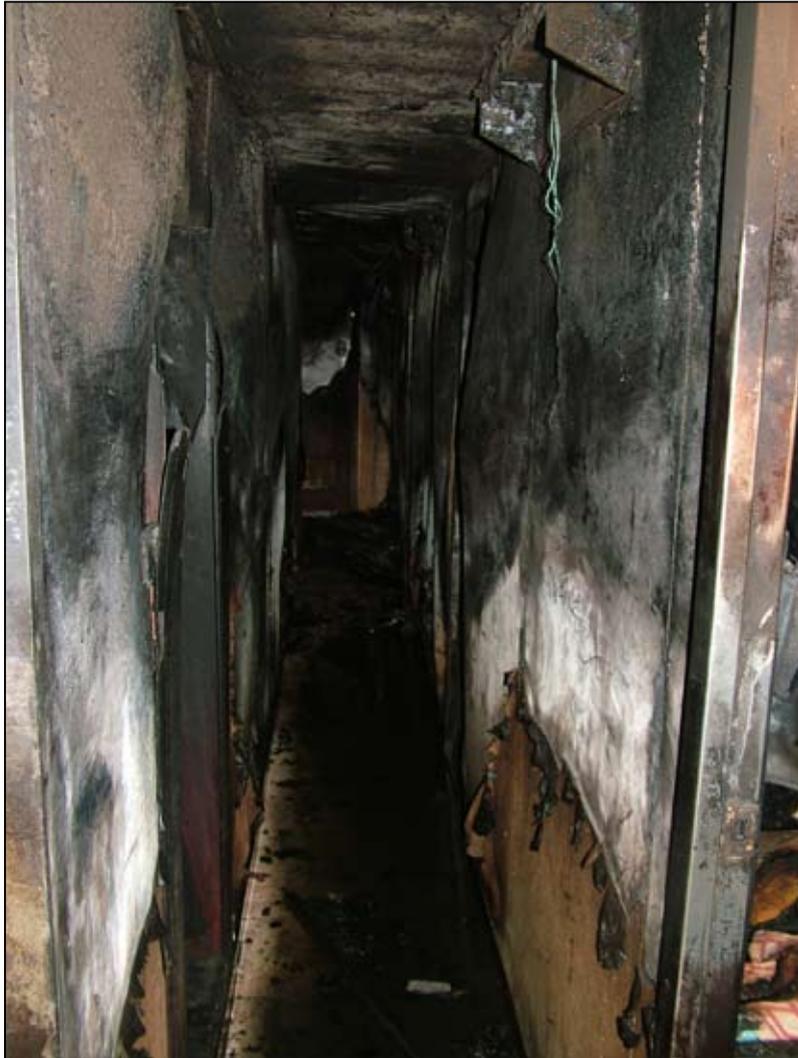
At approximately 0630 the fisherman preparing the long-line on the starboard side of the fishing park looked along the accommodation alleyway (**Figure 7**) and saw thick black smoke coming from the open door of No 2 cabin. He immediately shouted "fire, fire, fire" and ran towards the cabin to investigate, but when he was opposite No 3 cabin door, he was beaten back by the acrid black smoke. As he ran back to the fishing park he glanced into No 3 cabin and saw that it was clear of smoke and flame. He then re-joined his companion on the fishing park deck and did not close the alleyway to fishing park watertight door.

View along the accommodation alleyway

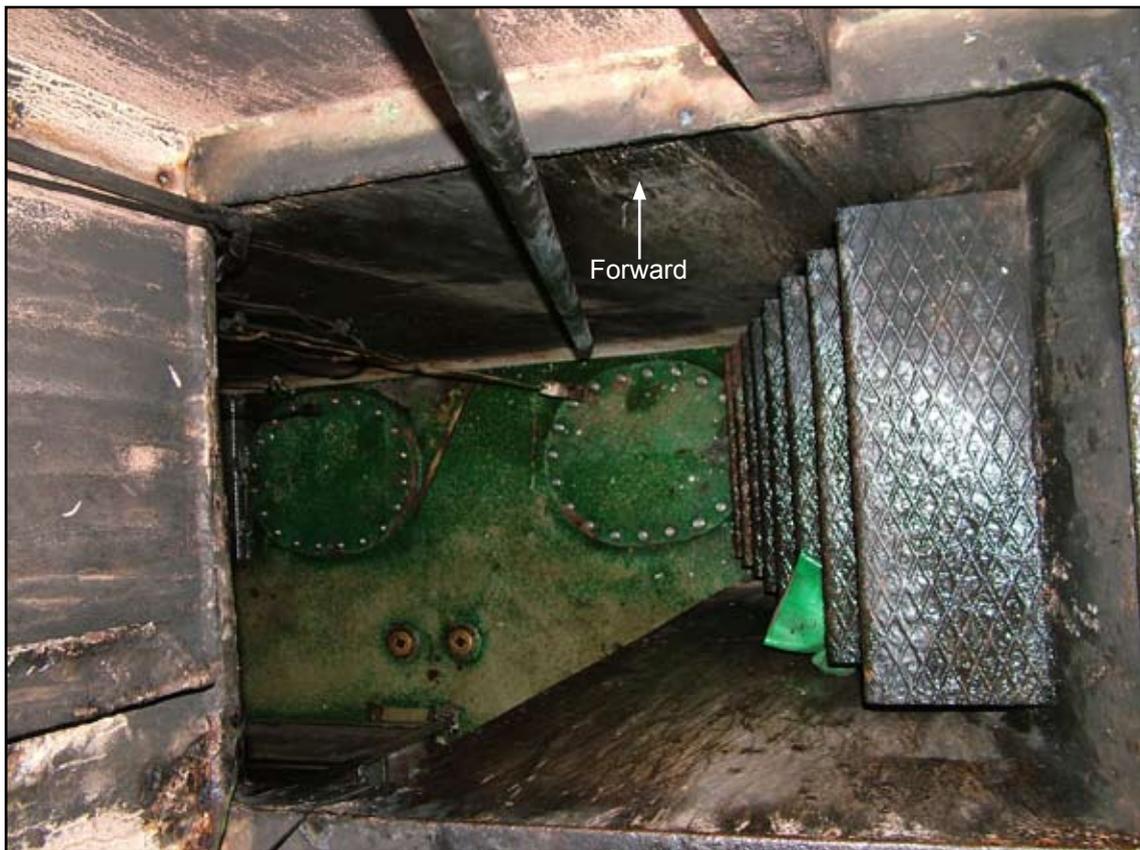
In the meantime, the fishing park was filling with smoke, and visibility in the accommodation alleyway had rapidly reduced. The two fishermen there made their way up the nearby ladder to the main deck, closing the door behind them (**Figure 8**). However, they did not close the after accommodation alleyway door, nor the after port working alleyway door, both of which gave access to the fishing park.

Access to the main deck from the fishing park

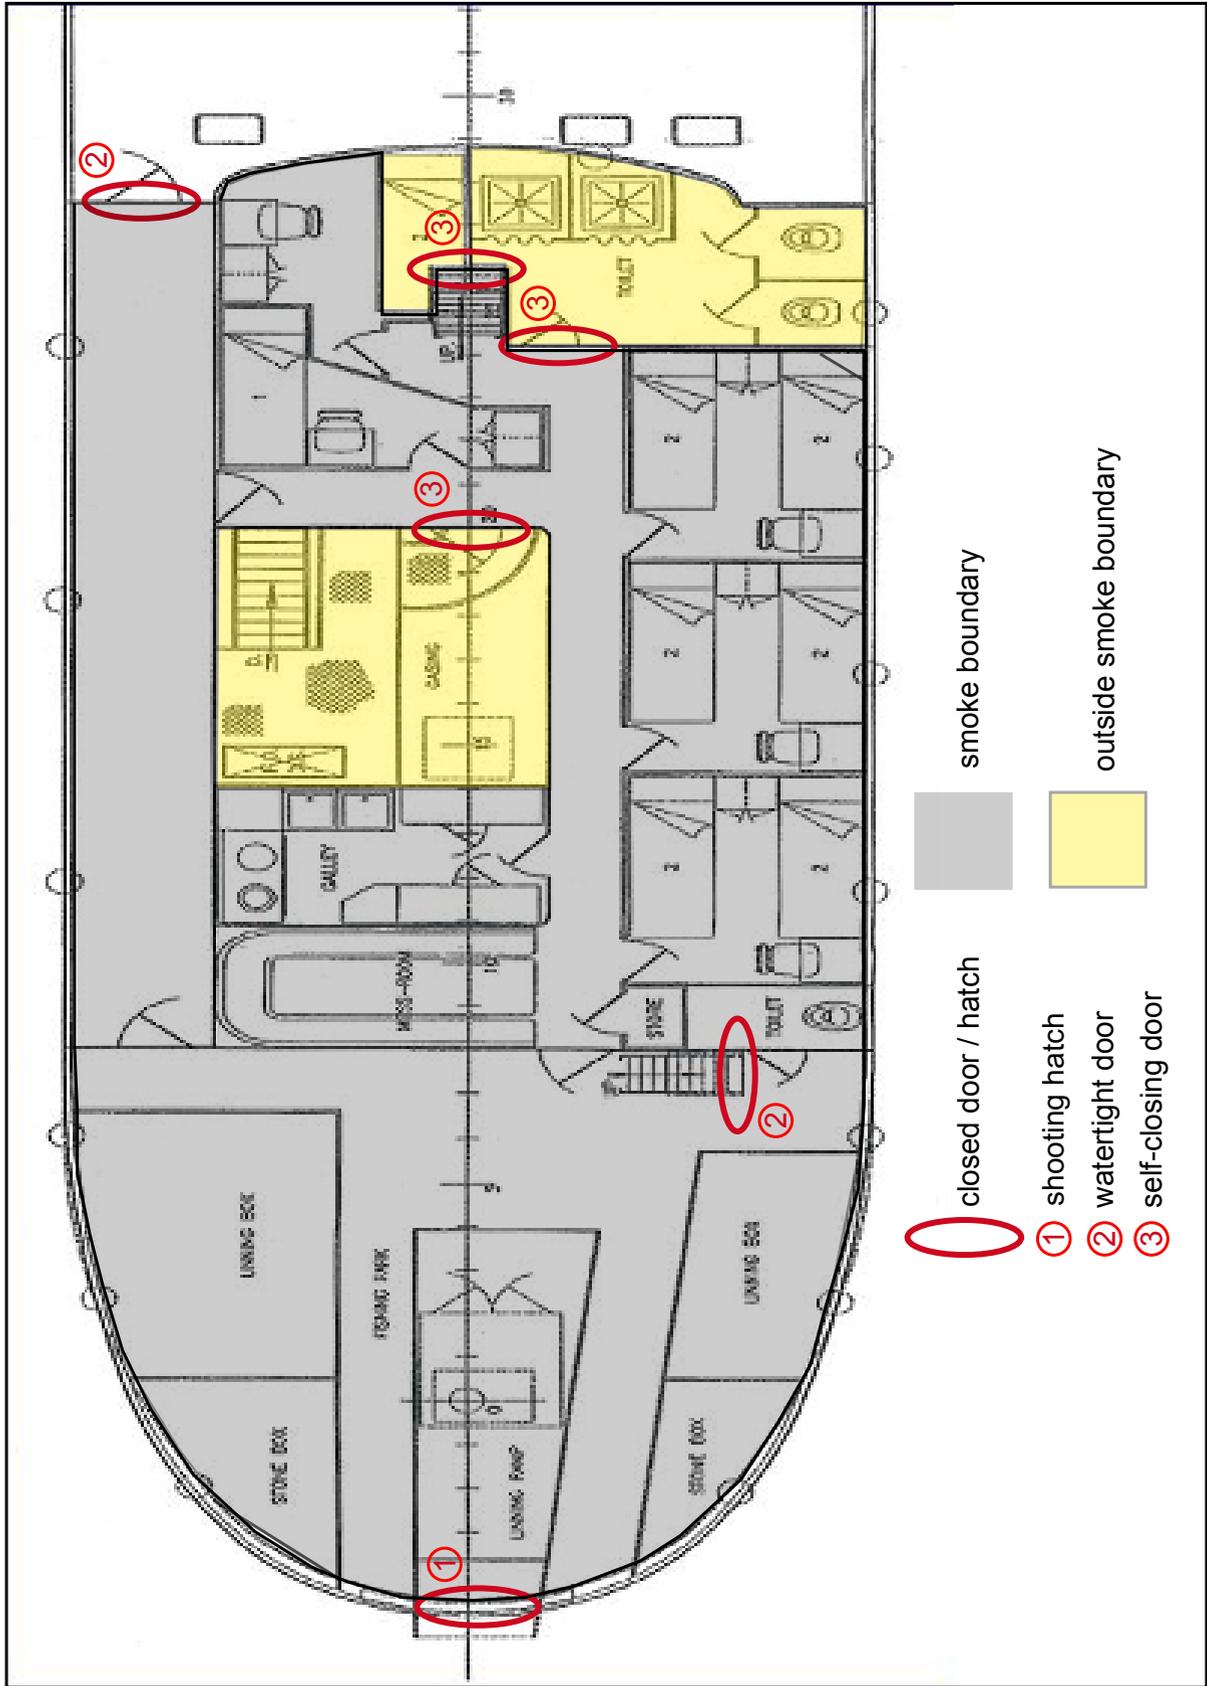
Figure 9

Aware of the need to create a smoke and fire boundary, the skipper and bosun managed to calm down the crew and were eventually able to determine which watertight doors were closed. The skipper then sent crew around the containment boundary to confirm that the doors were firmly shut. The boundary is shown at **Figure 9**. At the same time, the bosun released the long-line from the hauler and buoyed it for later recovery.

Smoke containment boundary at approximately 0635

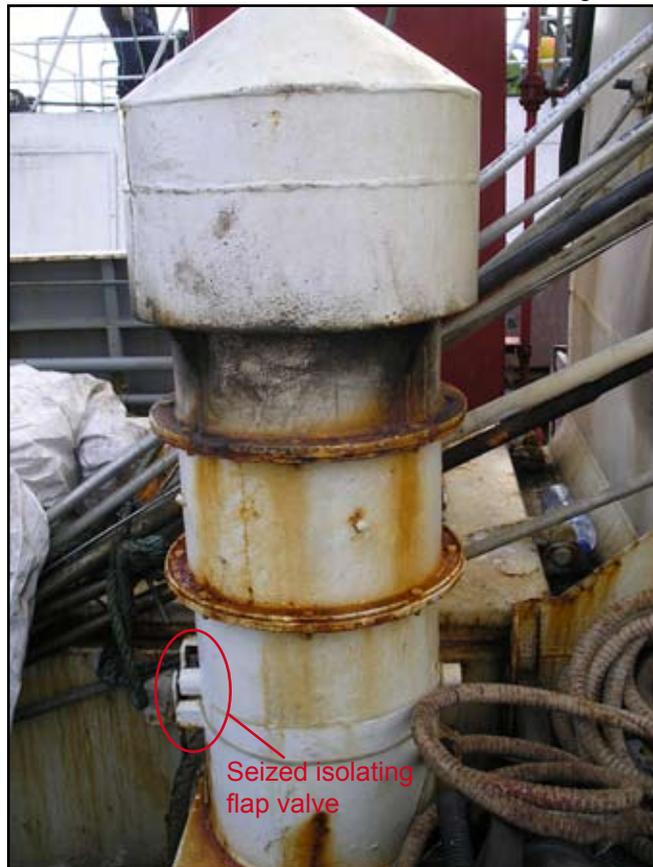
Figure 11

Ventilation terminal

As the hours passed, the skipper came under increasing pressure from the crew to check on the status of the fire. By 1220 the heat on the main deck had died away, there was no evidence of smoke or escalation of the fire and no new hot spots had been found. Despite there being no fire-fighting water available to protect those who would possibly make a re-entry, the skipper was persuaded to remove the rags from the ventilation terminals although it was unclear to him if the fire had been extinguished. However, with the inrush of air, the fire almost immediately strengthened and smoke was seen to come once more from the broken cabin scuttles, and the ventilation terminals, so the rags were replaced.

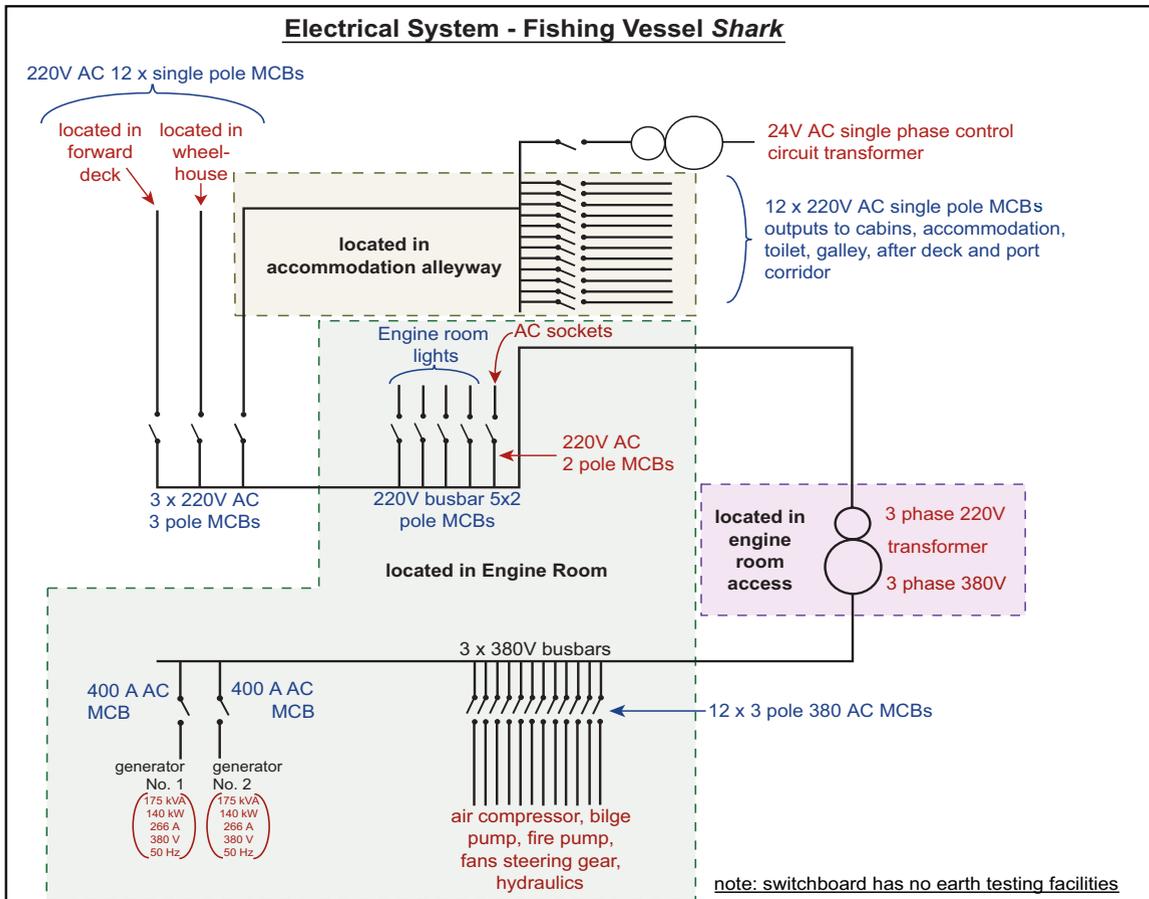
Figure 17

Schematic of the electrical generation and distribution system

The 220v distribution panel located in the cross-alleyway supplied a 24v transformer which, in turn, supplied a control circuit. This was used in the remote start/stop circuitry and pump starter control circuits (**Figure 17**). The control supply was used to "hold on" the starter contacts when the starter button was pushed, which maintained electrical supplies to the pump. When the 220v distribution panel was destroyed, the supply to the control circuit transformer was lost, so the contactor "hold on" circuit failed with the result that the pump could not be started.

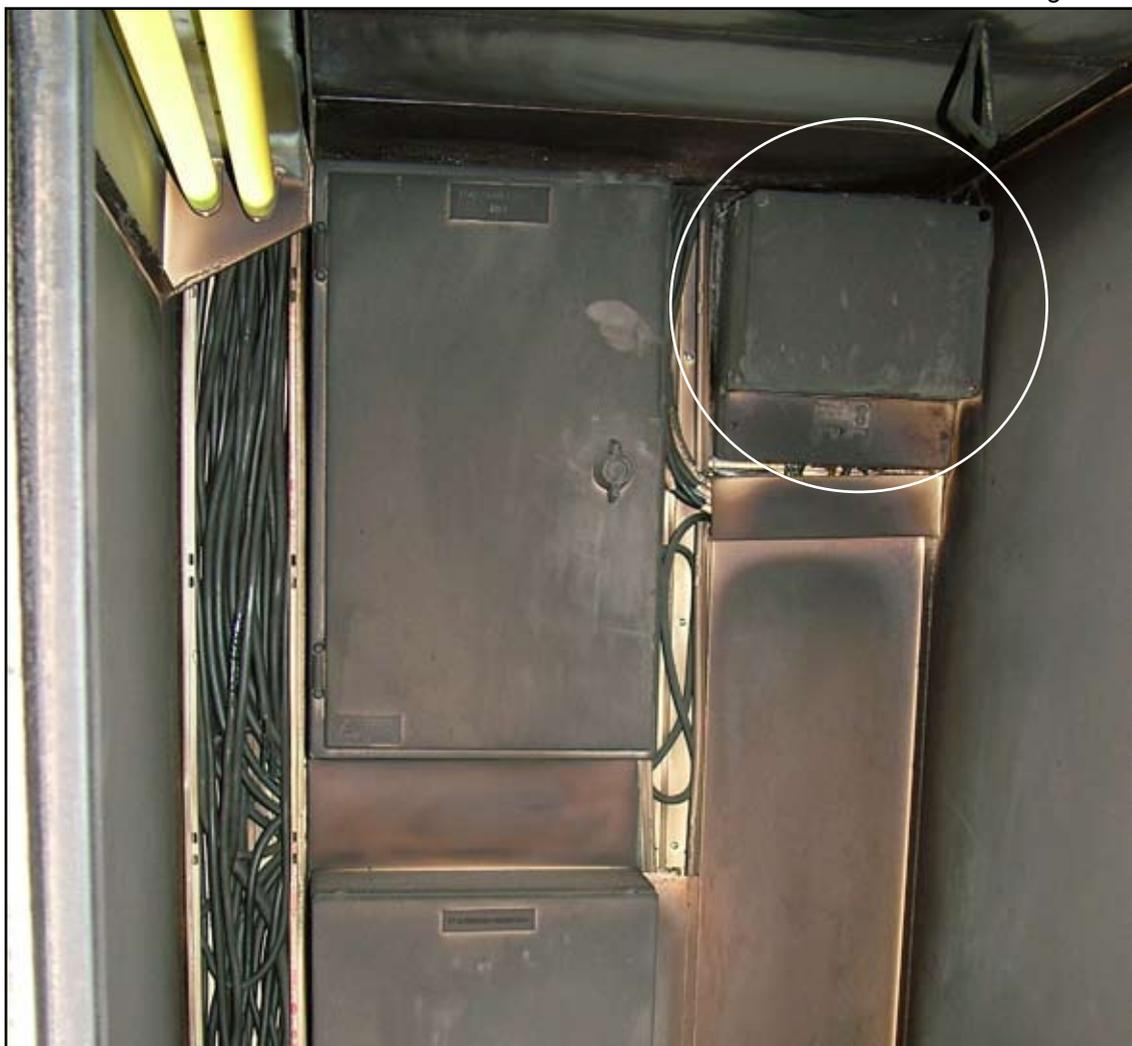
Figure 18

The control panel, which at the time of inspection by the MAIB had not been disturbed since the fire, was positioned at the top of the accommodation to wheelhouse ladder (Figure 18).

Location of fire detection system control box

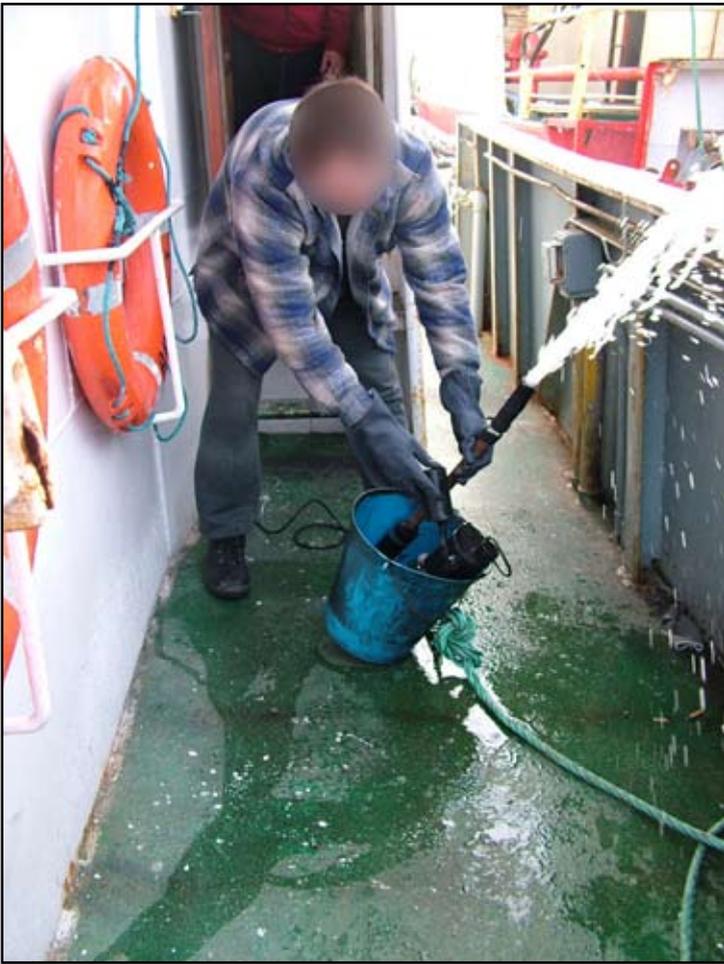
A single 16m<sup>3</sup>/hour submersible pump was carried and found to be in good working order (**Figure 26**).

Figure 26  
Submersible pump in operation

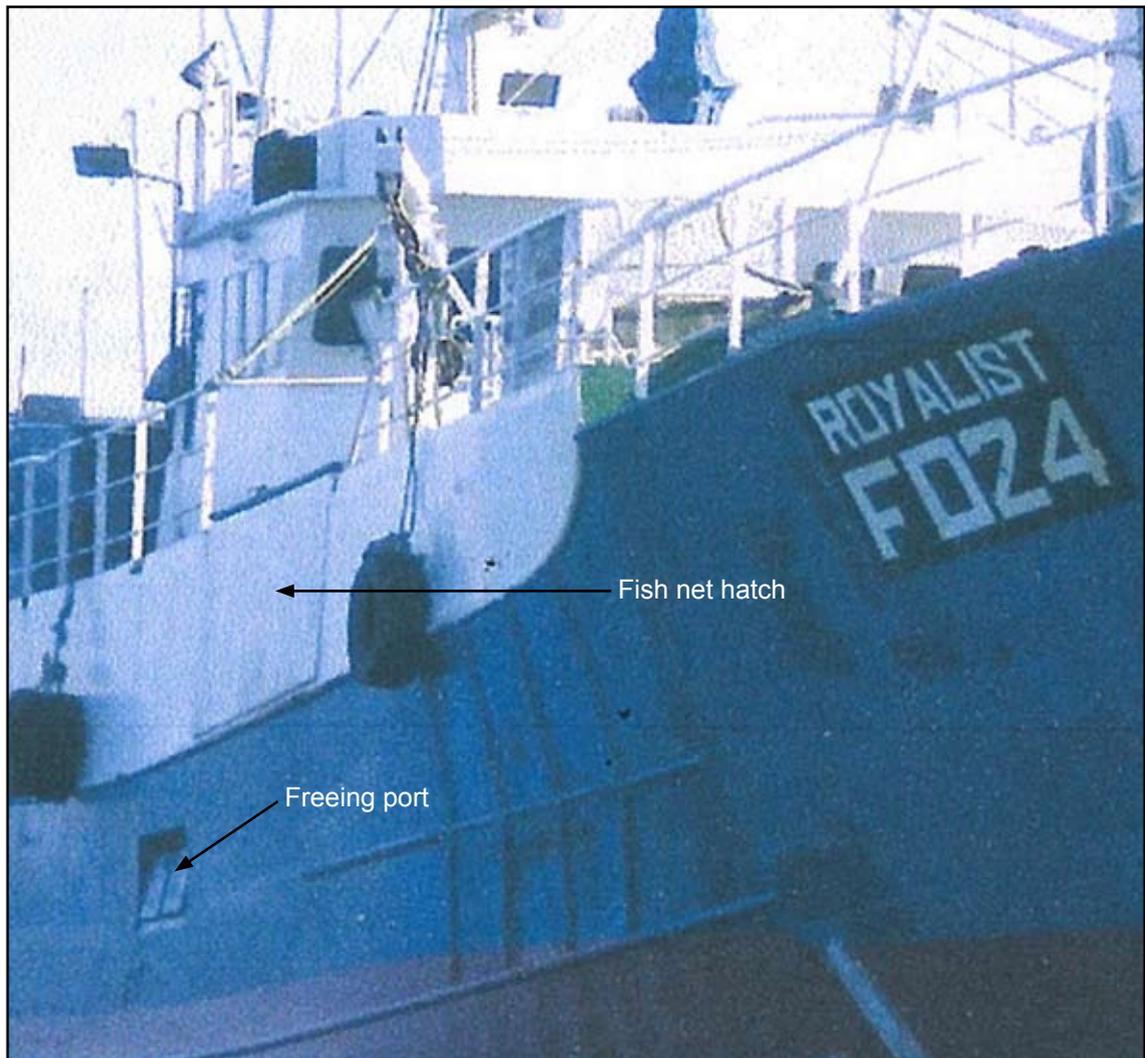
Figure 35

Expanded view of fish net hatch and freeing port arrangements

When steaming with a large swell and high seas directly on her beam, *Royalist* would have undoubtedly been rolling heavily. The waves were at least 6m high and, when she heeled to the extent that the gunwale in way of the fish net hatch on her starboard side was immersed, water would have been scooped onto the main deck. It would then have flowed unchecked through the weathertight door (**Figure 34, C**) which had been left open. Once inside the accommodation, the water was trapped and its weight would have reduced the vessel's stability and caused a list to starboard.

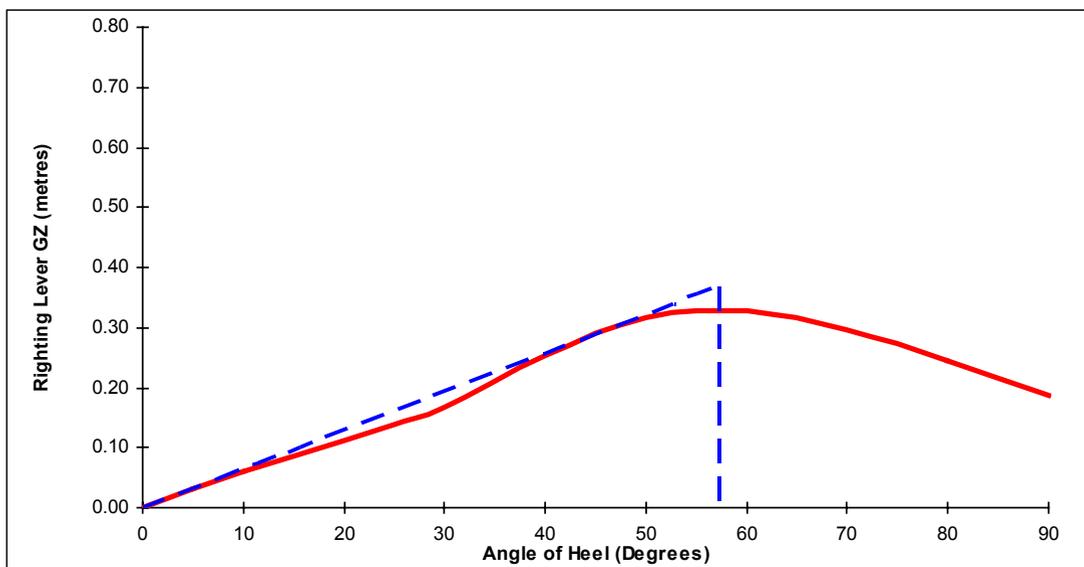
### Summary of Stability

Criteria	Rule Minimum	Actual Value
Area Under Righting Lever (GZ) to 30°	0.055 m rads.	0.051 m rads.
Area GZ from 30 degrees to lesser of 40° and X	0.030 m rads.	0.041 m rads.
Area Under Righting Lever (GZ) to 40°	0.090 m rads.	0.092 m rads.
Maximum Righting Lever (GZ)	0.20 m	0.370 m
Angle of Heel at which Maximum Righting Lever (GZ) Occurs	30 degrees	59 deg apprx
Transverse Metacentric Height ( $GM_{fluid}$ )	0.15 m	0.418 m

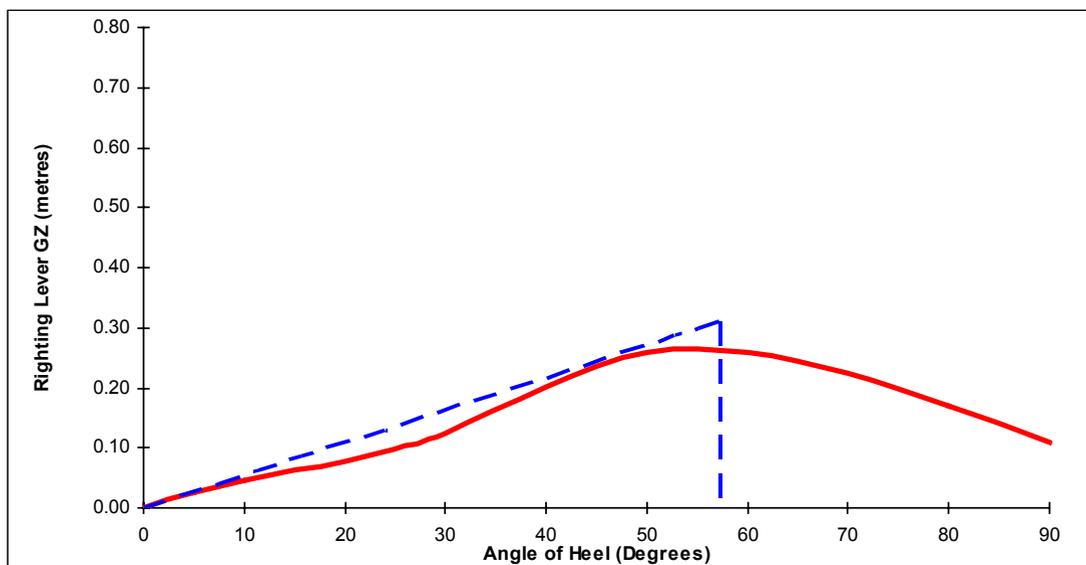
An initial heel of about 17° was required to immerse the starboard gunwale below the waterline. For the gunwale to remain immersed, the freeboard on the starboard side would have had to be reduced by about 1.1m. It is estimated that this would have been possible with about 10 tonnes of water on the main working deck and 9 tonnes of water in the starboard alleyway (**Table 2**).

Although the net hatch was not weathertight, its closure undoubtedly slowed the ingress of water. However, the water that accumulated in the alleyway was able to progressively down-flood via the doors to the engine room and aft accommodation (**Figure 34, E & F**), which were also left open. Ultimately, this led to a critical loss of buoyancy.

### Summary of Stability

Criteria	Rule Minimum	Actual Value
Area Under Righting Lever (GZ) to 30°	0.055 m rads.	0.038 m rads.
Area GZ from 30 degrees to lesser of 40° and X	0.030 m rads.	0.030 m rads.
Area Under Righting Lever (GZ) to 40°	0.090 m rads.	0.067 m rads.
Maximum Righting Lever (GZ)	0.20 m	0.283 m
Angle of Heel at which Maximum Righting Lever (GZ) Occurs	30 degrees	54 deg approx
Transverse Metacentric Height (GM <sub>fluid</sub> )	0.15 m	0.338 m
