Report on the investigation of the electrical blackout
and subsequent grounding of the ro-ro cargo ship

Moondance

in Warrenpoint Harbour, Northern Ireland

Report No 5/2009
February 2009

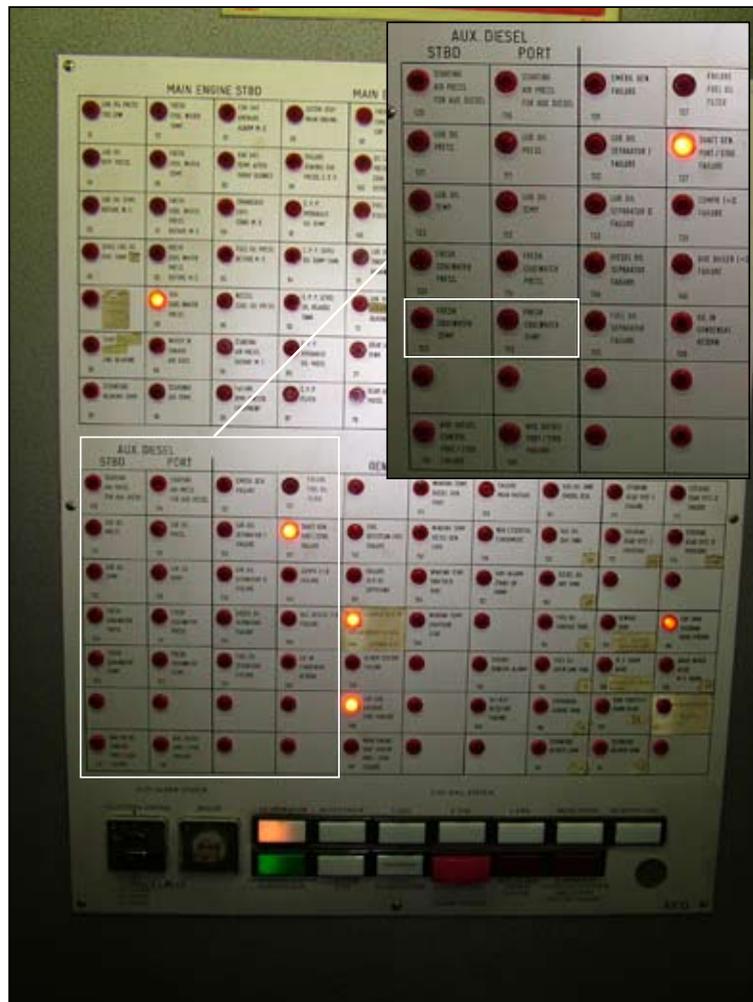
Figure 4

At approximately 1808, just before *Moondance* slipped from the berth, the second engineer was in the engine room when he heard an alarm. He returned to the ECR and saw that the port generator high fresh water temperature alarm was sounding and the red alarm light was illuminated on the ECR alarm panel (**Figure 4**). The second engineer cancelled the alarm and went into the engine room to investigate the cause. As he approached the port generator another alarm sounded, but he did not, at this point, return to the ECR to check what the fault was, nor did he alert the chief engineer or the master to the overheating problem.

The second engineer felt the port generator fresh water cooler outlet pipe and found it to be hot. He also noted that the fresh water cooling thermometer was reading above 90°C. Unable to determine the cause of the overheating, the second engineer returned to the ECR, where he was confronted with numerous red lights and audible alarms, including those for the starboard generator. He cancelled the alarms, but once again he did not alert the chief engineer to the problems. Believing there must have been an interruption in the sea water cooling of the generator fresh water system, the second engineer re-started the harbour service pump to supply the necessary cooling water to the generators. As he was about to leave the ECR to check the positions of the generator sea

Engine Control Room alarm panel

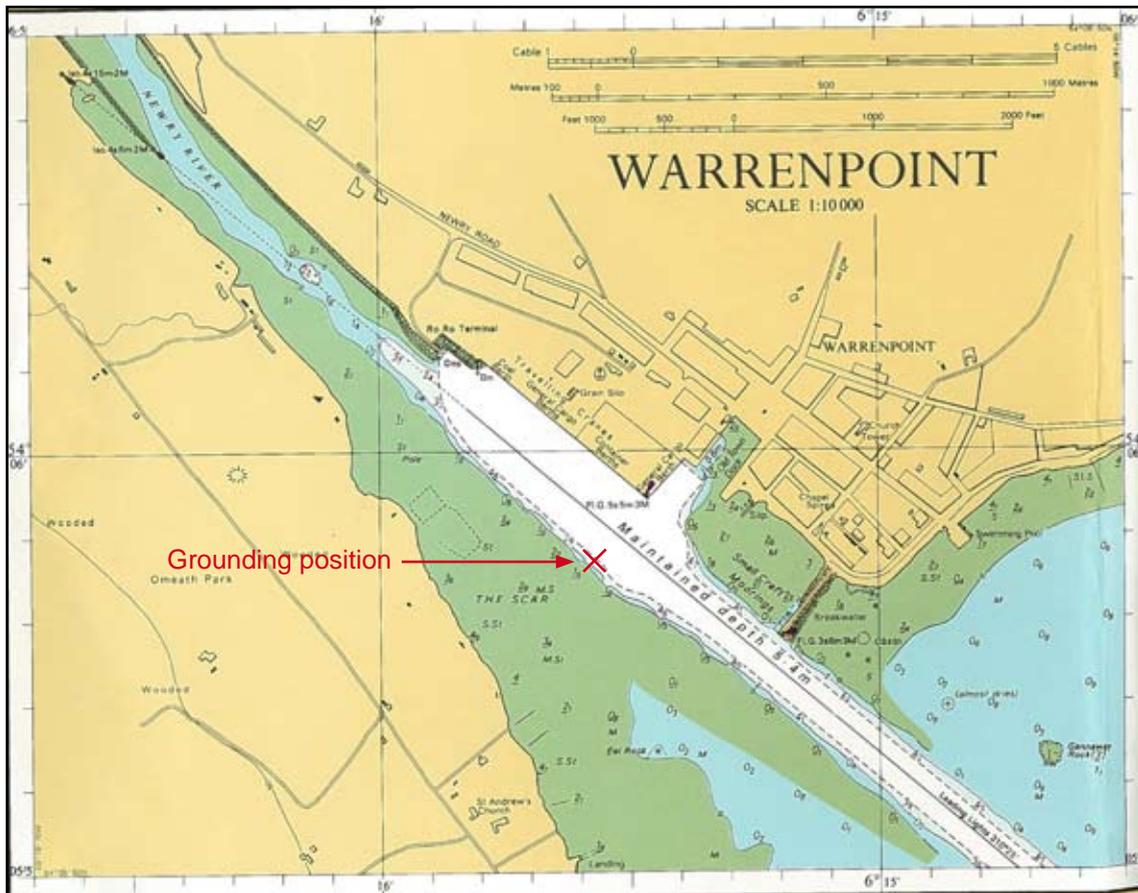
Figure 6

The second officer was in his cabin when he heard the alarms from the bridge. He immediately made his way there to mute the alarms and to assist the master. At 1812 the master noticed that the main engines had been stopped and that the port and starboard propeller pitch indicators, on the port bridge wing and on the bridge indicated full astern pitch. Recognising the immediate risk of grounding, the master ordered the bosun to let go both anchors, which he duly did. However, *Moondance* continued to make sternway and, at 1813, she grounded on the south-western bank of Carlingford Lough, with the ship's head at 055° (T). The incident was recorded on the Warrenpoint Harbour video monitoring system. The grounding position is shown on the chartlet at **Figure 6**.

Chartlet of Warrenpoint Harbour, showing grounding position

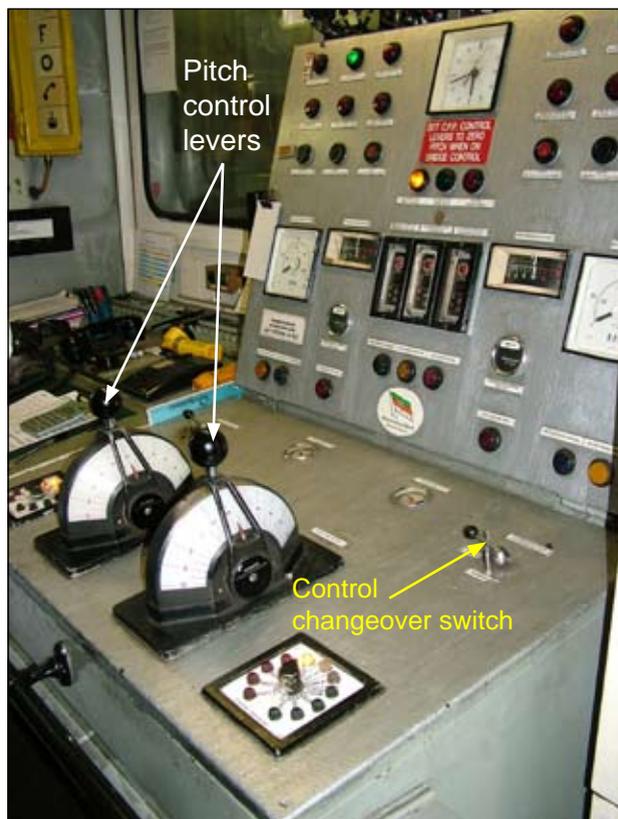
Figure 10

Both the chief and second engineers noted that the port and starboard ECR CPP control levers were set at zero and were selected for bridge control. The ECR port propeller pitch indicator was showing 15° astern, and the starboard pitch indicator was showing about 6° astern (**Figure 10**). No attempt was made to ascertain the true propeller pitch position by reading the mechanical indicator on the CPP oil transfer boxes.

Position of Engine Control Room controllable pitch propeller levers, control changeover switch and instrumentation

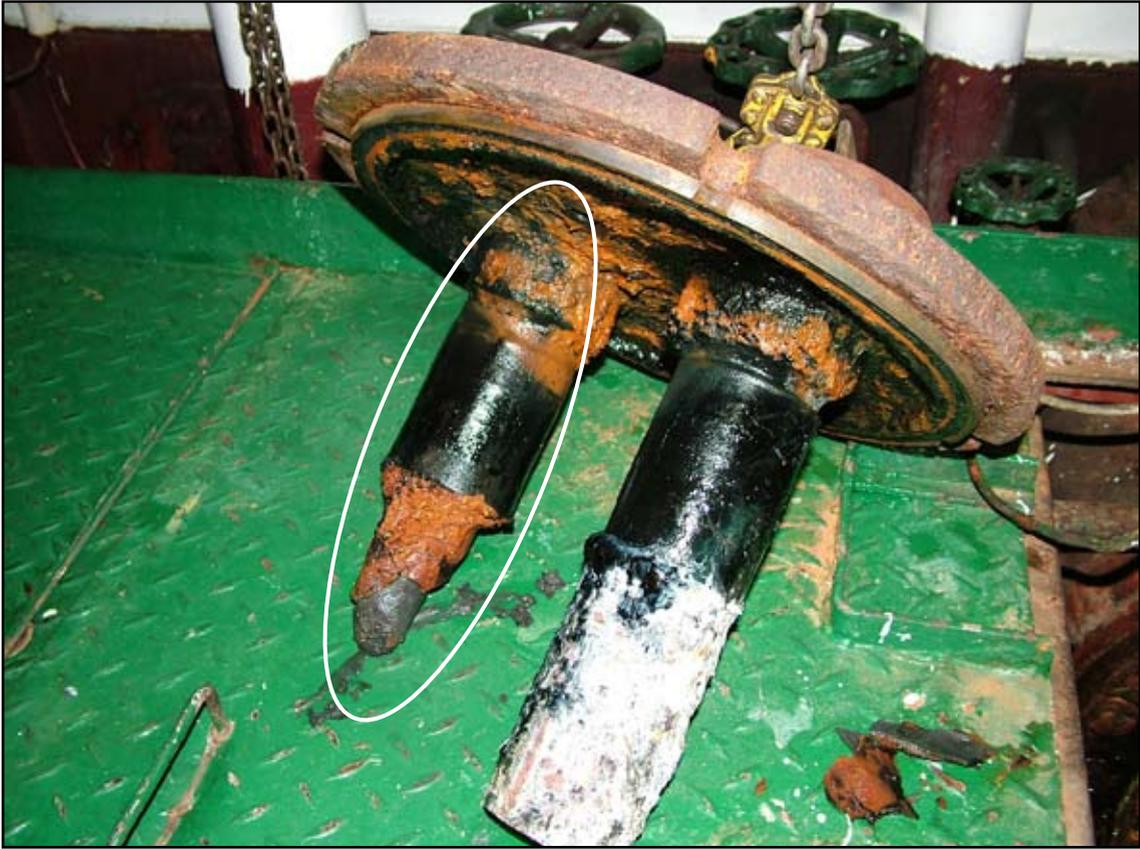
Figure 24

The sea water system was protected from the build up of marine growth, which could cause blockage and affect heat transfer, by an Intakematic Marine Growth Protection System. The port and starboard main service pump suction strainers were fitted with sacrificial anodes (**Figure 24**) fed by a low, direct current (dc), electrical supply provided via a control panel (**Figure 25**). The system operating instructions (**Annex F**) specified a normal current setting of 0.3 amps, but it was noted that the control panel was set to deliver 0.7 amps.

Main service pump suction strainer Intakematic
Marine Growth Protection System sacrificial anode

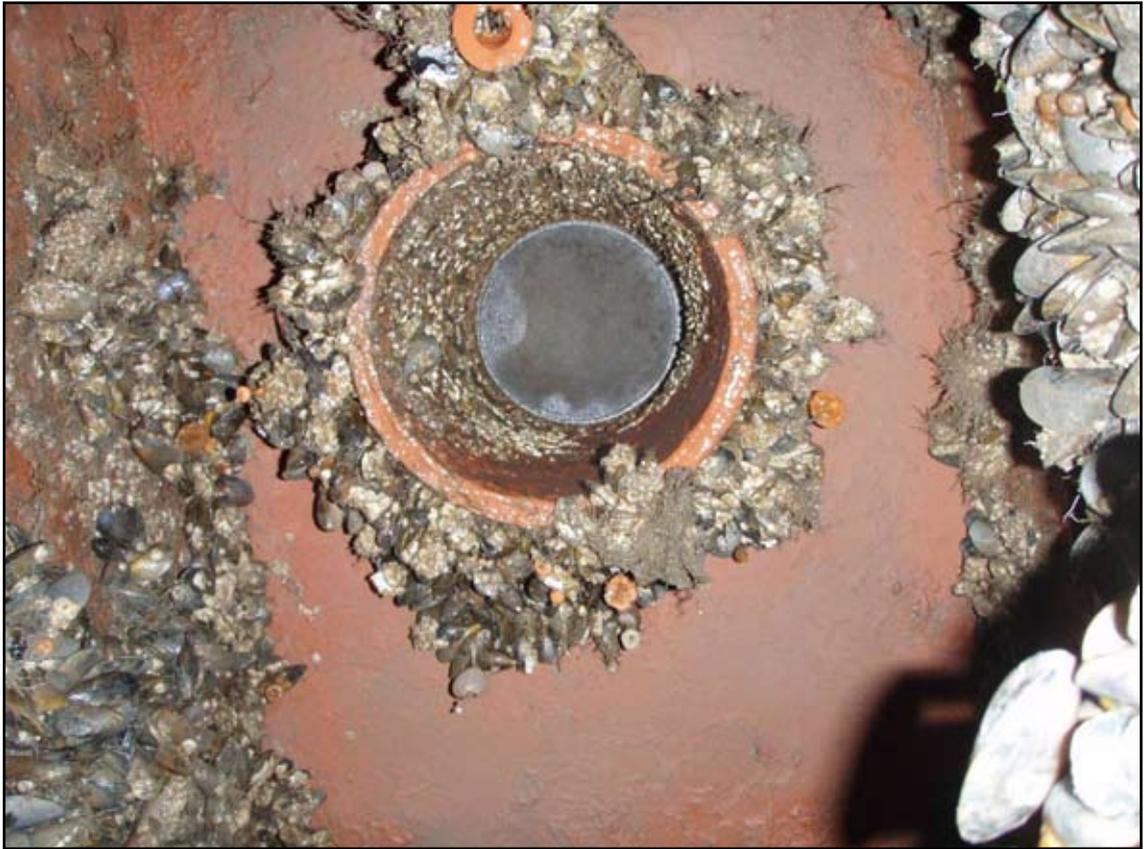
Figure 27

All gratings were found to be correctly secured. The mainly unused starboard, low level suction grating was largely free of marine and crustacean growth (**Figure 26**), although there was a small amount of mussel growth inside the sea chest (**Figure 27**). There was heavy mussel attachment to the outside of the port high level suction gratings for both the harbour service and main service pumps. Mussel attachment on the inside of the gratings was markedly worse. Mussels were also attached to the inside of the sea chest, although the pump suction stub pipes were clear (**Figures 28, 29 and 30**).

Inside starboard main service pump low level suction sea chest

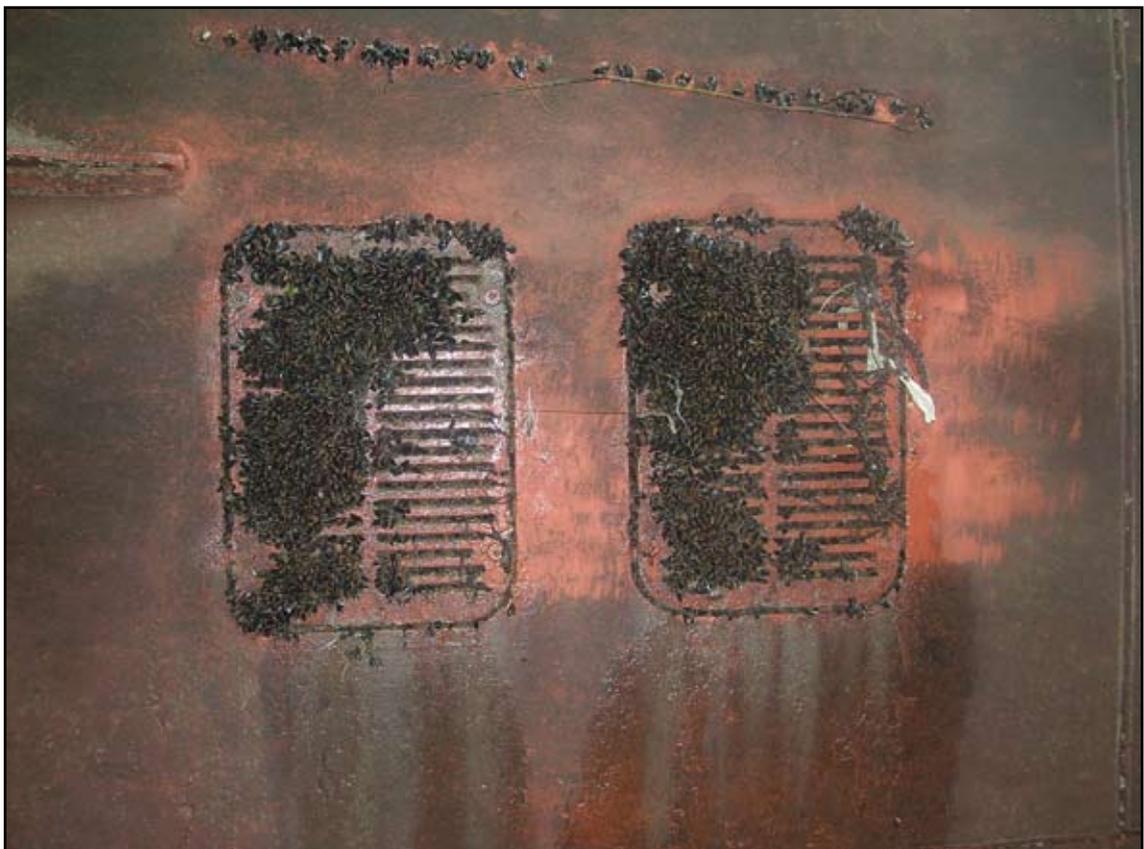
Figure 28

Port main service pump and harbour service pump
high level suction grating - external view

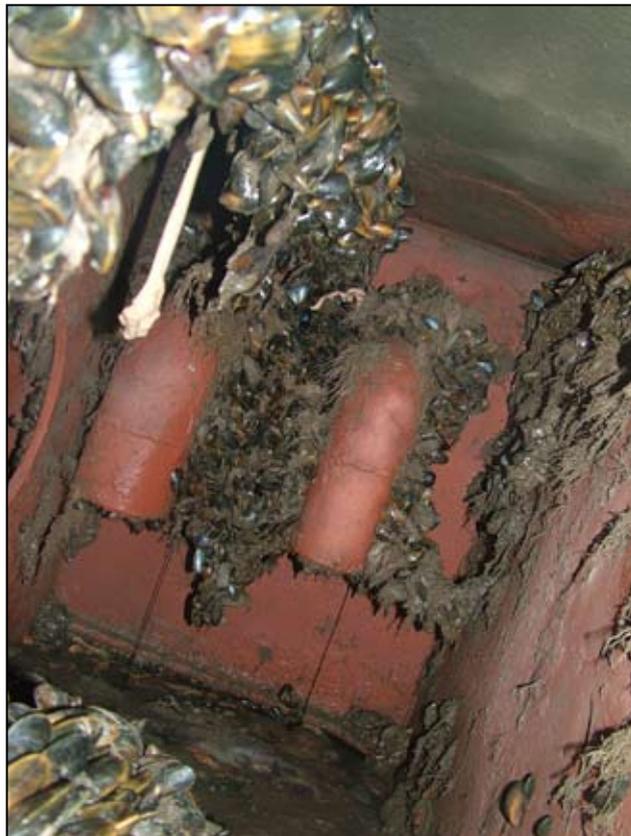
Figure 30

Port main service pump and harbour service
pump high level suction sea chest
